# COLORADO CULTURAL RESOURCE SURVEY

# Architectural Inventory Form

1. Resource number: 5DA875
2. Temporary resource number: 10065-5DA875
3. County: Douglas
4. City: Parker
5. Historic building name: Ponce de Leon Chalybeate Springs, Allison's Twin House, Allison Ranch
6. Current building name: Agricultural property
7. Building address: 13100 block Parker Road, Parker, Colorado 80134
8. Owner name and address: Parker & Stroh LLC, P.O. Box 40326, Denver, Colorado 80204

## Evaluation of Ponce de Leon Chalybeate Springs/ Allison's Twin House, Douglas County, Colorado

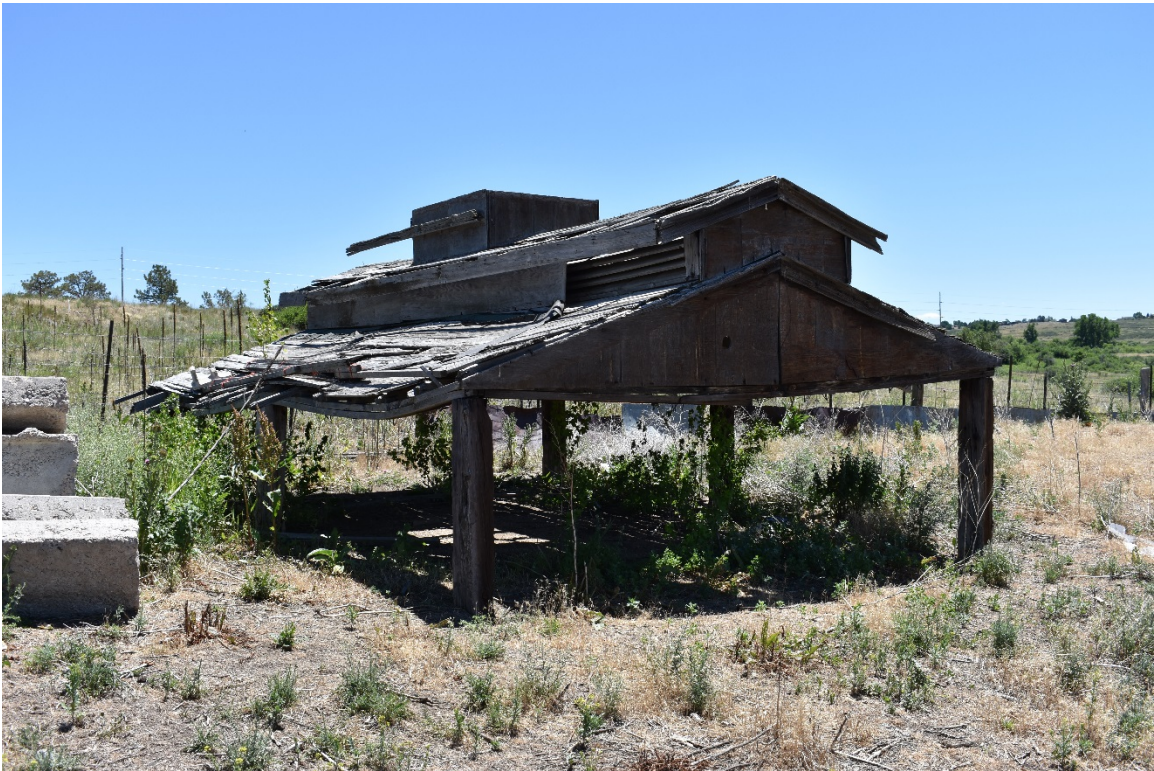
In the southeast corner of the building complex is a possible chicken coop (F6). The building remains include a deteriorating gabled roof clad in horizontal wood boards. The monitor roof (double-pitched gable roof) roof has wood louvers along the long sides of the monitor. The roof is set on top of 4-ft-tall wood piers and there are no walls; the piers are about 8 inch by 8 inch. Remnants of mesh fabric are visible along the roof line.

5DA875 – Possible chicken coop (F6); view to the southeast.  
Photograph: DSC\_0278      Date: 6/25/2018
