Asbestos Inspection Report

McDonalds Parker – Store# 50162

May 23, 2023 | Terracon Project No. 25237106

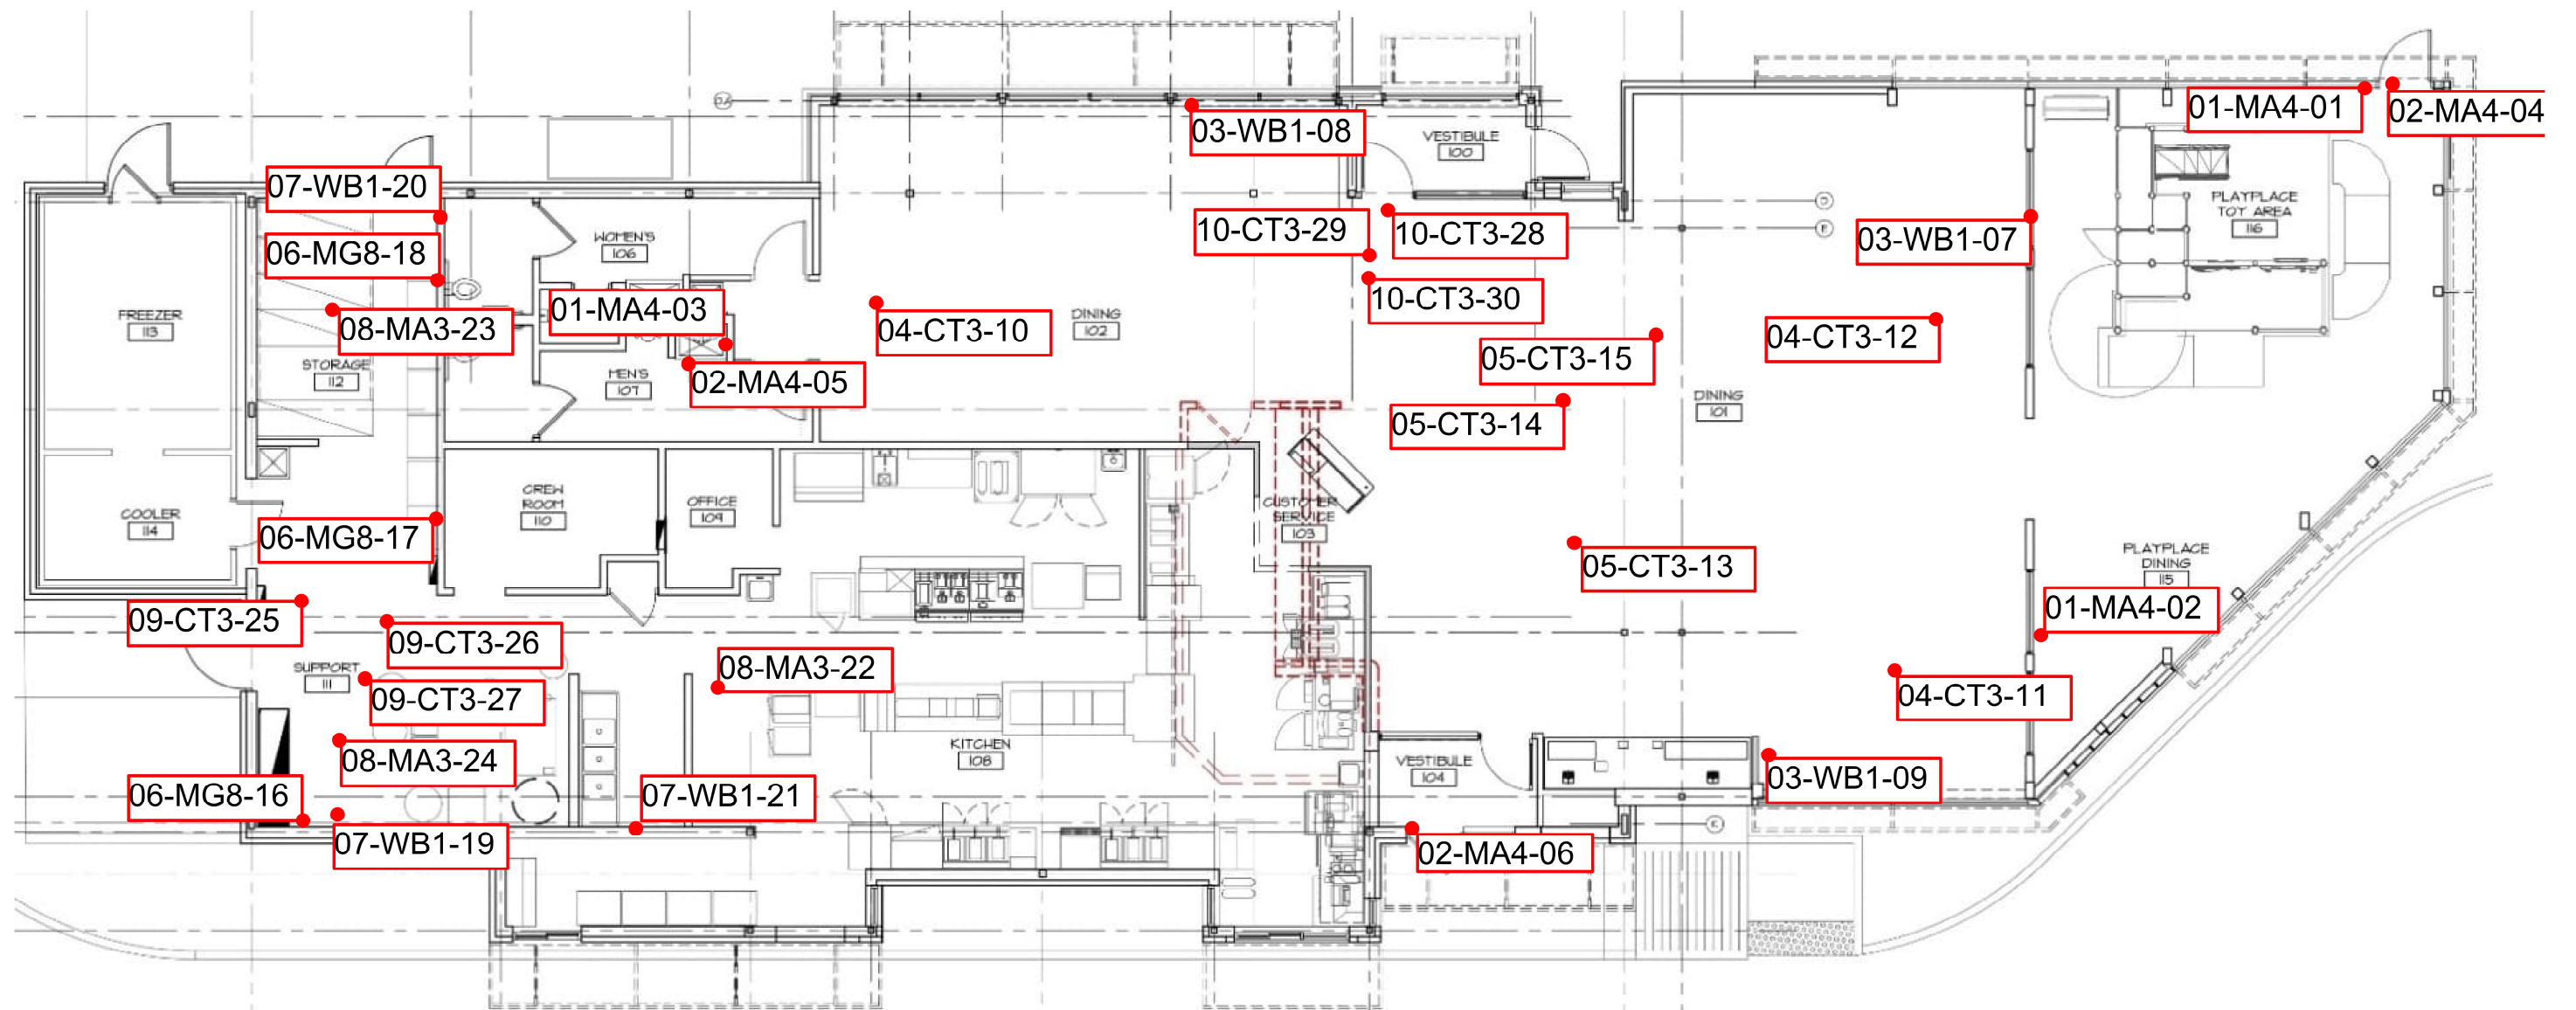
Figure
1

SUSPECT ACM SAMPLE LOCATION DRAWING
MCDONALDS - 50162 10950 SOUTH PARKER ROAD PARKER, COLORADO

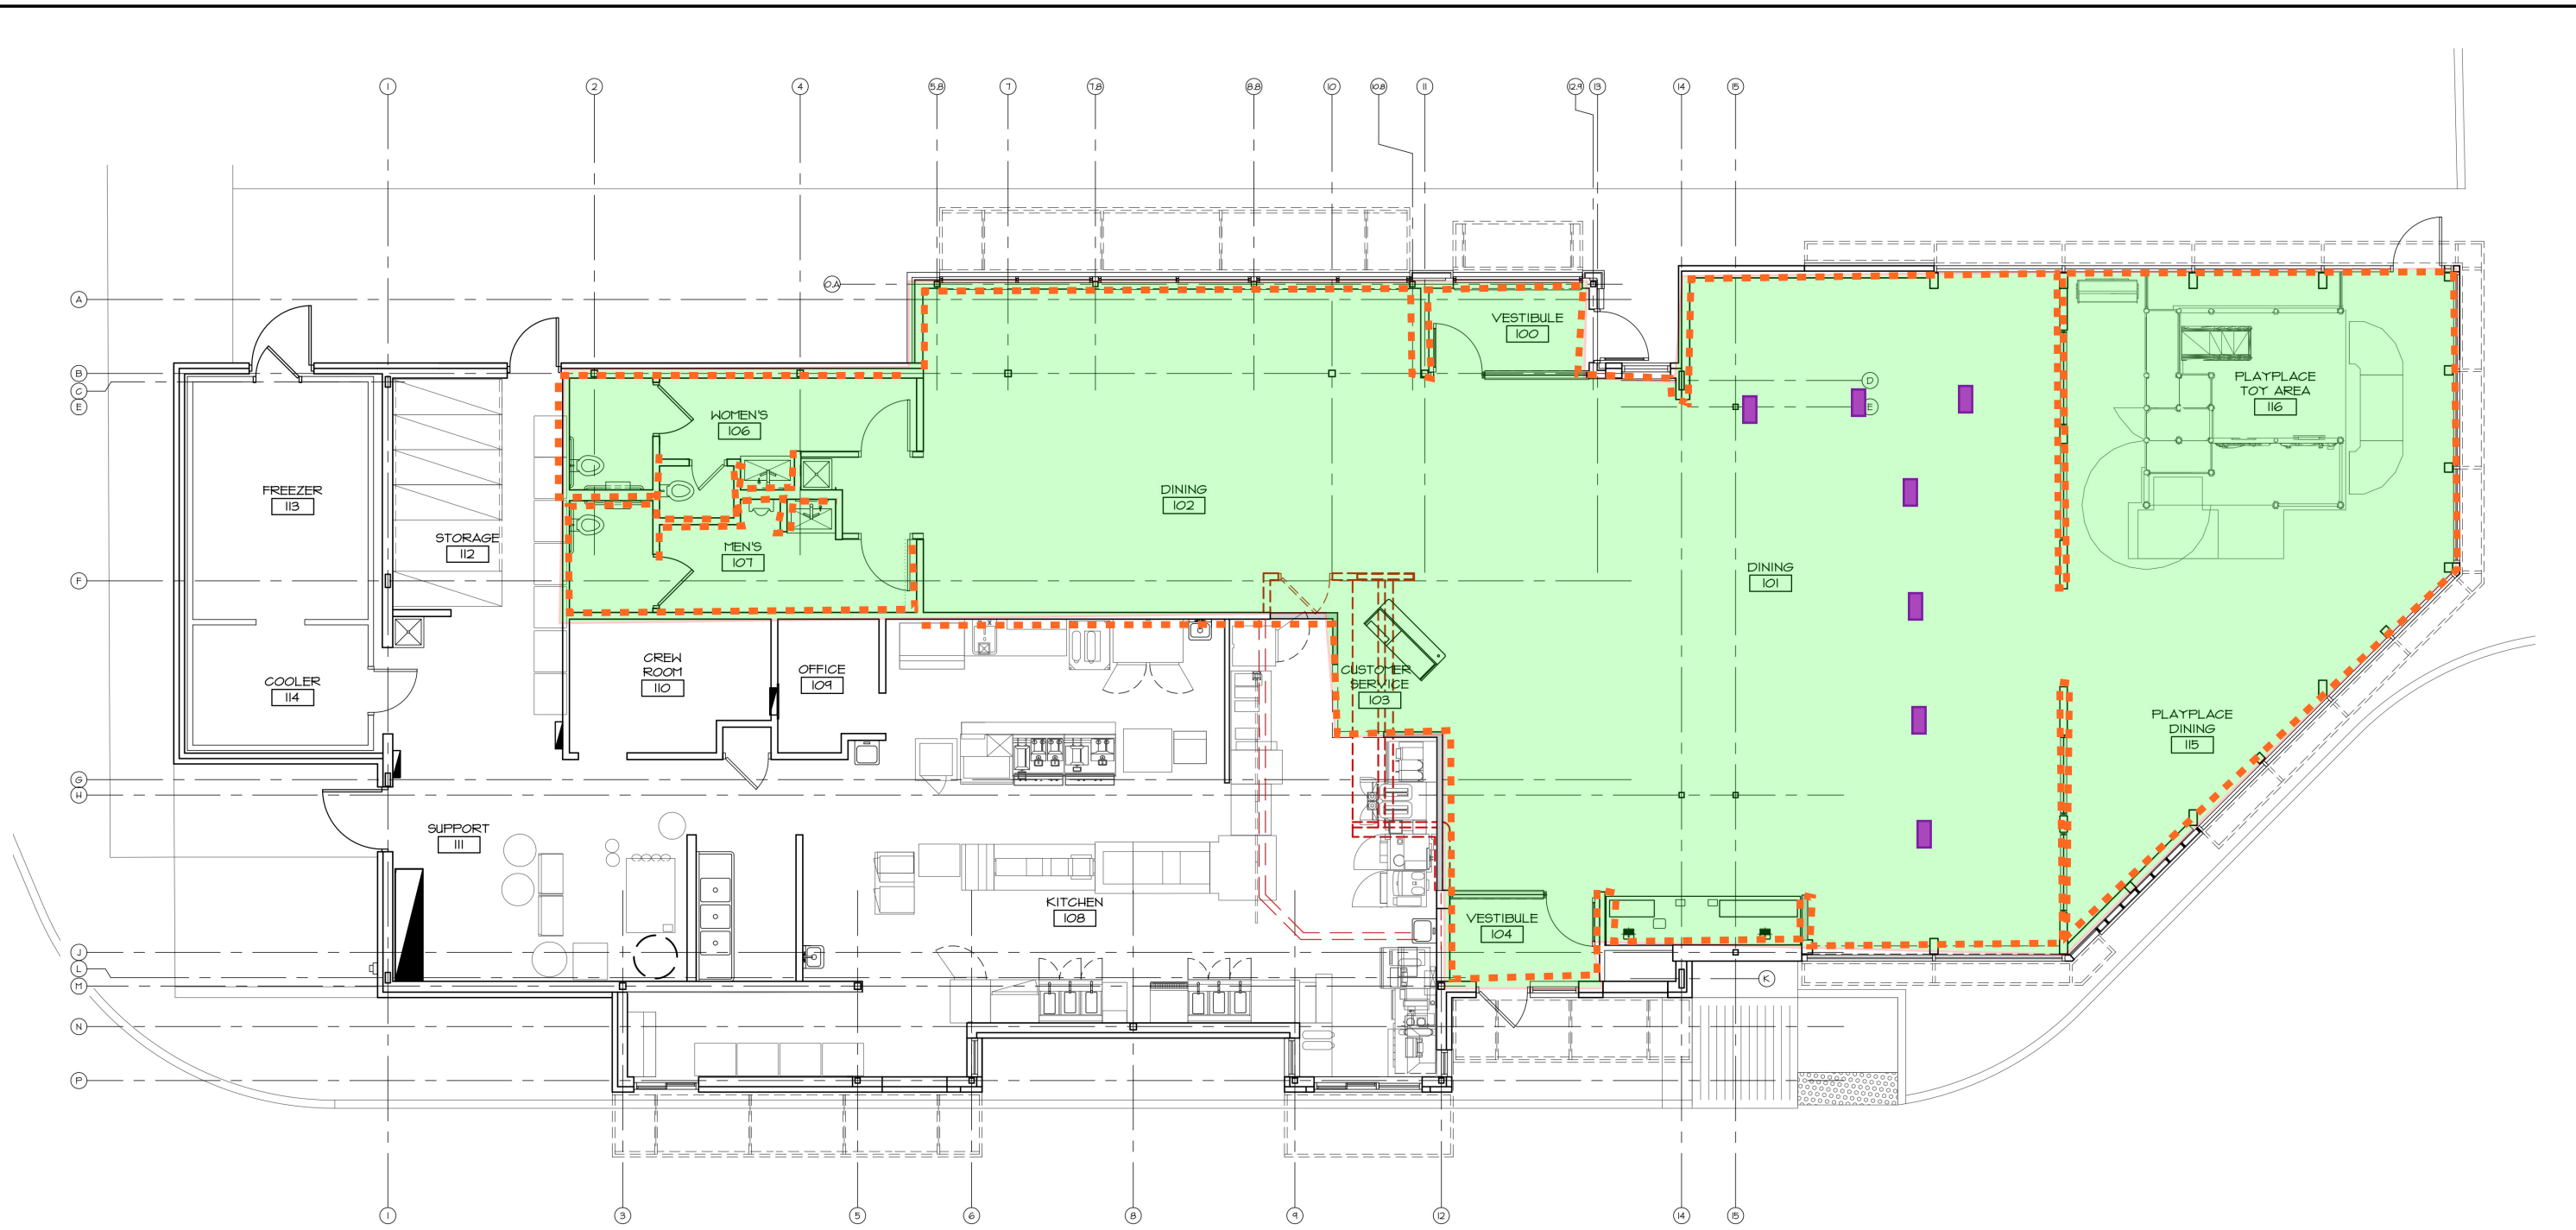
Figure
2

ASSUMED ACM LOCATION DRAWING
MCDONALDS - 50162 10950 SOUTH PARKER ROAD PARKER, COLORADO

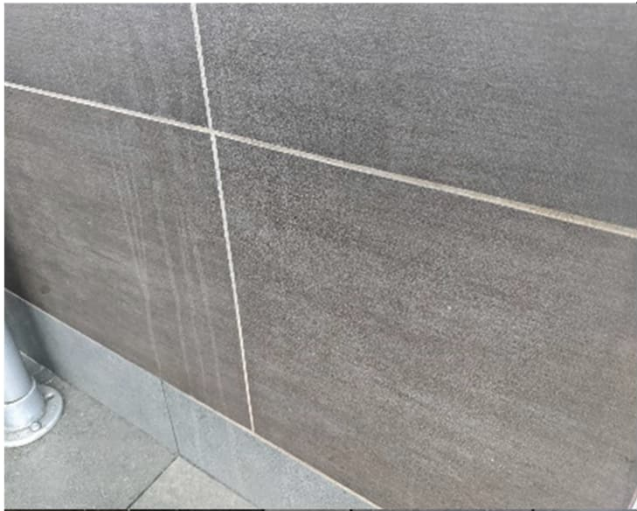
HA# 01 | Brown Grout associated with Ceramic Wall Tile

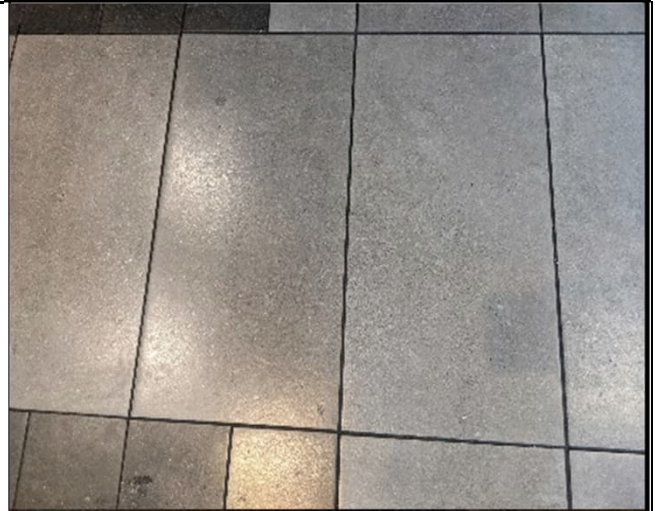
HA# 02 | Black Grout associated with Ceramic Floor Tile

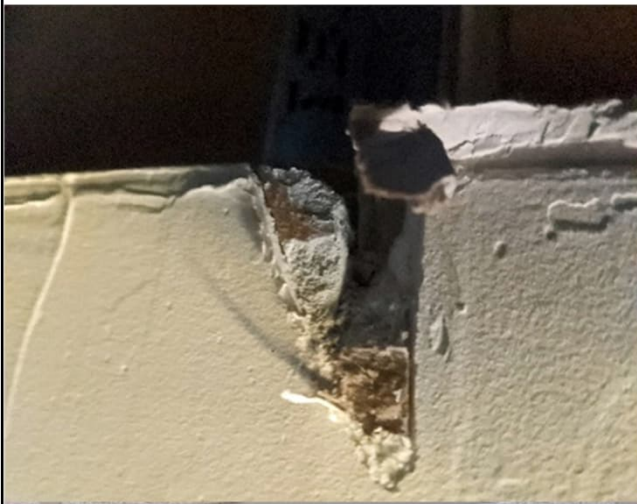
HA# 03 | White 5/8" Gypsum Wallboard with Joint Compound and Tape

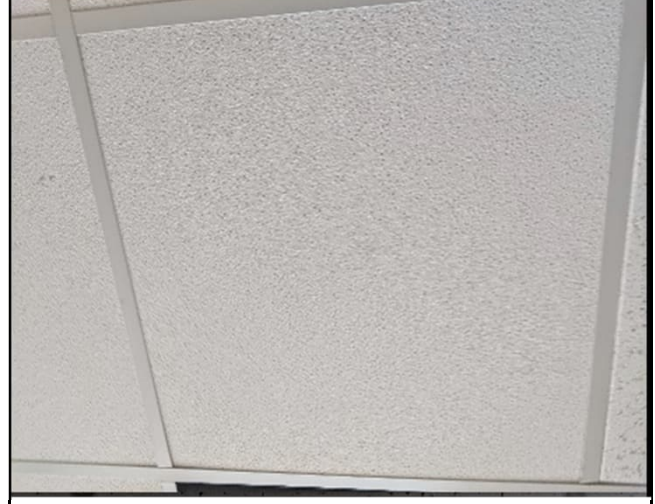
HA# 04 | White with pinholes and sand texture 2' X 2' Ceiling Tile

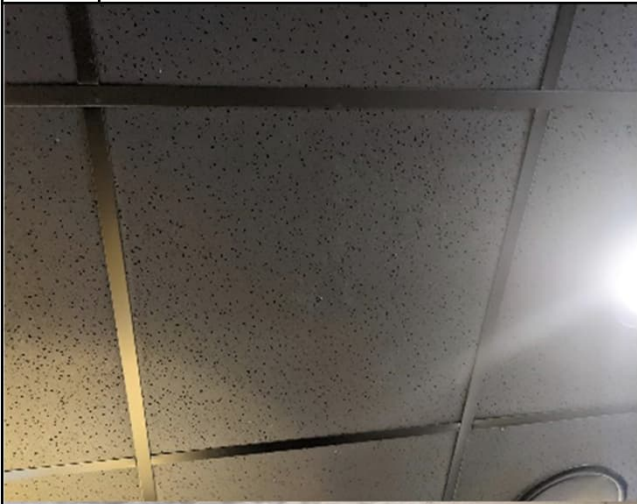
HA# 05 | Black with pinholes and sand texture 2'x2' Ceiling Tile

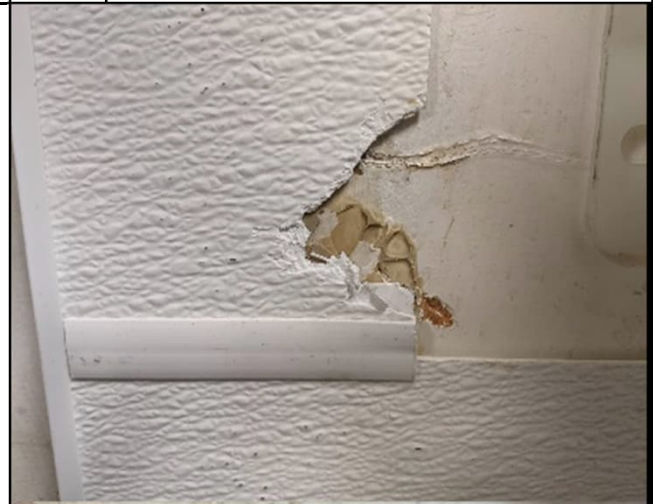
HA# 06 | Tan Fiber Reinforced Panel Adhesive

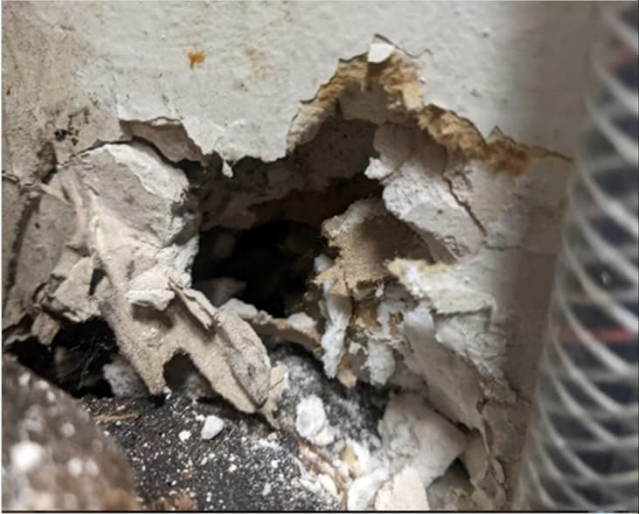
HA# 07 Pink 5/8" Wallboard with Tape and Joint Compound

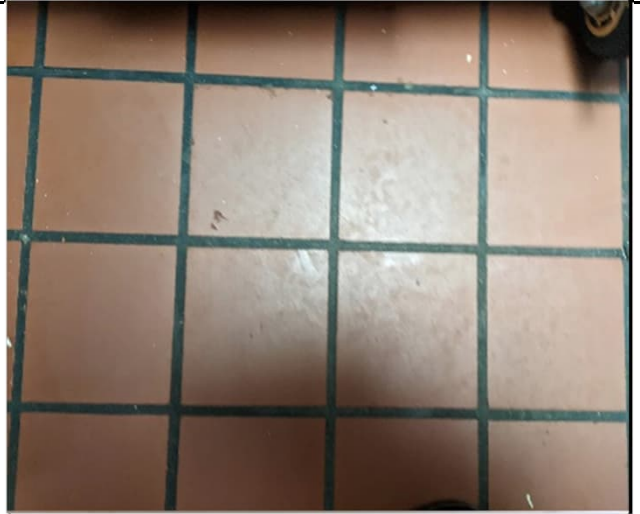
HA# 08 Mortar associated with Red 6"x6" Ceramic Floor Tile

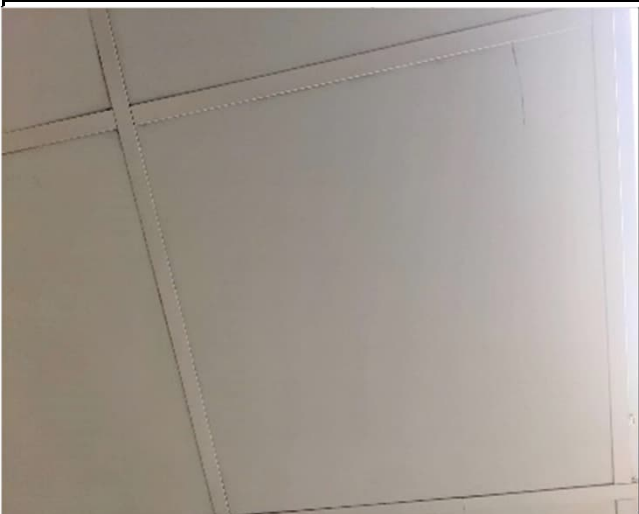
HA# 09 White Smooth 2'x2' Ceiling Tile (Gypsum Board)

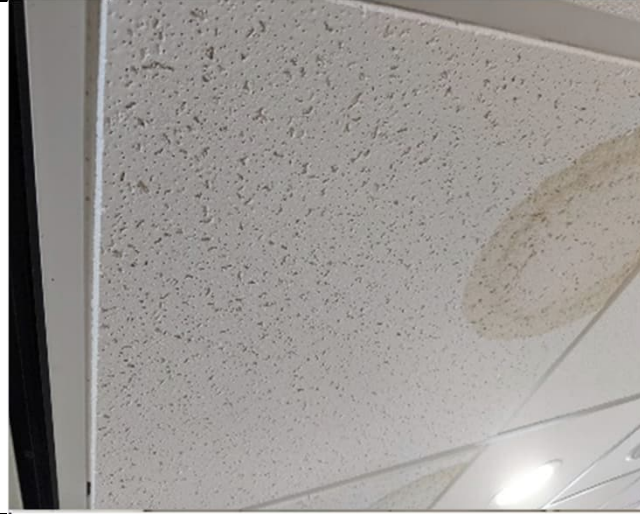
HA# 10 White with divots and pinholes 2'x2' Ceiling Panel

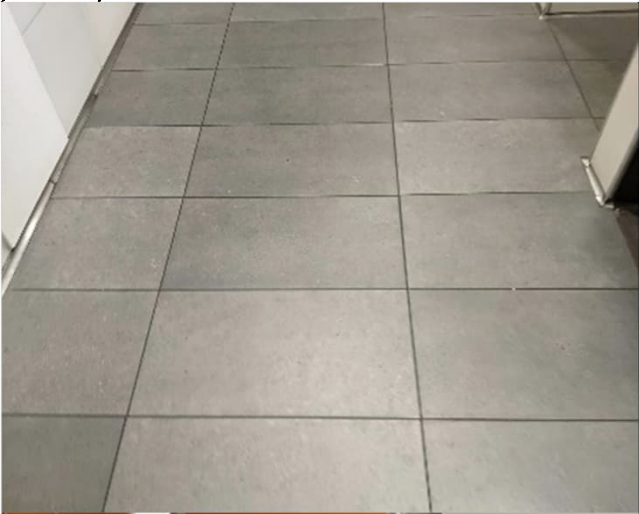
HA# 11 Mortar associated with Ceramic Floor Tile

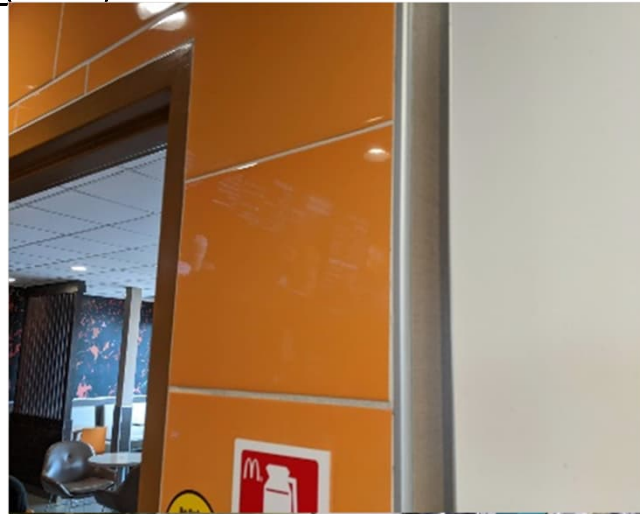
HA# 12 Mortar associated with Ceramic Wall Tile
