COLORADO CULTURAL RESOURCE SURVEY

## Architectural Inventory Form

1. Resource number: 5DA875
2. Temporary resource number: 10065-5DA875
3. County: Douglas
4. City: Parker
5. Historic building name: Ponce de Leon Chalybeate Springs, Allison's Twin House, Allison Ranch
6. Current building name: Agricultural property
7. Building address: 13100 block Parker Road, Parker, Colorado 80134
8. Owner name and address: Parker & Stroh LLC, P.O. Box 40326, Denver, Colorado 80204

# Evaluation of Ponce de Leon Chalybeate Springs/ Allison's Twin House, Douglas County, Colorado

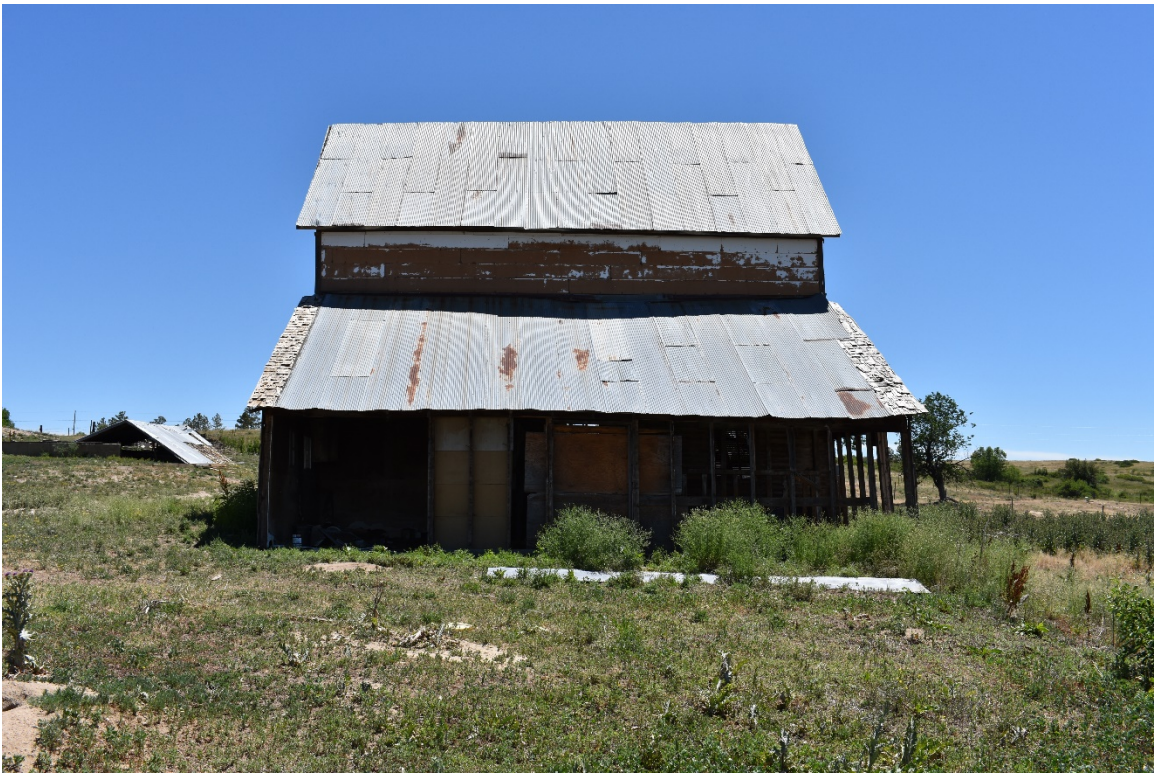
The house (F1) is a two-story wood-frame structure with a stacked cobble pier foundation. The exterior walls are clad with horizontal board cladding. Much of the original cladding is extant on the north and south elevations and is missing almost entirely from the east and west elevations; previous owners have patched pieces of salvaged corrugated and galvanized steel sheets over areas of missing wall and roof shingles over the years. All of the windows are missing and many are covered over with plywood. All of the windows were wood framed with a protruding wood lintel; muntin in window fenestrations under the west addition and on the south elevation indicate the original windows were double hung with two panes in each sash. Entrances were historically centered on the east and west elevations; each entrance has an empty transom window fenestration above it. The doors are now missing and the west entrance (facing Parking Road) is now covered with a one-story addition (added when the house was converted into a barn around 1960). The house has a steep pitched side gable roof with boxed eaves; the original wood shingle cladding is visible under the corrugated steel sheets that currently cover the roof. The shed roof on the west addition also has corrugated steel sheets over the original wood shingle cladding, and features exposed rafter tails.

5DA875 – House (F1) west elevation; view to the east.  
Photograph: DSC\_0214      Date: 6/25/2018

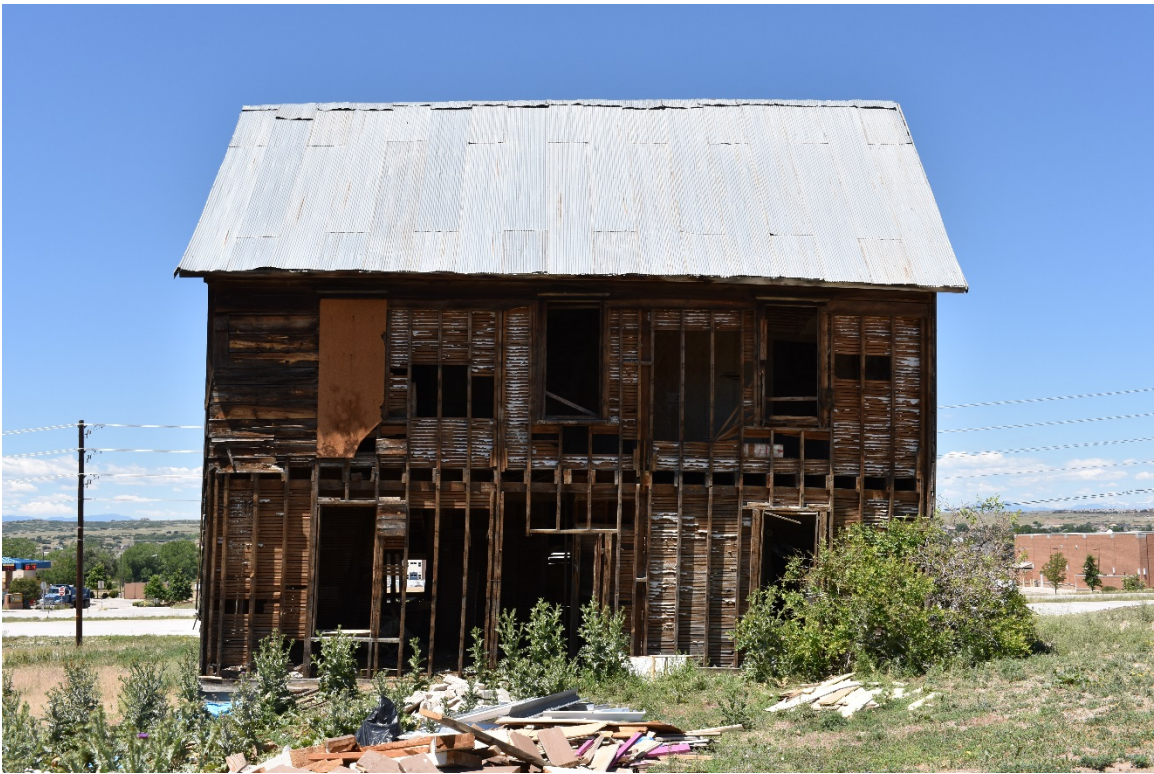
5DA875 – House (F1) east elevation; view to the west.  
Photograph: DSC\_0247      Date: 6/25/2018

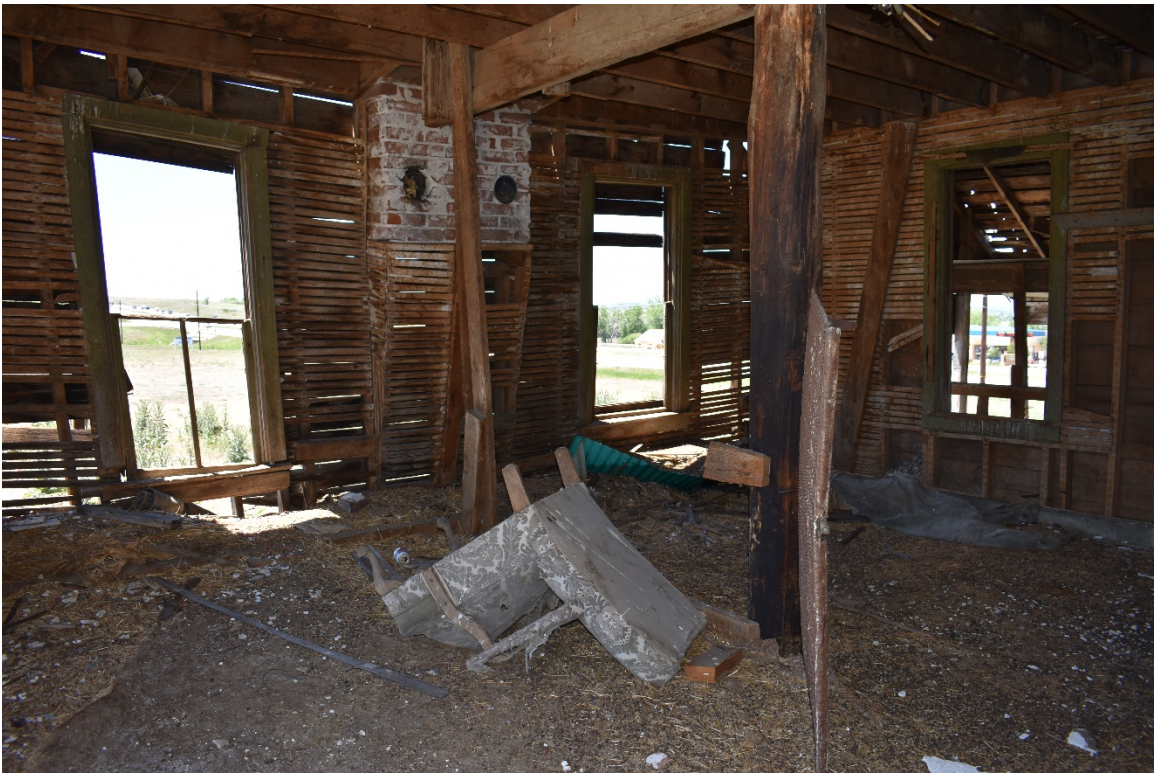
The interior floor plan has a shared common space and two small bedrooms on the first floor, and four bedrooms on the second floor. The solid oak wood staircase is located centrally within the building. The interior is destroyed due to purposeful removal of walls, stoves, furnishings, and doors for use as a barn. An interior brick chimney with attachments for stoves (removed) is located in the center of the north side of the house and the center of the south side of the house; the chimneys or stove pipes are not visible on the exterior roof line of the house as they were removed when the roof was covered with corrugated steel sheets. There is no evidence the house ever had electricity or plumbing.

5DA875 – House (F1) interior of common room on first floor; view to the southwest.  
Photograph: DSC\_0233      Date: 6/25/2018

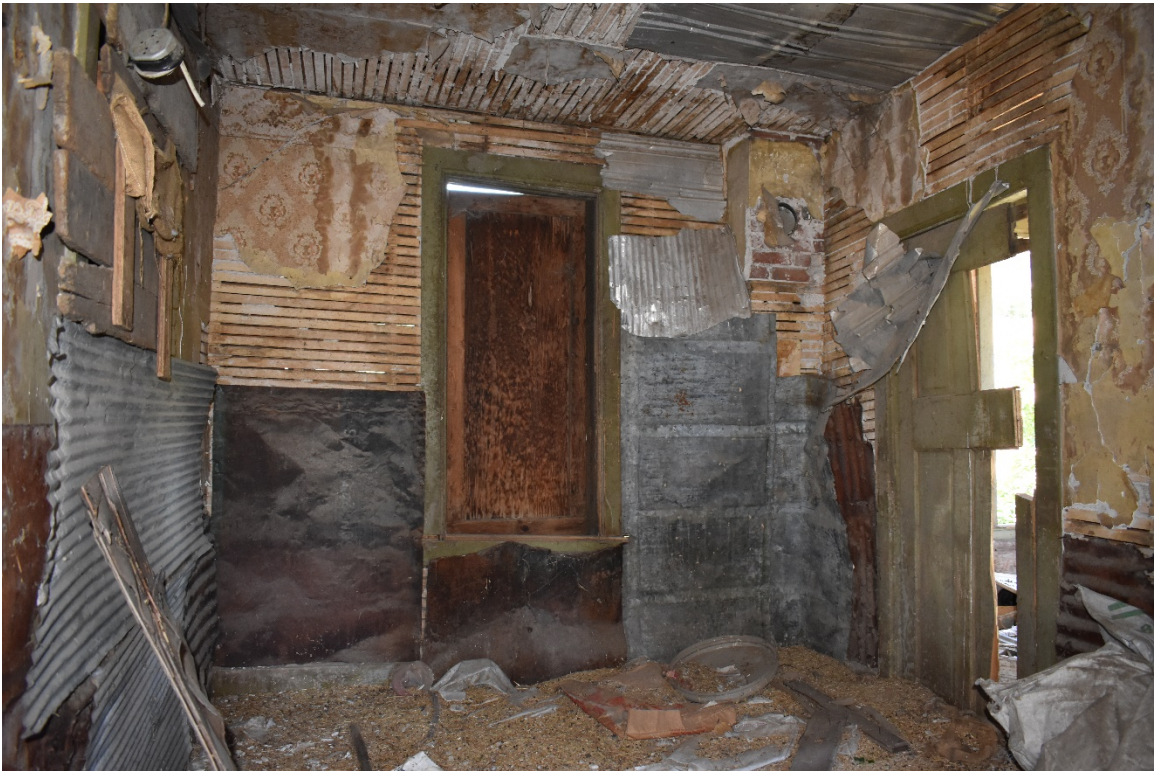
5DA875 – House (F1) interior of northwest first floor bedroom; view to the north.  
Photograph: DSC\_0235      Date: 6/25/2018

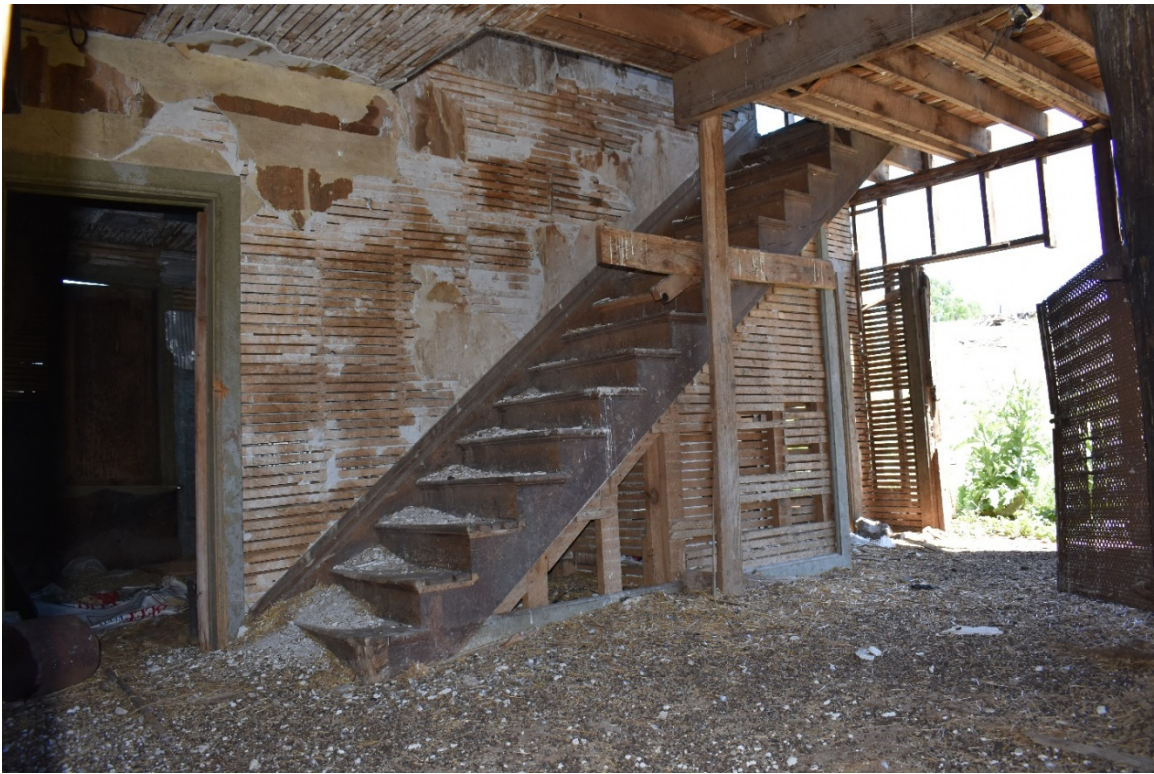
5DA875 – House (F1) interior view showing stair case in center of first floor; view to the northeast.  
 Photograph: DSC\_0242      Date: 6/25/2018

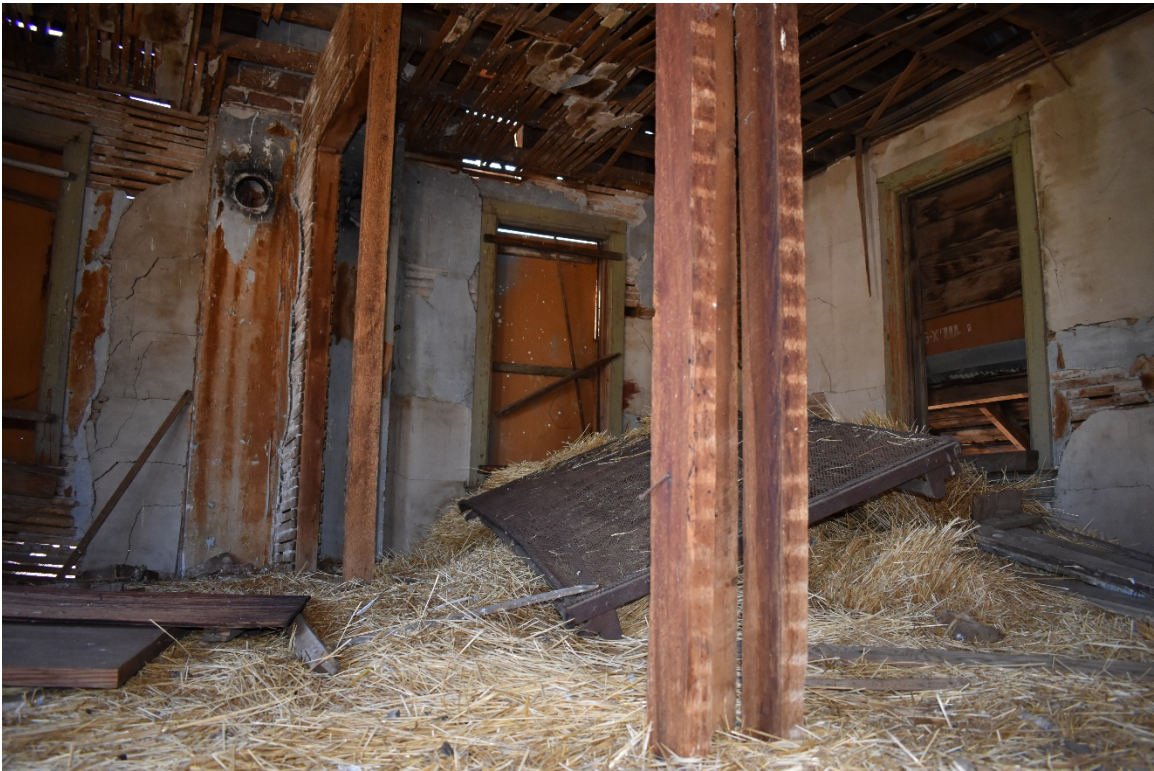
5:DA875 – House (F1) interior view of two south bedrooms on second floor; view to the south-southwest.  
 Photograph: DSC\_0244      Date: 6/25/2018

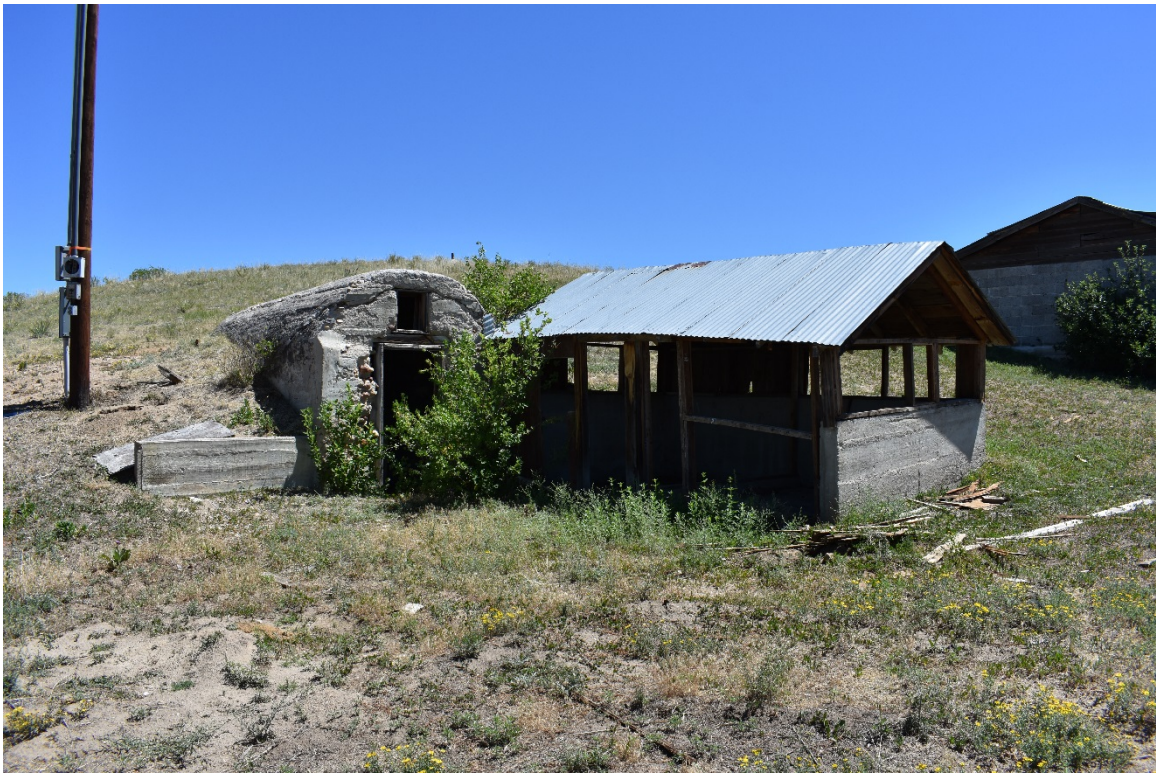
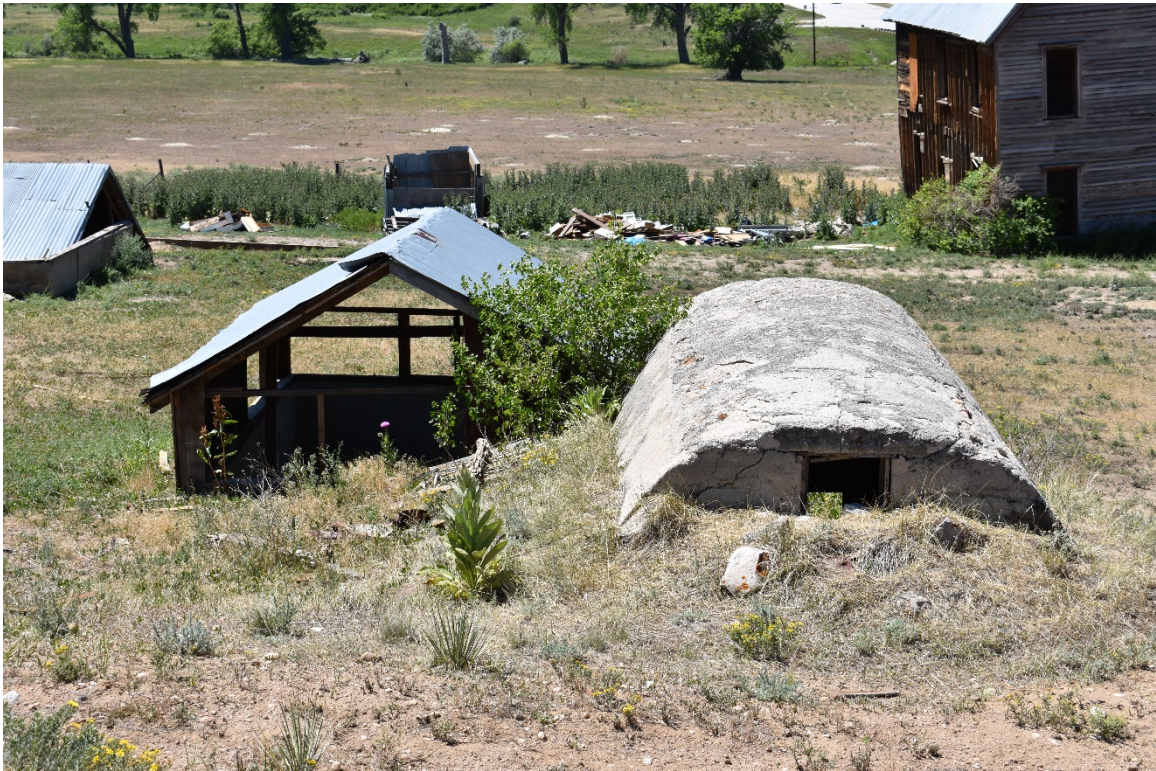
The root cellar (F2) is a poured concrete structure with an arched roof, about 16 ft long and 8 ft wide. The concrete is tempered with cobbles and brick fragments. The north half of the building is mostly buried in the south-facing hillside, and the entrance is centered on the south elevation. The entrance is framed in wood and uncovered. A square wood-framed transom window fenestration is centered in the top of the north and south elevations. The interior is divided into a front and rear room. Broken glass jars and bottles are sparsely littered

A two-room outbuilding (F3) is located on the southeast corner of the root cellar and is also partially built into the hillside. It is about 18 ft long and 11.5 ft wide. The bottom half of the south, west, and north elevations is poured concrete and the remainder of the building is wood framed. There is no cladding on the west elevation, and the wood frame of an entrance is visible in the center of the elevation. Very little of the horizontal and vertical wood cladding that covered the walls remains on the east and elevations, and some of the cladding is sparsely littered on the ground outside the building. The side gabled roof has exposed rafter tails; the original cladding is unknown and currently covered with corrugated steel sheets.

5DA875 – Overview of root cellar (F2) and outbuilding (F3); view to the northeast.

5DA875 – Overview of root cellar (F2) and outbuilding (F3); view to the south.

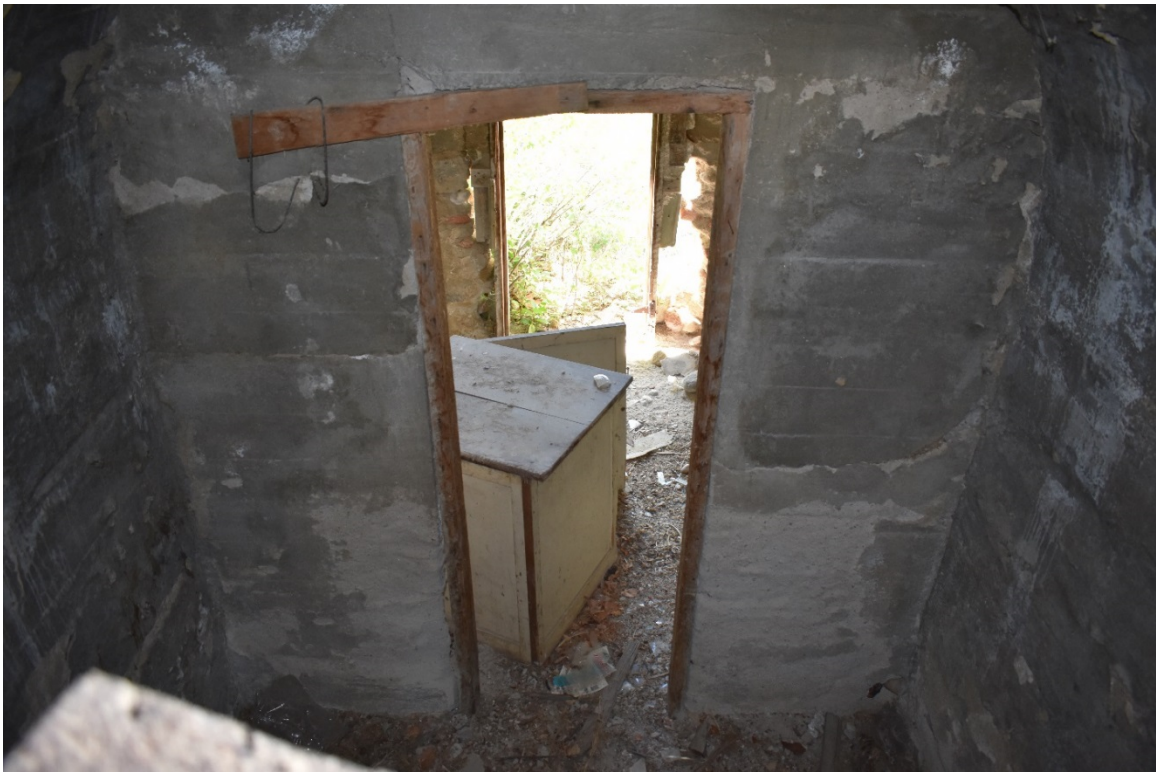
on the floor and have been trampled from stock entering the cellar; identifiable containers include colorless Kerr jars (manufactured between ca. 1920-1974 (Lockhart et al. 2016).

5DA875 – Interior view of rear and front rooms of root cellar (F2); view to the south.

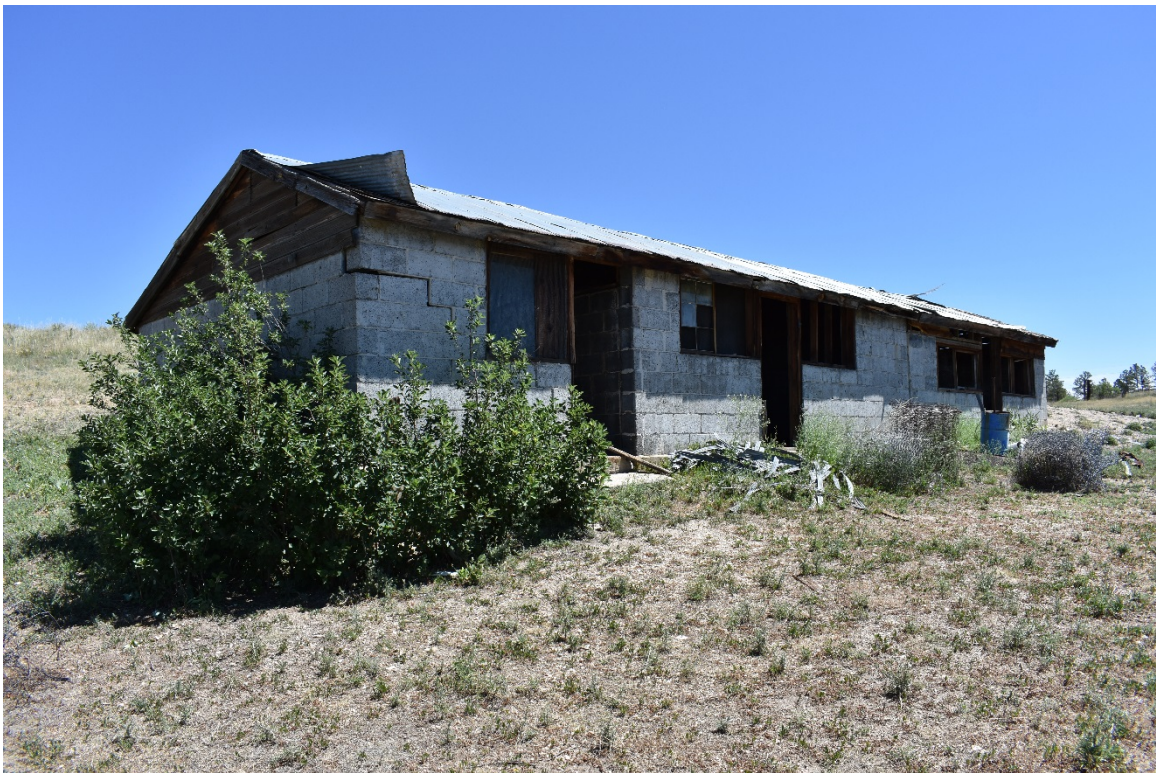
A three-room outbuilding (F4) is located about 40 ft west of the root cellar (F2) and is also built into the south slope of the hill. It has cement block walls and is about 50 ft by 20 ft. Three uncovered door fenestrations are located across the south elevation. Window fenestrations are located adjacent to the door fenestrations; extant windows have no operation and are various sizes and glazing patterns. The side gabled roof has an off-center apex and boxed eaves; the original wood shingle cladding is visible under the corrugated steel sheets that are currently covering the roof. The gable faces are clad with horizontal wood siding.

5DA875 – Outbuilding (F4) west and south elevations; view to the northeast.

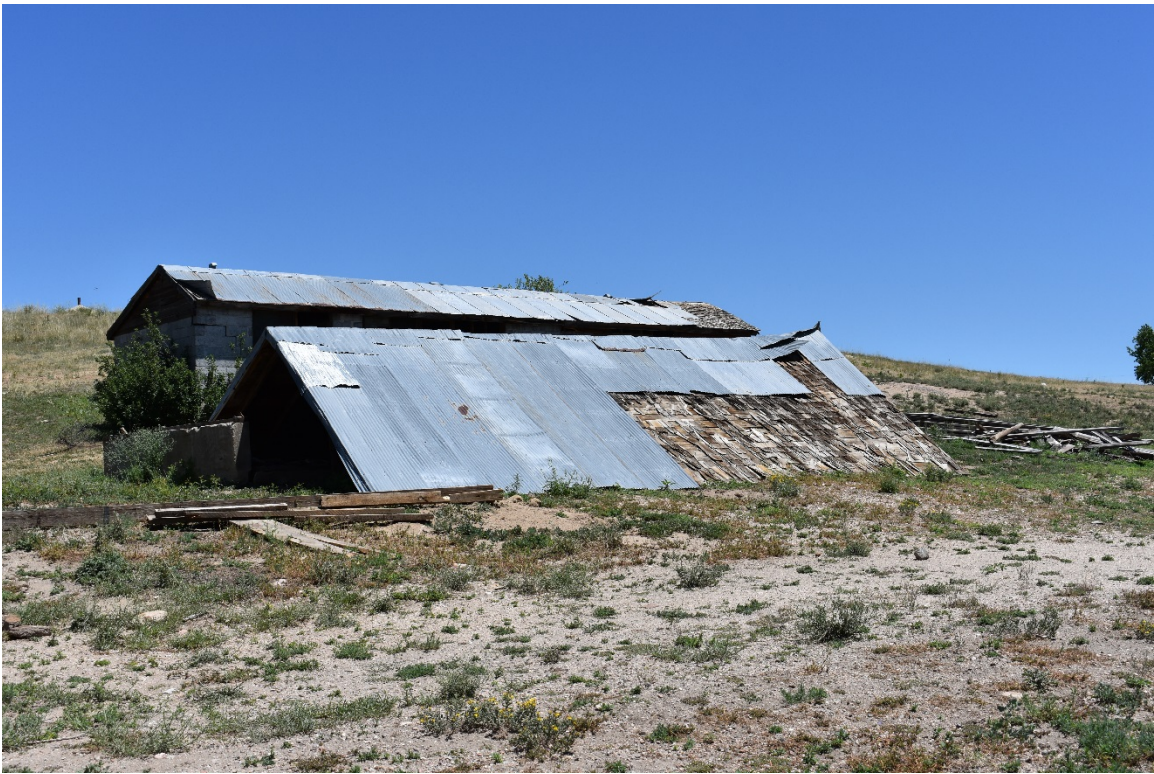
In the center of the building complex is a collapsed barn (F5). The only extant structural elements are the gabled roof and a poured concrete foundation. The roof features exposed rafter tails and the original wood shingle cladding is visible under the current corrugated steel cladding. The foundation is poured concrete, and measures about 25 ft by 20 ft.

5DA875 – Collapsed barn (F5); view to the north-northeast.  
Photograph: DSC\_0246      Date: 6/25/2018

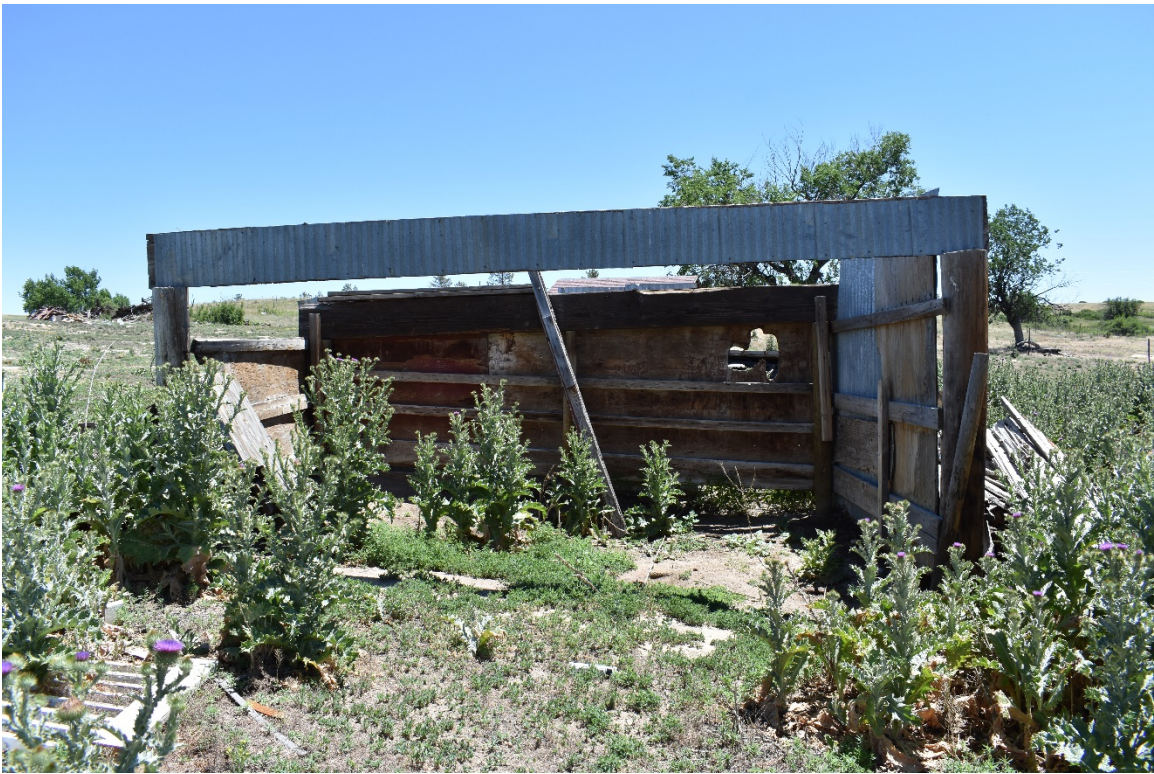
The only intact structure remaining from the corral located on the south side of the house (F1) after 1960 is an 18 ft by 10 ft wood frame shed. The shed has an open west elevation and the walls are comprised of salvaged dimensional lumber, plywood sheet, and corrugated steel sheets. The roof is missing.

5DA875 – Loafing shed (F7); view to the east.  
Photograph: DSC\_0254      Date: 6/25/2018

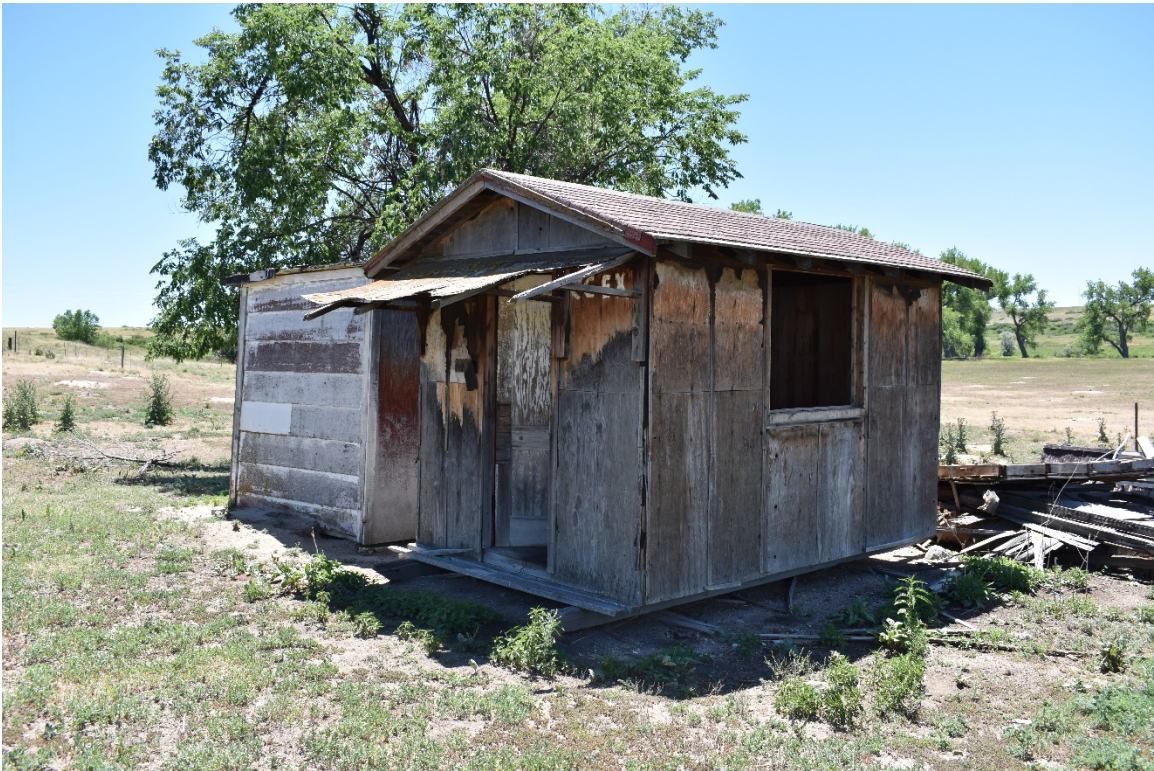
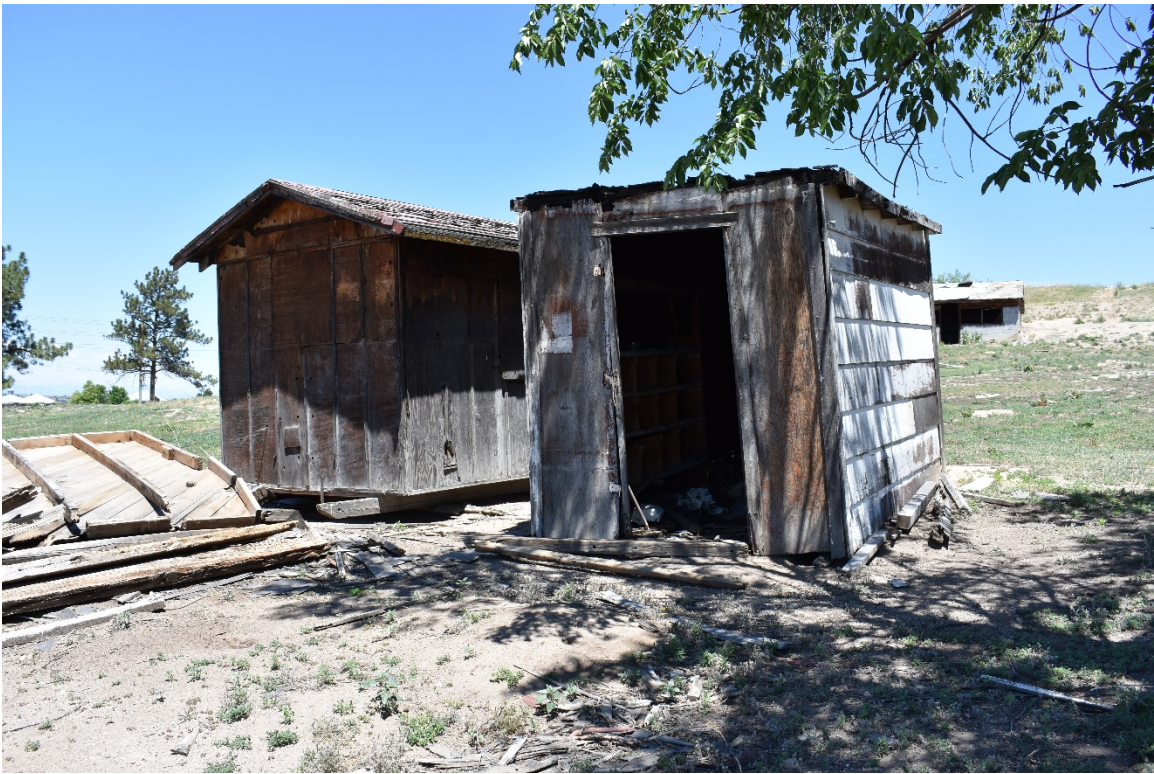
East of the house and outside the corral are several collapsed outbuildings and two extant outbuildings (F8 and F9) located adjacent to each other. Both outbuildings have skids on the foundation and were moved to the property after 1960. The outbuilding on the west side (F8) has plywood walls. The front gabled roof is covered with asphalt shingles and features exposed rafter tails. A window fenestration is centered on the west/side elevation and an entrance is located in the center of the north elevation; the entrance is covered with an operational plywood door and sheltered under a short shed roof extension. Immediately adjacent to the east side of the F8 outbuilding is another wood frame outbuilding; it is clad with plywood on one side and wide horizontal boards on three sides. The roof is flat. An uncovered entrance is centered on the south elevation.

5DA875 – Overview of outbuildings F8 and F9; view to the southeast.  
Photograph: DSC\_0261      Date: 6/25/2018

5DA875 – Overview of outbuildings F8 and F9; view to the northwest.  
Photograph: DSC\_0268      Date: 6/25/2018

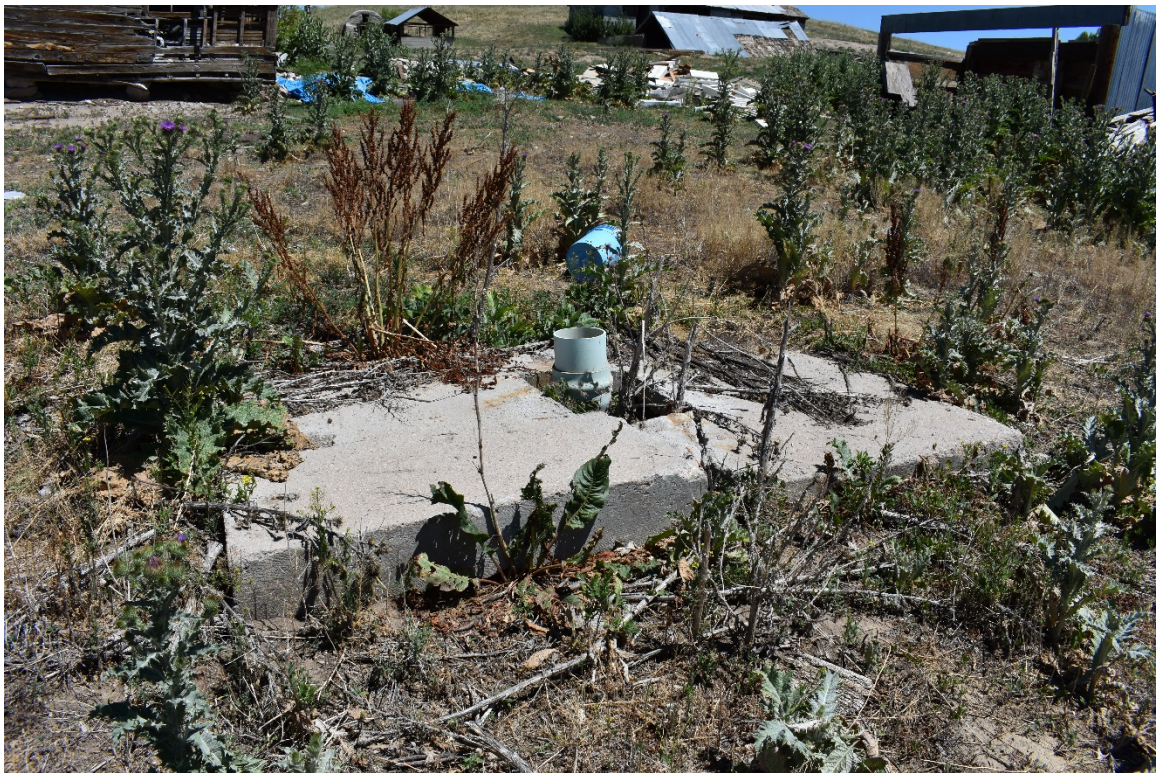
About 40 ft south of the house is a possible well or cistern (F12). On the ground surface is a 9 ft by 6 ft poured concrete pad, 8 inches thick. An 8 inch diameter vertical plastic pipe is located off-center in the pad; the pipe is stuffed with fiberglass wall insulation.

5DA875 – Possible well or cistern (F12) on the south side of house (F1, background); view to the north-northeast. Photograph: DSC\_0219 Date: 6/25/2018
