COLORADO CULTURAL RESOURCE SURVEY

Architectural Inventory Form

1. Resource number: 5DA875
2. Temporary resource number: 10065-5DA875
3. County: Douglas
4. City: Parker
5. Historic building name: Ponce de Leon Chalybeate Springs, Allison's Twin House, Allison Ranch
6. Current building name: Agricultural property
7. Building address: 13100 block Parker Road, Parker, Colorado 80134
8. Owner name and address: Parker & Stroh LLC, P.O. Box 40326, Denver, Colorado 80204

47. Photograph numbers: DSC_0145 through DSC 0325
Negatives filed at: ERO Resources Corporation, digital files
48. Report title: Twin Houses Property Evaluation of Eligibility for Parker Area Historical Society
49. Date(s): June 25, 2018
50. Recorder(s): Abigail Sanocki
51. Organization: ERO Resources Corporation
52. Address: 1842 Clarkson Street, Denver, Colorado 80218
53. Phone number(s): 303-830-1188

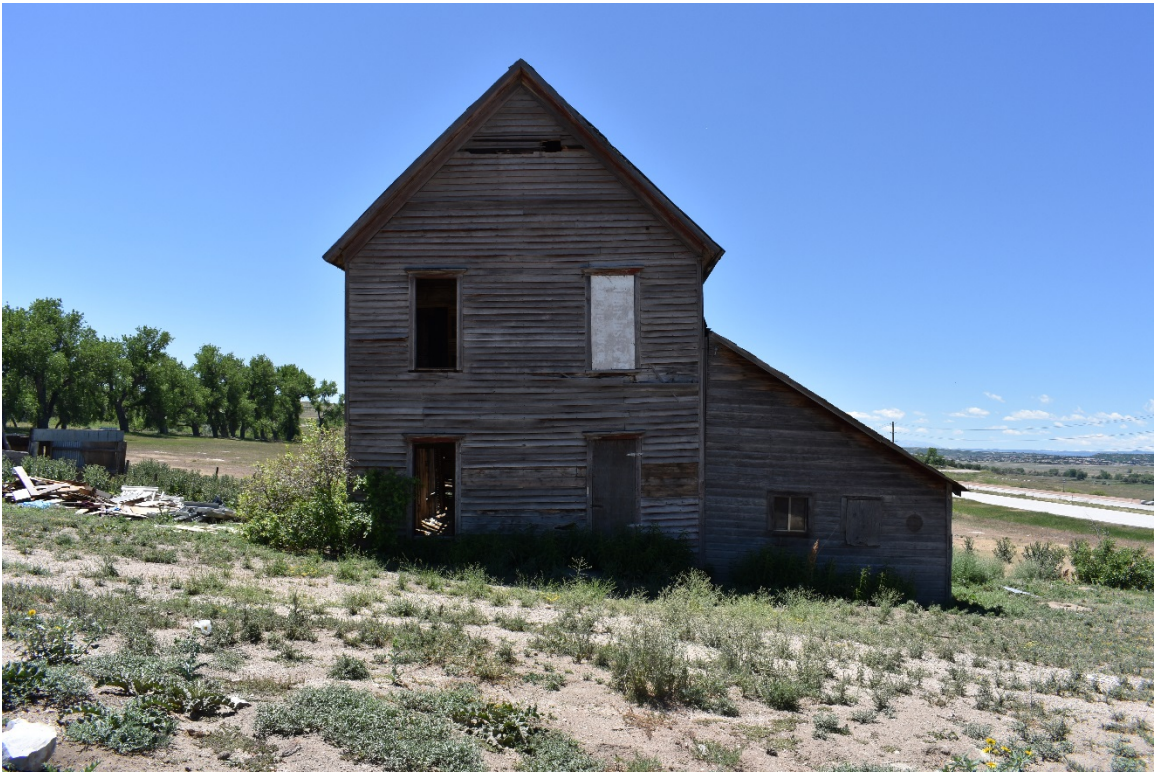
5DA875 – House (F1) north elevation; view to the south.
Photograph: DSC_0211 Date: 6/25/2018

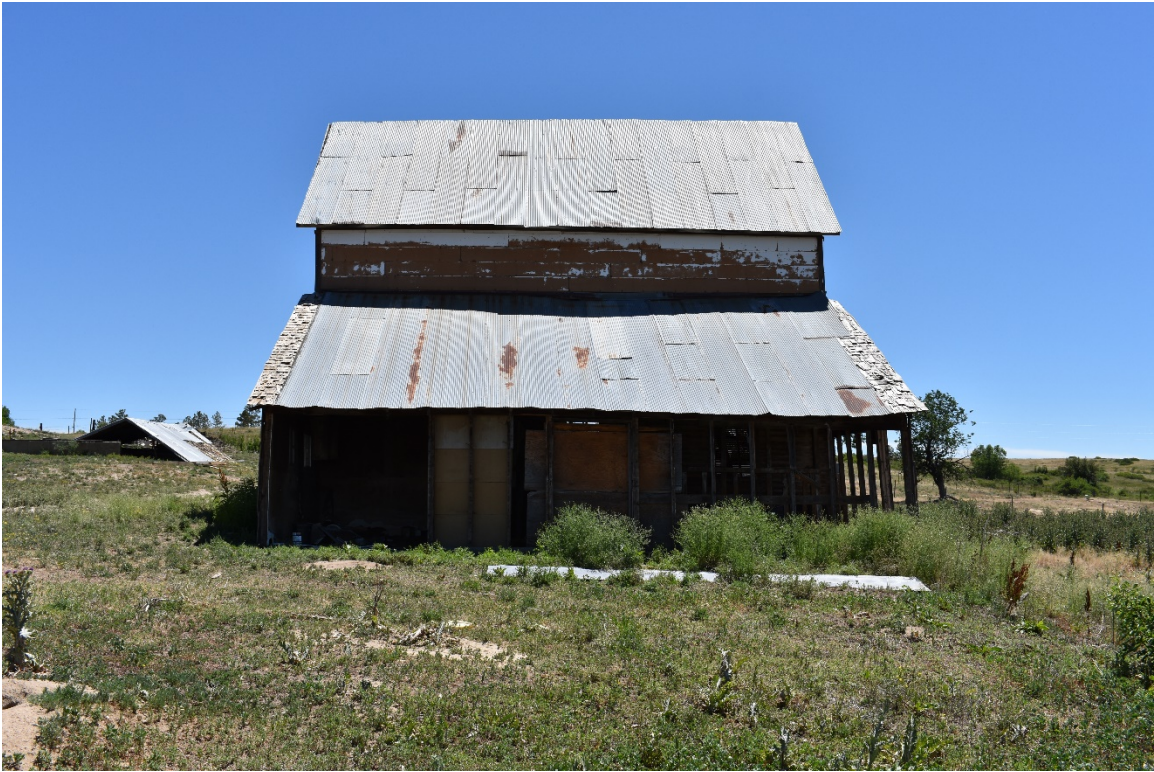
5DA875 – House (F1) west elevation; view to the east.
Photograph: DSC_0214 Date: 6/25/2018

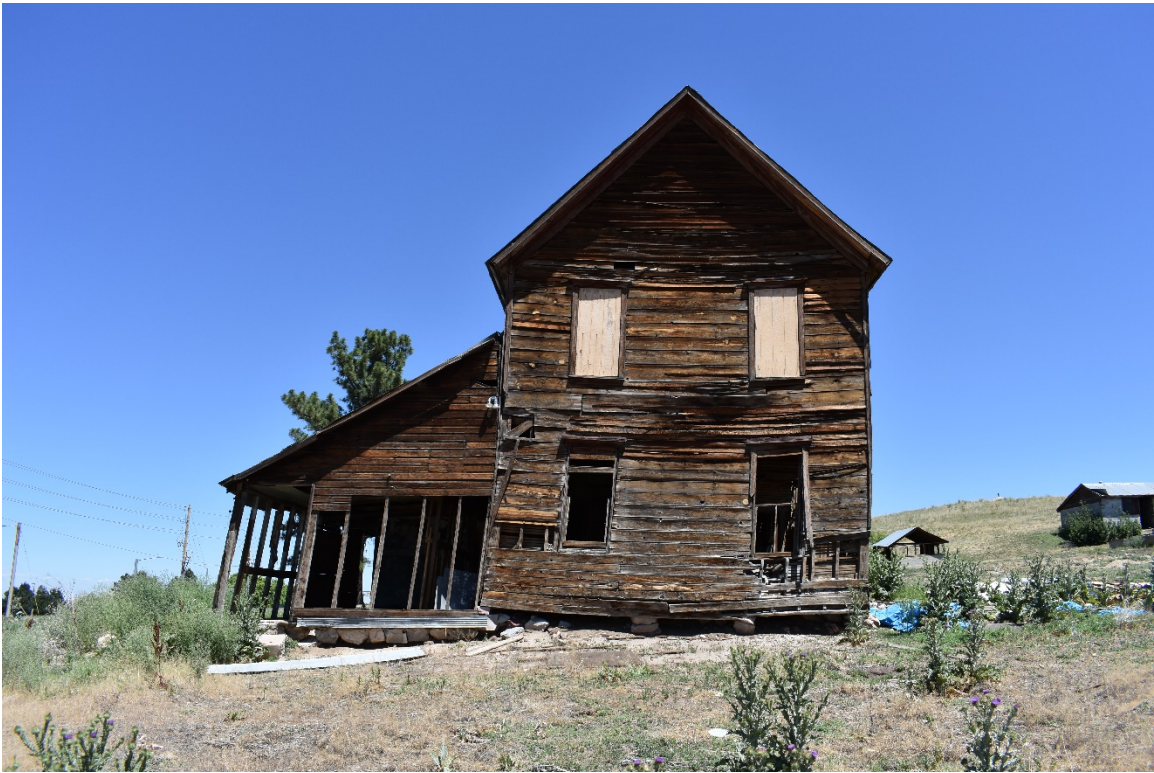
5DA875 – House (F1) south elevation; view to the north.
Photograph: DSC_0223 Date: 6/25/2018

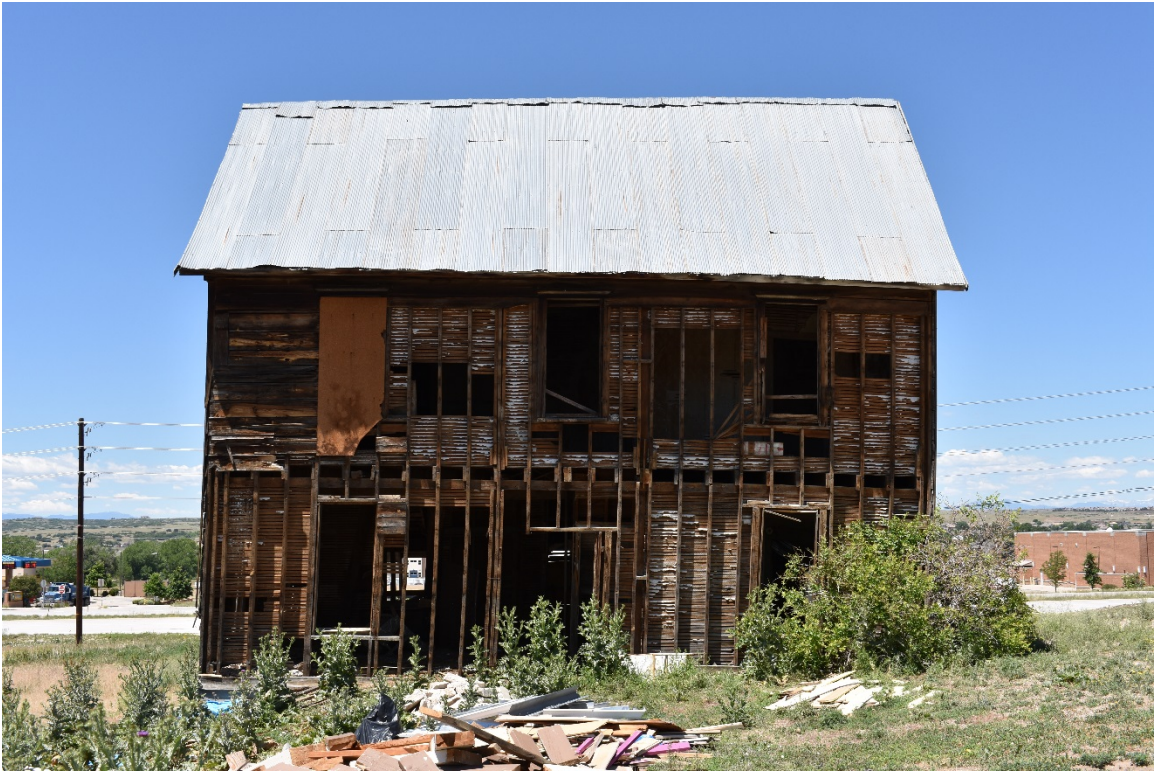
5DA875 – House (F1) east elevation; view to the west.
Photograph: DSC_0247 Date: 6/25/2018

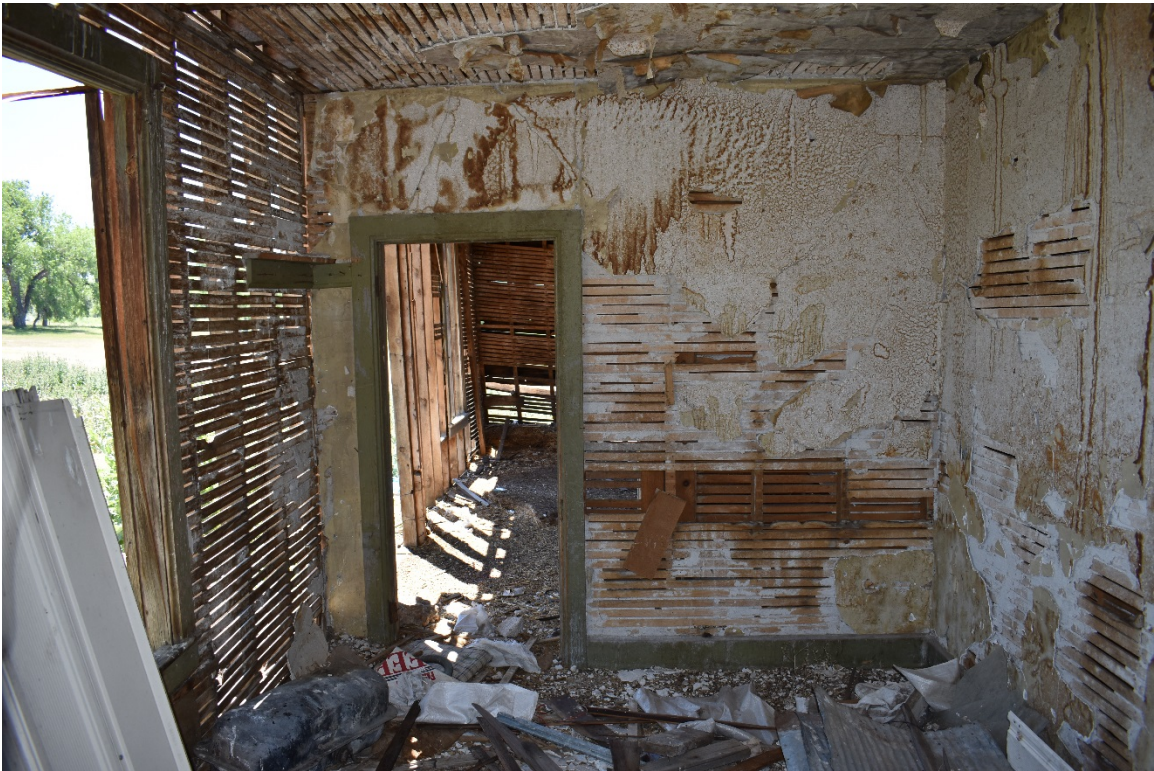
The interior floor plan has a shared common space and two small bedrooms on the first floor, and four bedrooms on the second floor. The solid oak wood staircase is located centrally within the building. The interior is destroyed due to purposeful removal of walls, stoves, furnishings, and doors for use as a barn. An interior brick chimney with attachments for stoves (removed) is located in the center of the north side of the house and the center of the south side of the house; the chimneys or stove pipes are not visible on the exterior roof line of the house as they were removed when the roof was covered with corrugated steel sheets. There is no evidence the house ever had electricity or plumbing.

5DA875 – House (F1) interior of northeast first floor bedroom; view to the south.
Photograph: DSC_0213 Date: 6/25/2018

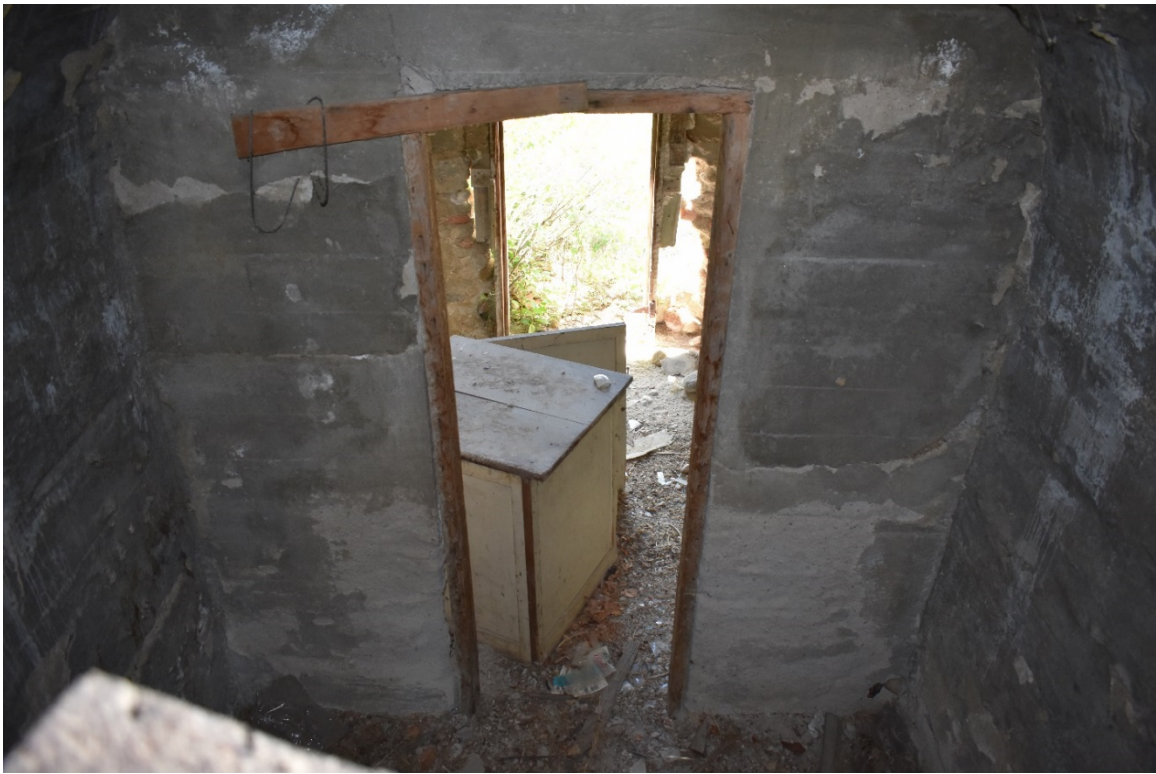
The root cellar (F2) is a poured concrete structure with an arched roof, about 16 ft long and 8 ft wide. The concrete is tempered with cobbles and brick fragments. The north half of the building is mostly buried in the south-facing hillside, and the entrance is centered on the south elevation. The entrance is framed in wood and uncovered. A square wood-framed transom window fenestration is centered in the top of the north and south elevations. The interior is divided into a front and rear room. Broken glass jars and bottles are sparsely littered

on the floor and have been trampled from stock entering the cellar; identifiable containers include colorless Kerr jars (manufactured between ca. 1920-1974 (Lockhart et al. 2016).

5DA875 – Interior view of rear and front rooms of root cellar (F2); view to the south.

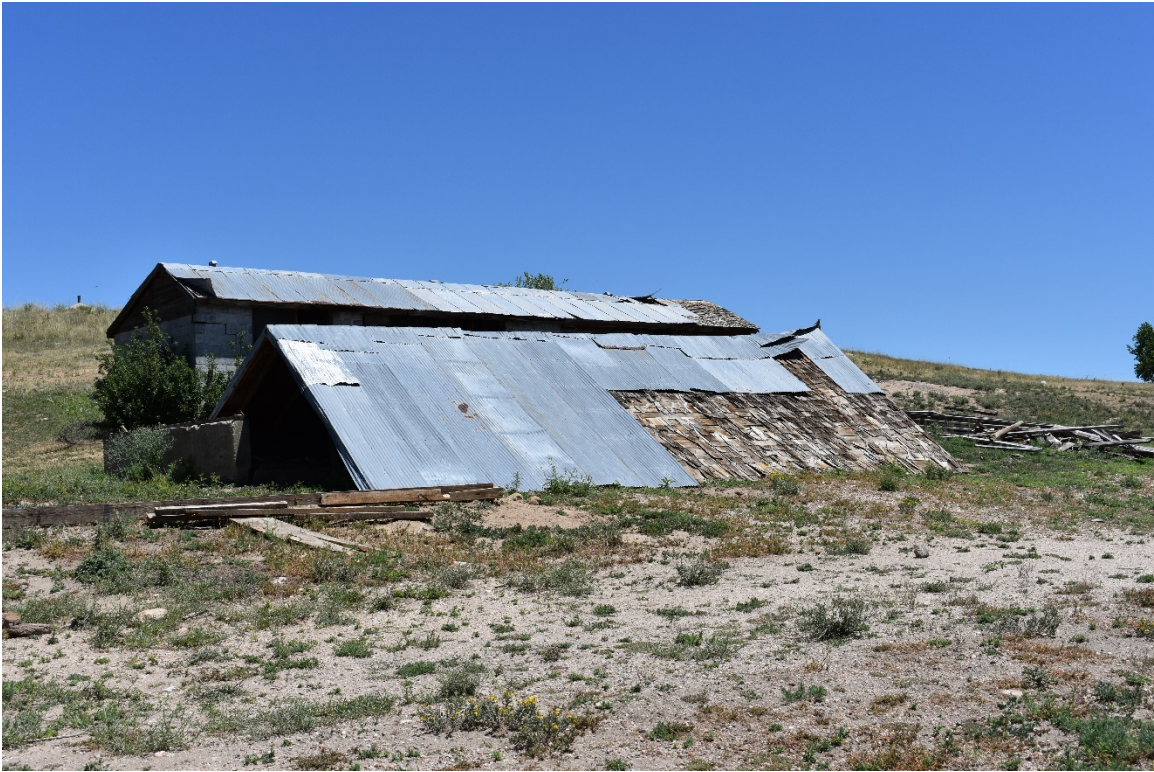
In the center of the building complex is a collapsed barn (F5). The only extant structural elements are the gabled roof and a poured concrete foundation. The roof features exposed rafter tails and the original wood shingle cladding is visible under the current corrugated steel cladding. The foundation is poured concrete, and measures about 25 ft by 20 ft.

5DA875 – Collapsed barn (F5); view to the north-northeast.
Photograph: DSC_0246 Date: 6/25/2018

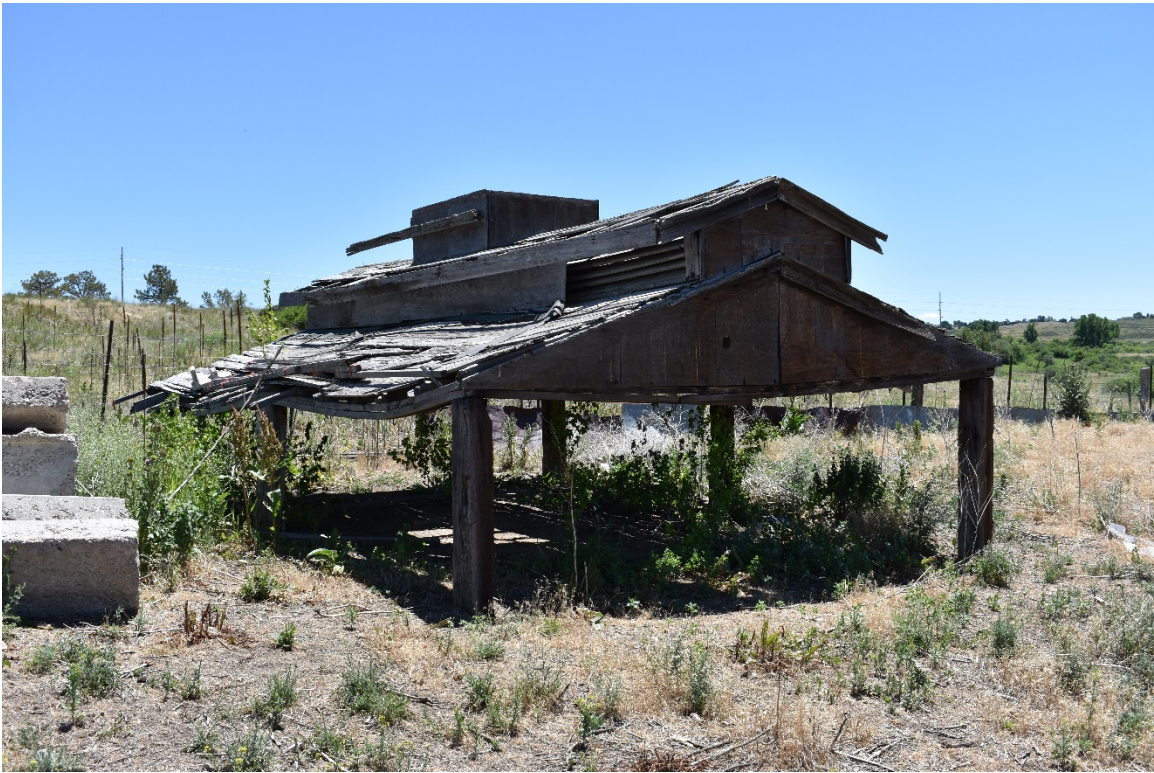
In the southeast corner of the building complex is a possible chicken coop (F6). The building remains include a deteriorating gabled roof clad in horizontal wood boards. The monitor roof (double-pitched gable roof) roof has wood louvers along the long sides of the monitor. The roof is set on top of 4-ft-tall wood piers and there are no walls; the piers are about 8 inch by 8 inch. Remnants of mesh fabric are visible along the roof line.

5DA875 – Possible chicken coop (F6); view to the southeast.
Photograph: DSC_0278 Date: 6/25/2018

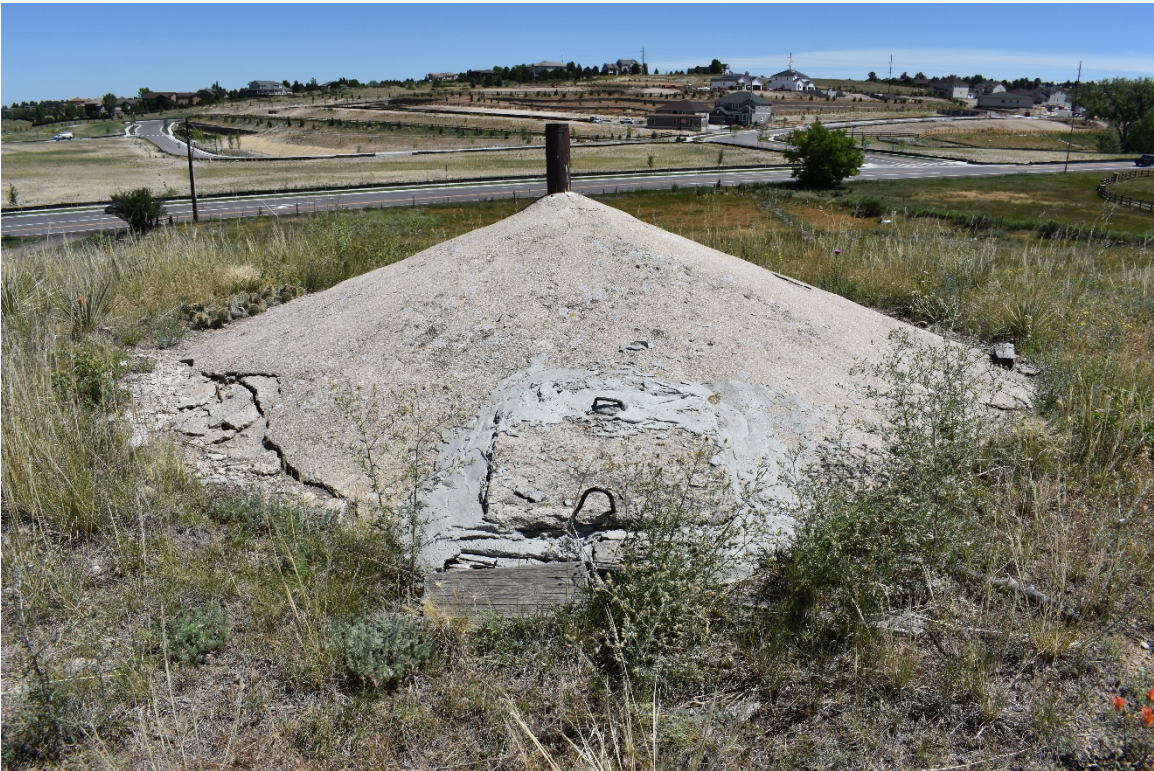
A cistern (F10) is located on top of the hill north of the building complex. The walls and roof are poured concrete and wire mesh. The structure has a 15-ft-diameter cone-shaped roof, the center point is about 3 ft tall. A 4-inch-diameter steel pipe extends vertically from the center point. A square shaped door is located on the south side of the structure; the door is poured concrete with iron cable handles. Under the ground surface, the cistern is roughly 6 ft deep and lined with concrete.

5DA875 – Overview of Cistern (F10) showing door; view to the northwest.

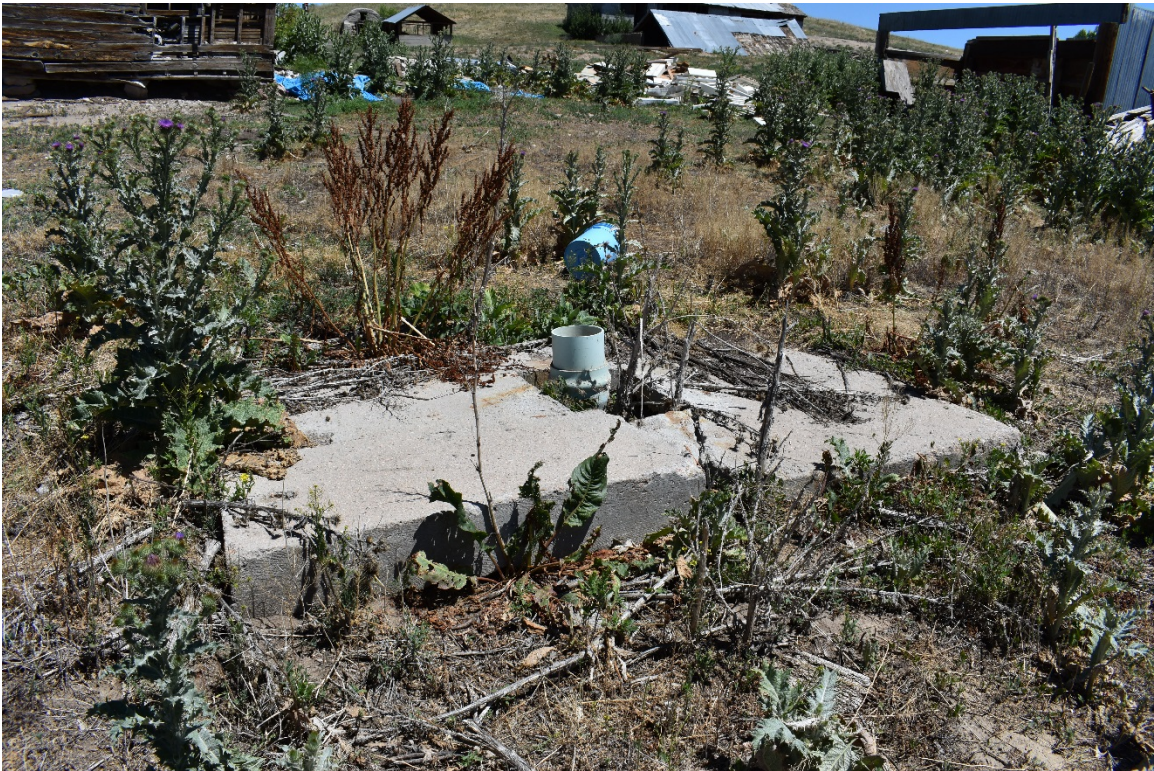
About 40 ft south of the house is a possible well or cistern (F12). On the ground surface is a 9 ft by 6 ft poured concrete pad, 8 inches thick. An 8 inch diameter vertical plastic pipe is located off-center in the pad; the pipe is stuffed with fiberglass wall insulation.

5DA875 – Possible well or cistern (F12) on the south side of house (F1, background); view to the north-northeast. Photograph: DSC_0219 Date: 6/25/2018

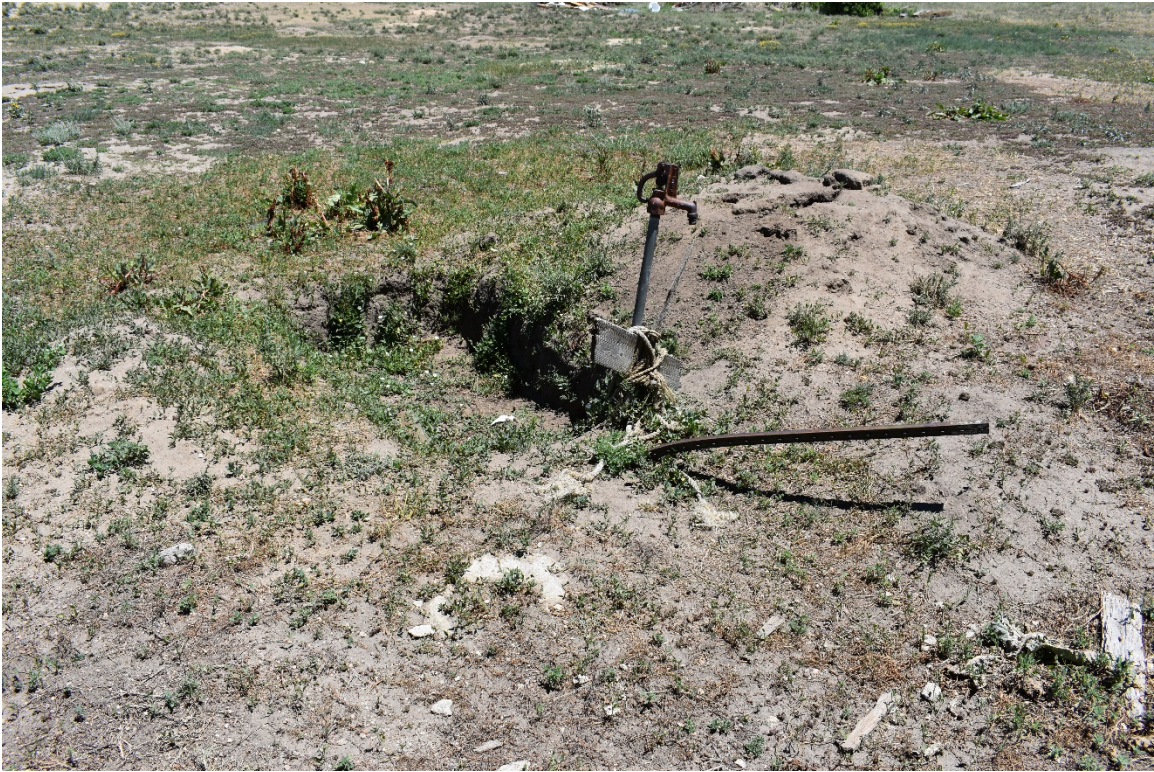
Located along the abandoned ditch is a small water pump (F13). It is constructed of 1-inch diameter lead pipes and has a metal hand pump and spout at the top.

5DA875 – Water pump and spigot (F13); view to the east-northeast.
