COLORADO CULTURAL RESOURCE SURVEY

## Architectural Inventory Form

1. Resource number: 5DA875
2. Temporary resource number: 10065-5DA875
3. County: Douglas
4. City: Parker
5. Historic building name: Ponce de Leon Chalybeate Springs, Allison's Twin House, Allison Ranch
6. Current building name: Agricultural property
7. Building address: 13100 block Parker Road, Parker, Colorado 80134
8. Owner name and address: Parker & Stroh LLC, P.O. Box 40326, Denver, Colorado 80204

# Evaluation of Ponce de Leon Chalybeate Springs/ Allison's Twin House, Douglas County, Colorado

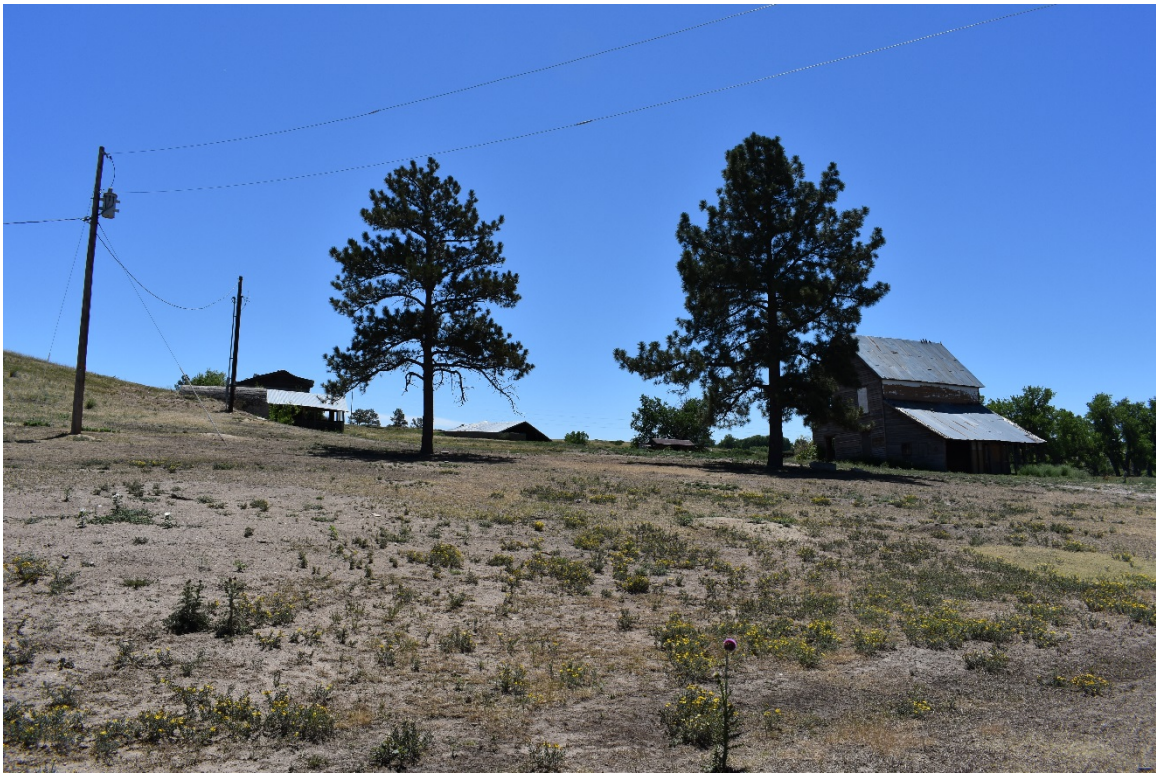
5DA875 – Property overview, house (F1) on right; view to the east-southeast.  
Photograph: DSC\_0147      Date: 6/25/2018

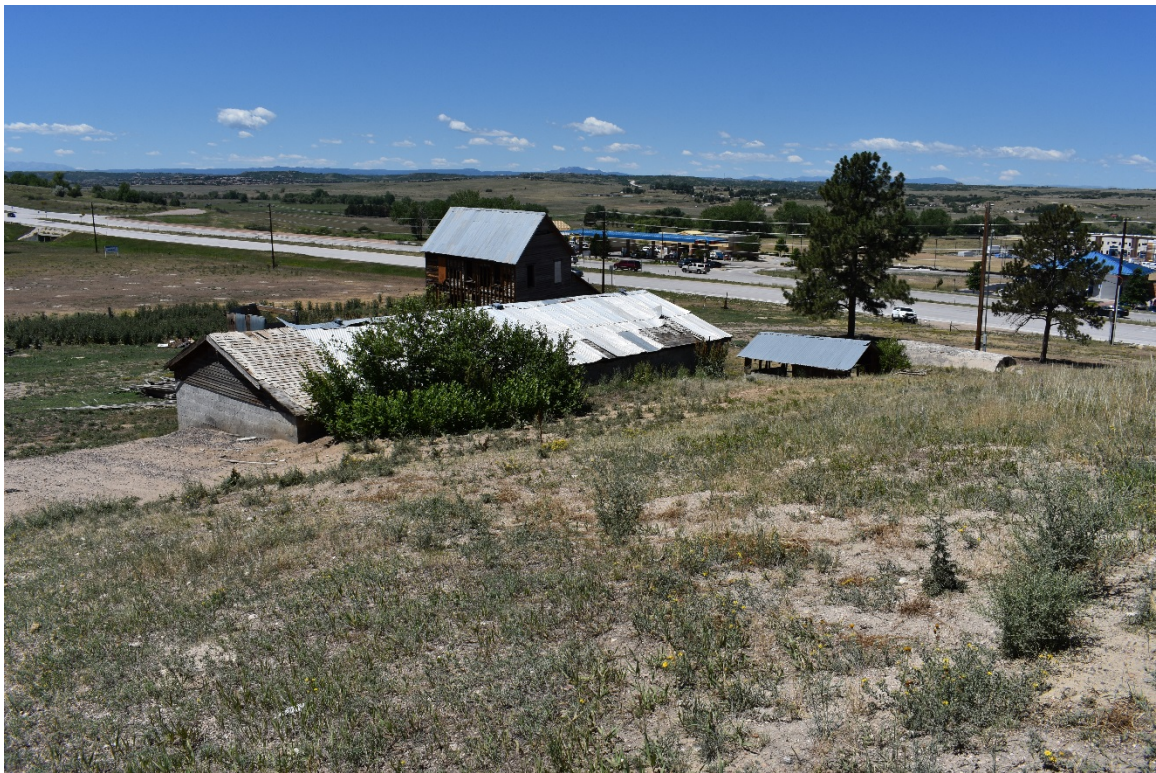
5DA875 – Property overview, outbuilding (F4) in foreground; view to the south-southeast.  
Photograph: DSC\_0173      Date: 6/25/2018

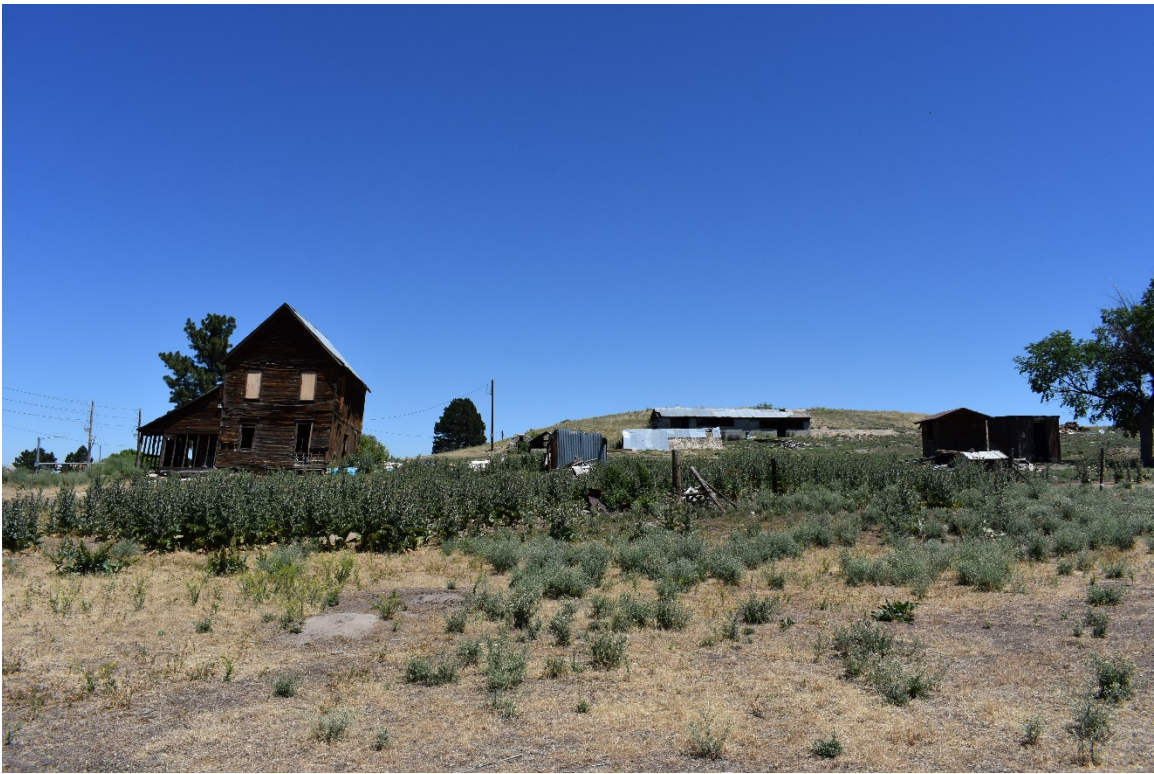
5DA875 – Property overview, house (F1) on left; view to the north.  
Photograph: DSC\_0218      Date: 6/25/2018

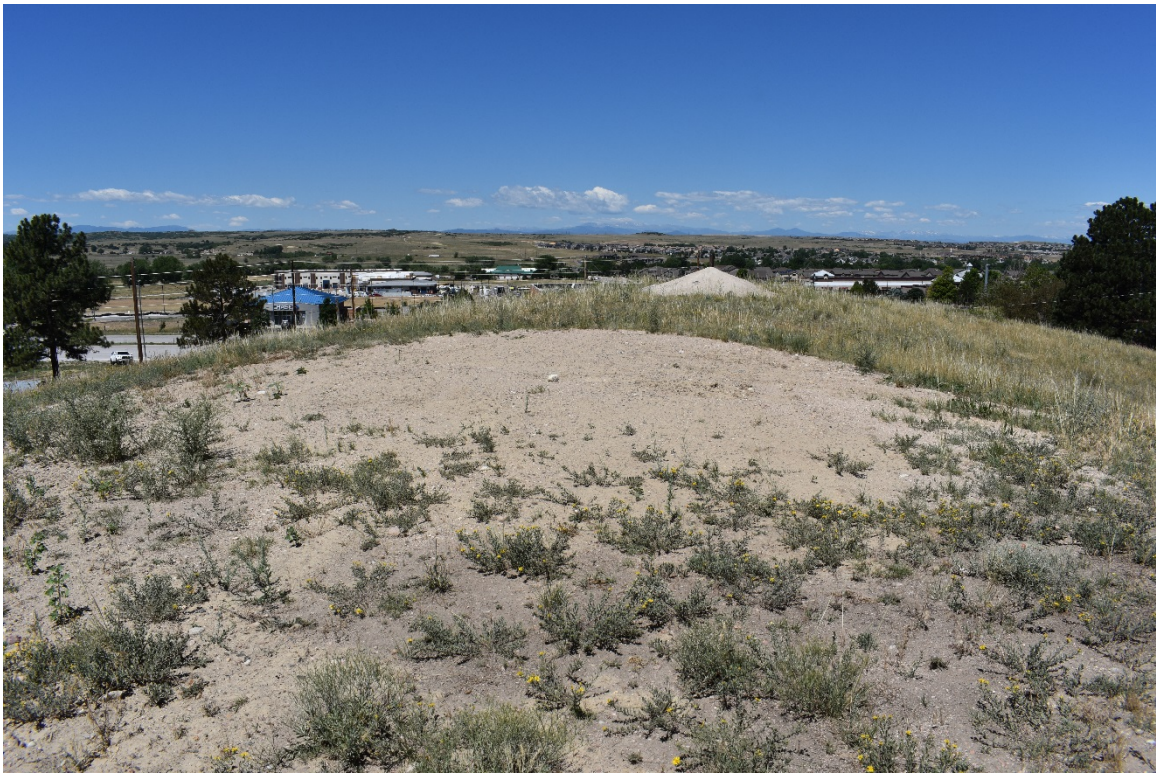
5DA875 – Overview depicting top of swale in the middle of the property and disturbance from recently removed windmill, F10 in background; view to the west. Photograph: DSC\_0171 Date: 6/25/2018
