# Geotechnical Engineering Report

**Proposed Daycare Building  
Southeast of Pine Lane and Twenty Mile Road  
Parker, Colorado**

August 24, 2020 (Revised September 23, 2020)  
Terracon Project No. 25205205

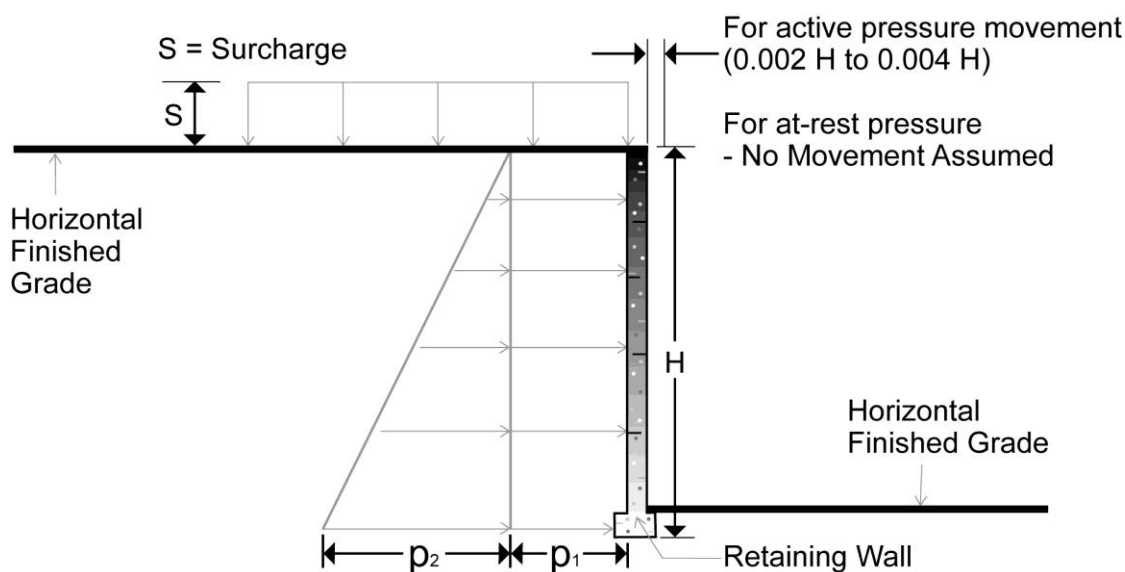
Below-grade walls or free-standing retaining walls are not anticipated for this project; however, we have included lateral earth pressures recommendations in case plans should change. Reinforced concrete walls with unbalanced backfill levels on opposite sides should be designed for earth pressures at least equal to those indicated in the following table. Earth pressures will be influenced by structural design of the walls, conditions of wall restraint, methods of construction and/or compaction and the strength of the materials being restrained. Two wall restraint conditions are shown. Active earth pressure is commonly used for design of free-standing cantilever retaining walls and assumes wall movement. The "at-rest" condition assumes no wall movement. The recommended design lateral earth pressures do not include a factor of safety and do not provide for possible hydrostatic pressure on the walls.

Earth Pressure Conditions	Lateral Earth Pressure Coefficient	Equivalent Fluid Density (pcf)	Surcharge Pressure, $p_1$ (psf)	Earth Pressure, $p_2$ (psf)
Active ( $K_a$ )	0.47	60	$(0.47)S$	$(60)H$
At-Rest ( $K_o$ )	0.64	80	$(0.64)S$	$(80)H$
Passive ( $K_p$ )	2.1	250	---	---

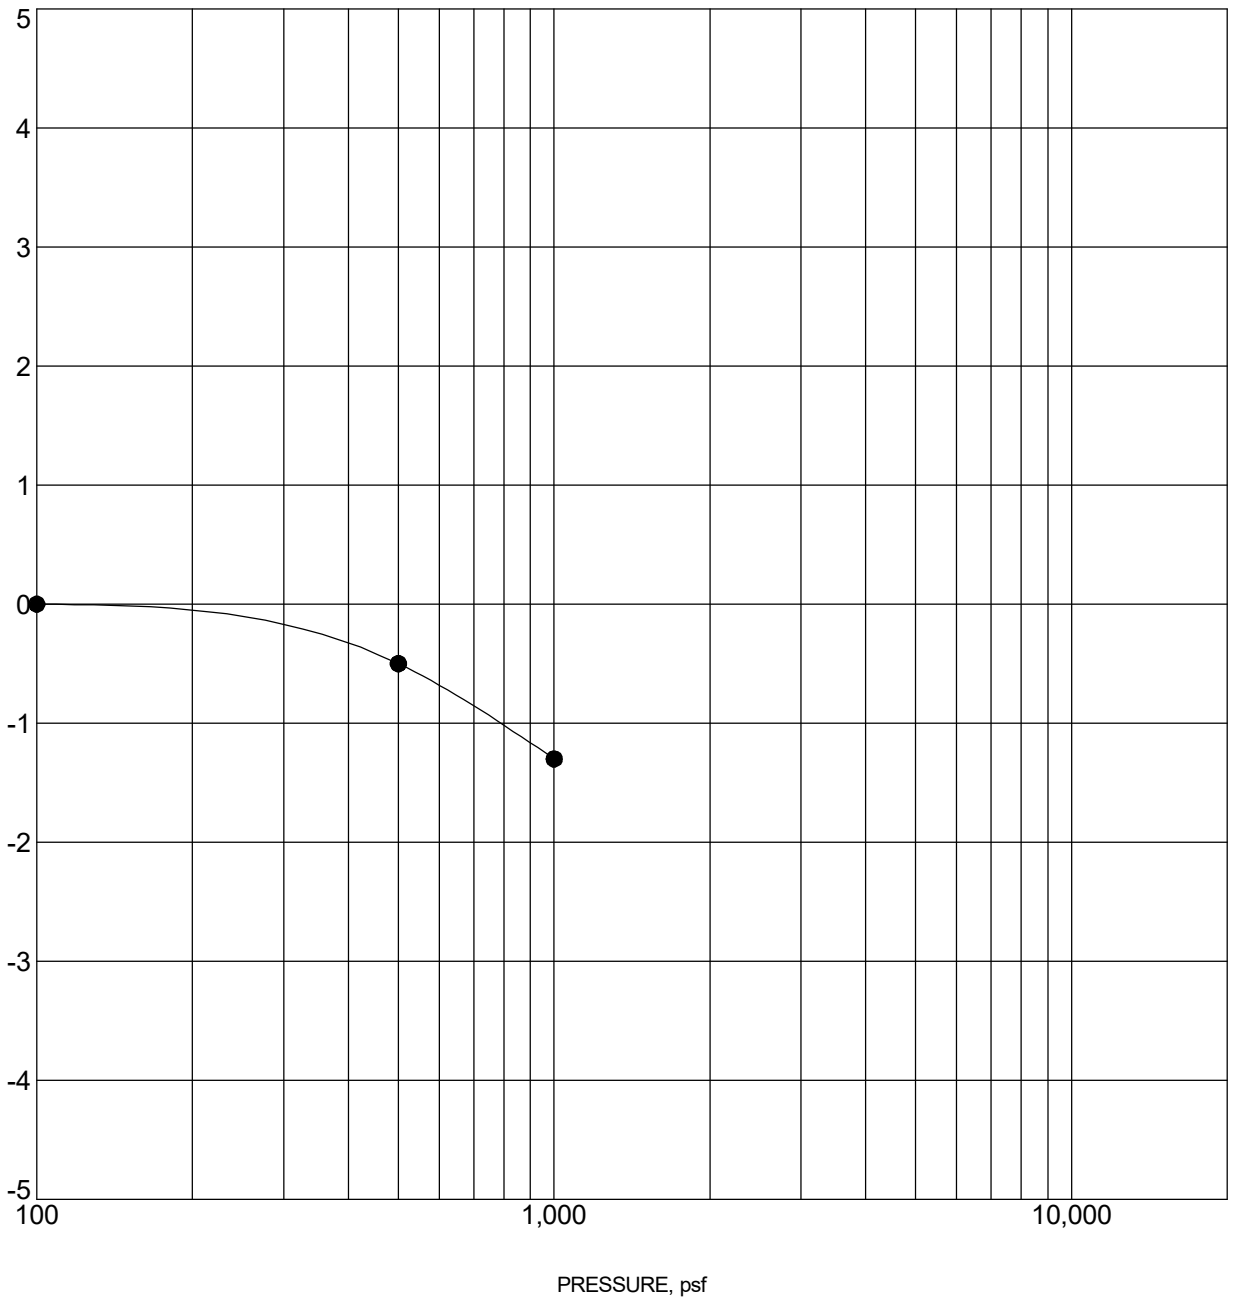
# SWELL CONSOLIDATION TEST

Specimen Identification		Classification	$\gamma_d$ , pcf	WC, %
●	1      9 - 10 ft	LEAN CLAY (CL)	108	18.0

NOTES: Water was added at 500 psf.

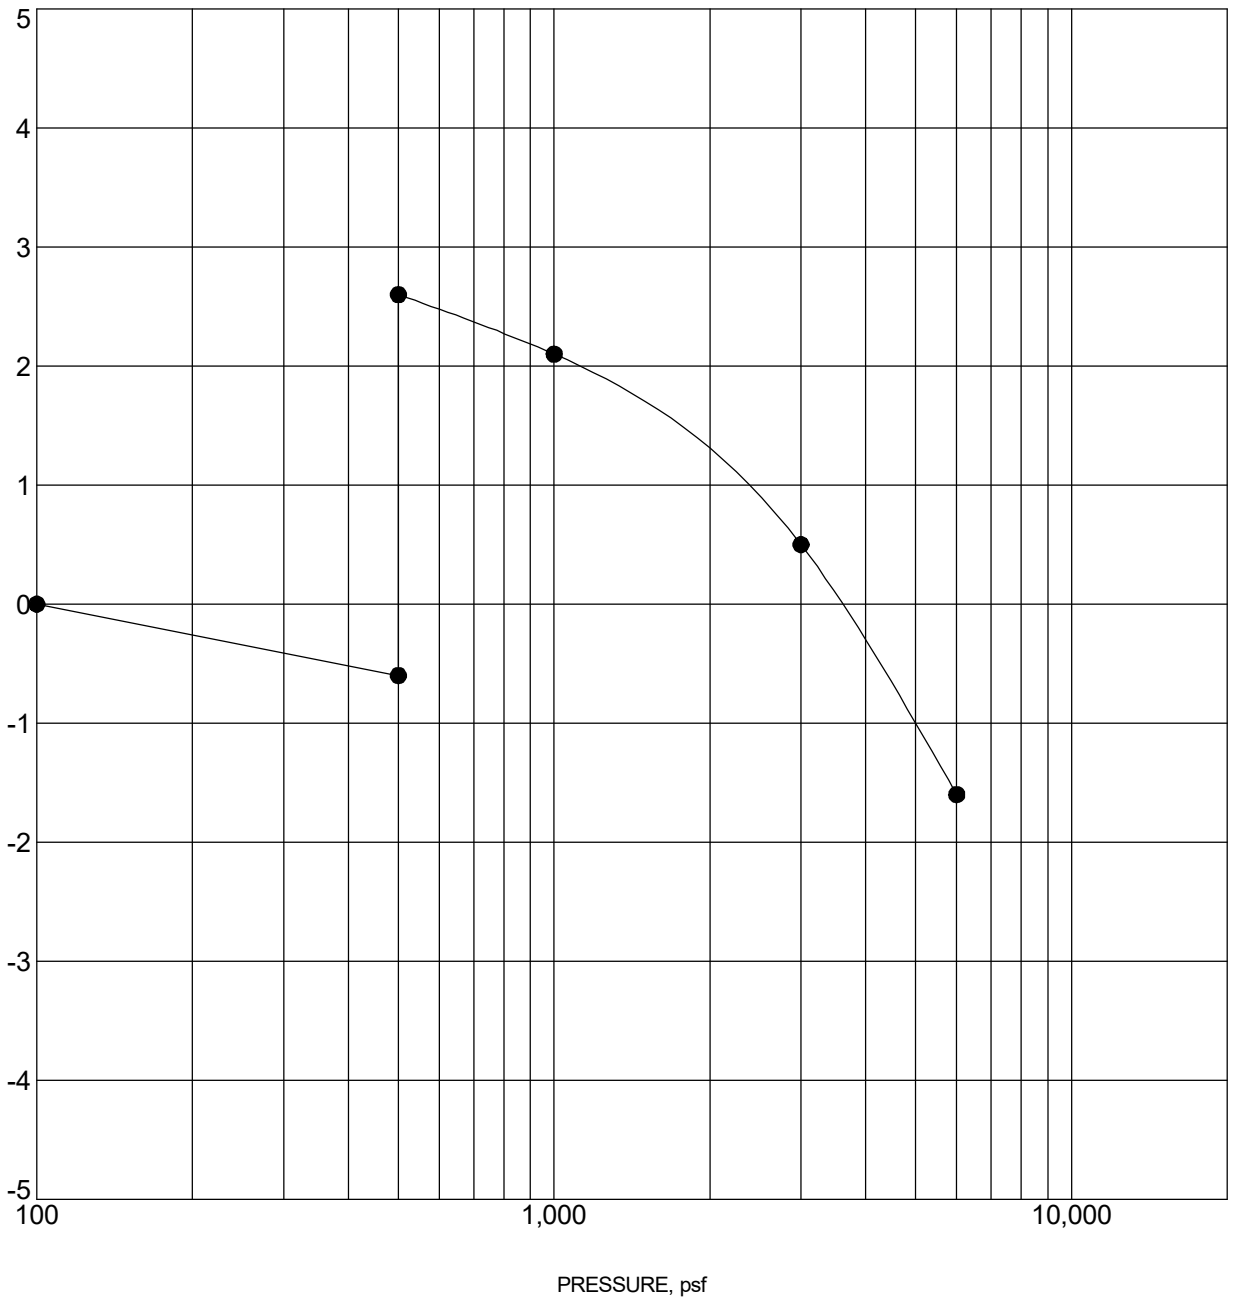
# SWELL CONSOLIDATION TEST

Specimen Identification		Classification	$\gamma_d$ , pcf	WC, %
●	3      4 - 5 ft	SANDY LEAN CLAY (CL)	116	12.6

NOTES: Water was added at 500 psf.

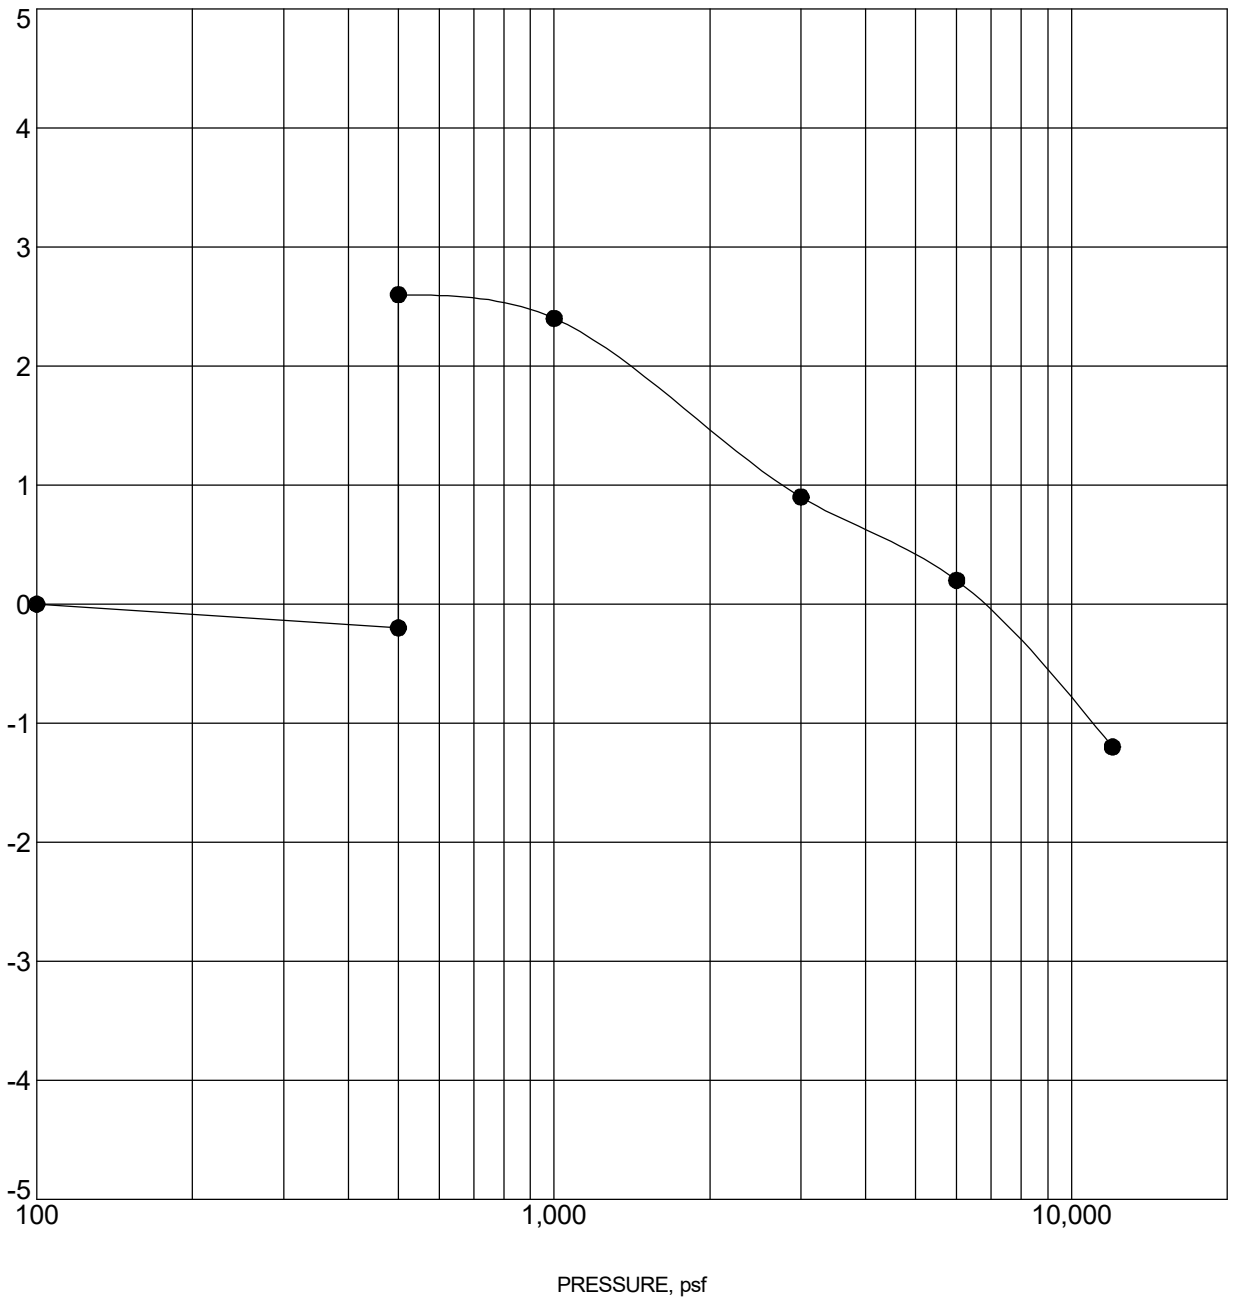
# SWELL CONSOLIDATION TEST

Specimen Identification		Classification	$\gamma_d$ , pcf	WC, %
●	4      4 - 5 ft	SANDY LEAN CLAY (CL)	117	14.0

NOTES: Water was added at 500 psf.

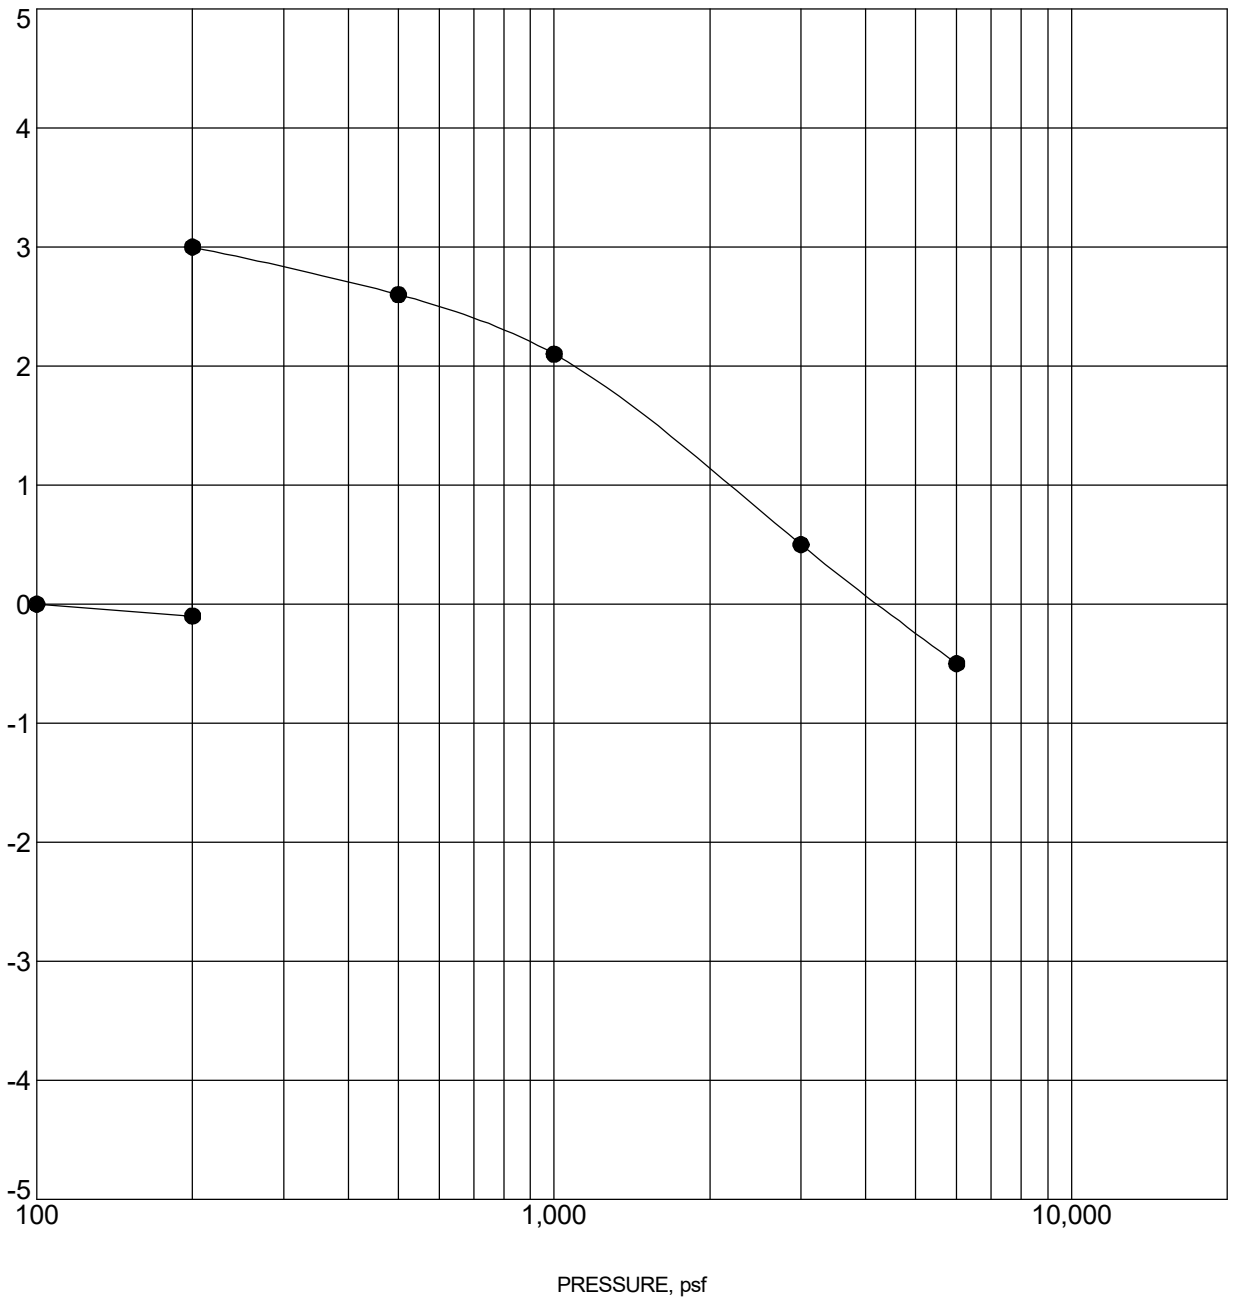
# SWELL CONSOLIDATION TEST

Specimen Identification		Classification	$\gamma_d$ , pcf	WC, %
●	P2 2 - 3 ft	SANDY LEAN CLAY (CL)	120	11.4

NOTES: Water was added at 200 psf.

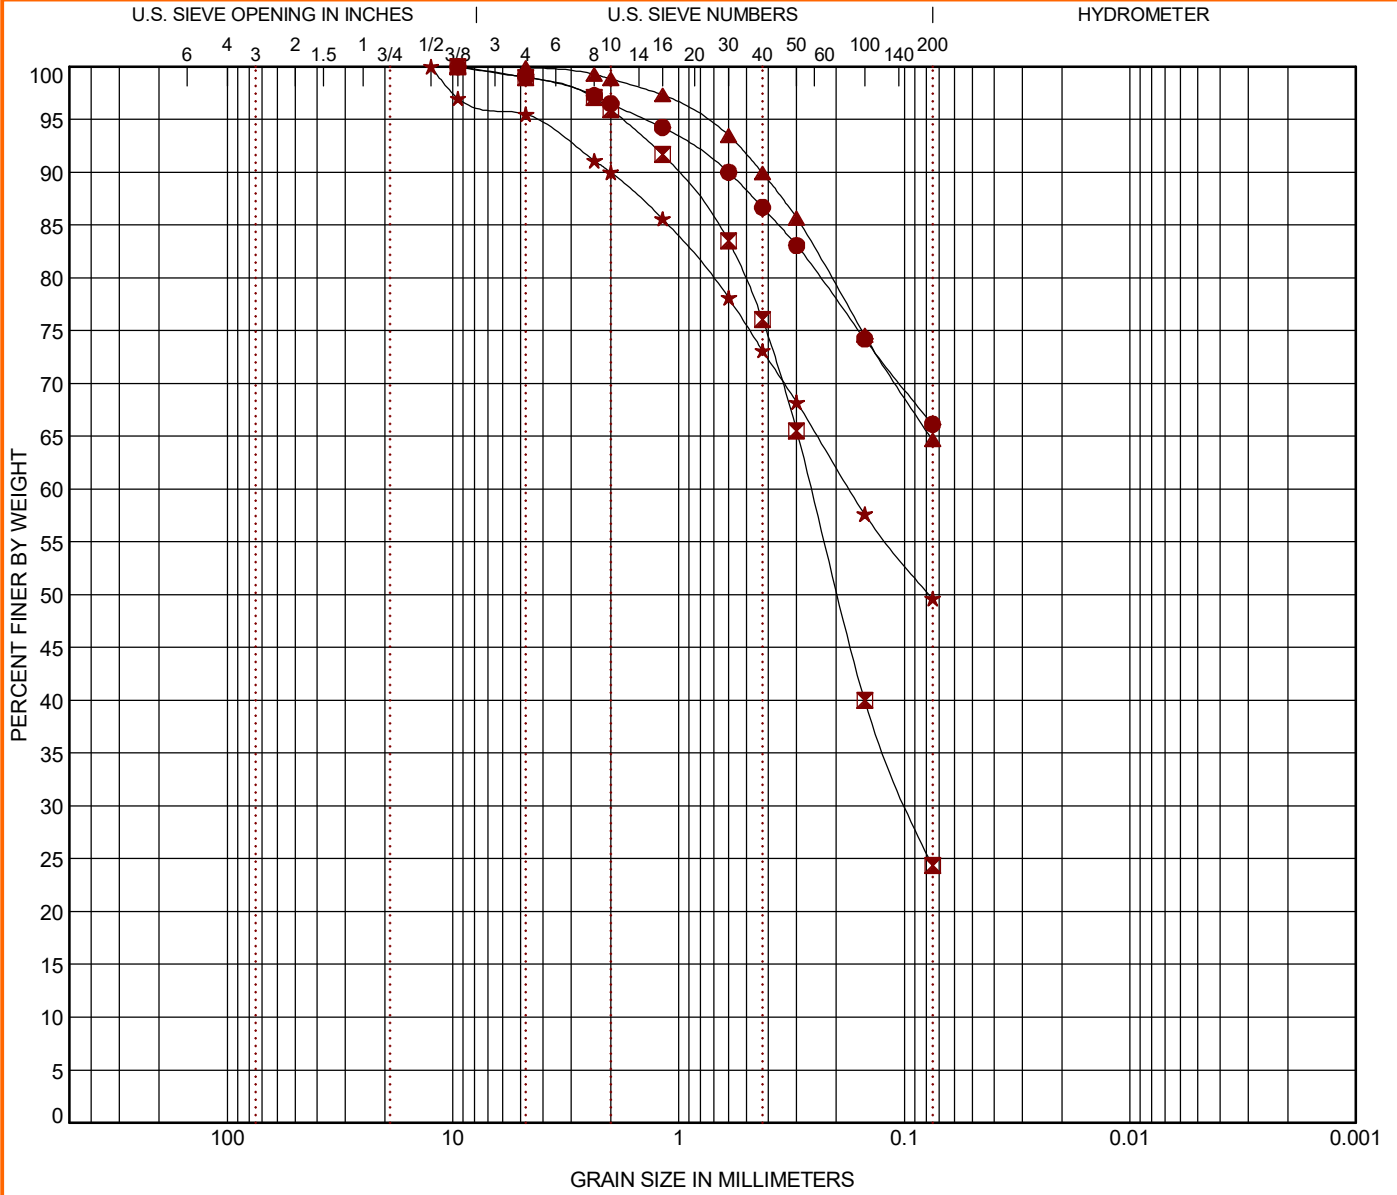
ASTM D422 / ASTM C136

COBBLES	GRAVEL		SAND			SILT OR CLAY
	coarse	fine	coarse	medium	fine

Boring ID	Depth	USCS Classification	AASHTO Classification	WC (%)	LL	PL	PI	Cc	Cu
● 1	0 - 5	SANDY LEAN CLAY (CL)	A-6 (11)		39	20	19		
☒ 1	24 - 25	SILTY SAND (SM)	A-2-4 (0)	4.0	NP	NP	NP		
▲ 2	0 - 5	SANDY LEAN CLAY (CL)	A-7-6 (13)		42	18	24		
★ 2	7 - 8	CLAYEY SAND (SC)	A-7-6 (9)	16.0	44	18	26

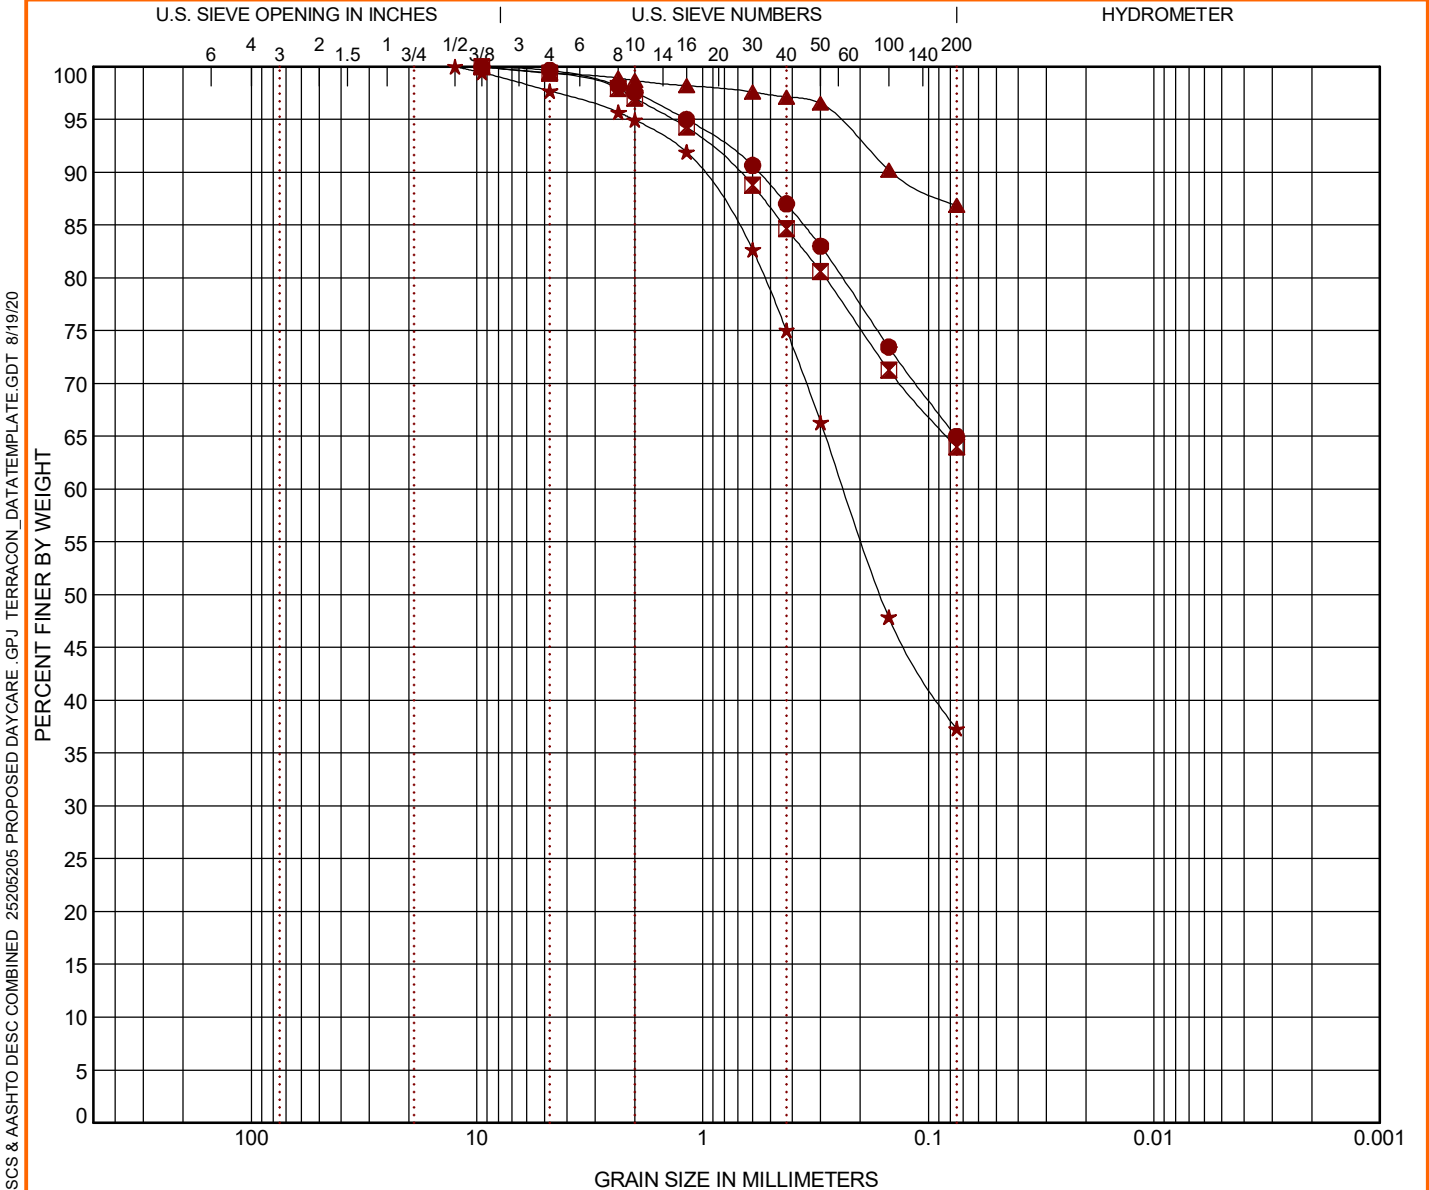
# GRAIN SIZE DISTRIBUTION

COBBLES	GRAVEL		SAND			SILT OR CLAY
	coarse	fine	coarse	medium	fine

Boring ID	Depth	USCS Classification	AASHTO Classification	WC (%)	LL	PL	PI	Cc	Cu
● 4	0 - 5	SANDY LEAN CLAY (CL)	A-7-6 (13)		43	19	24		
☒ 4	9 - 10	SANDY LEAN CLAY (CL)	A-7-6 (17)	12.7	46	15	31		
▲ 4	19 - 20	FAT CLAY (CH)	A-7-6 (29)	21.7	51	19	32		
★ P1	0 - 5	CLAYEY SAND (SC)	A-6 (1)		35	21	14

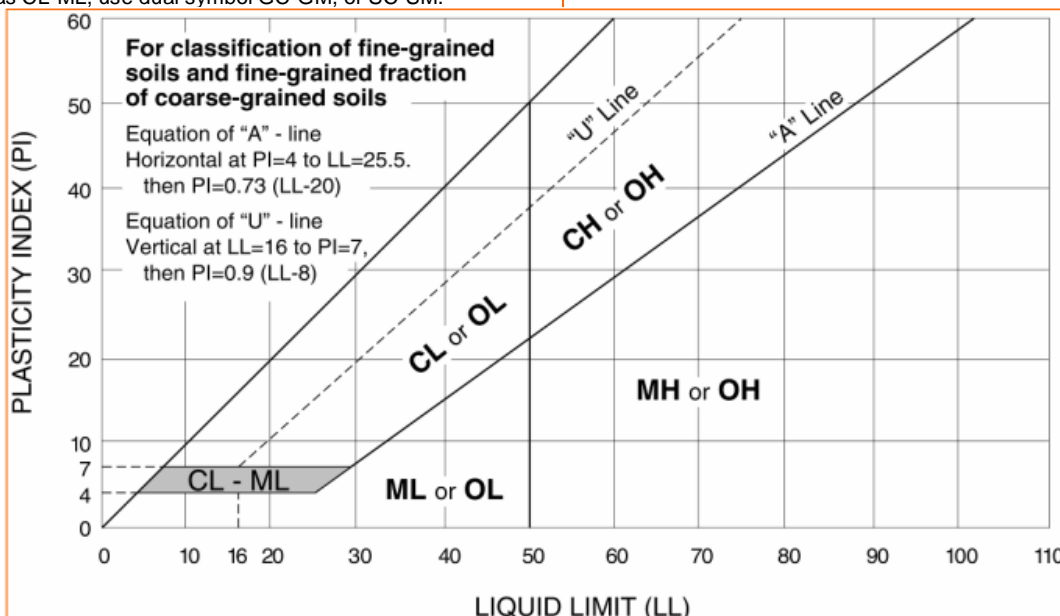
<sup>P</sup>  $PI$  plots on or above "A" line.

<sup>Q</sup>  $PI$  plots below "A" line.
