# Geotechnical Engineering Report

**Proposed Parker McDonald's Restaurant #5078  
Southeast of South Chambers Road and South Red Sky Drive  
Parker, Colorado**

April 9, 2021  
Terracon Project No. 25215044

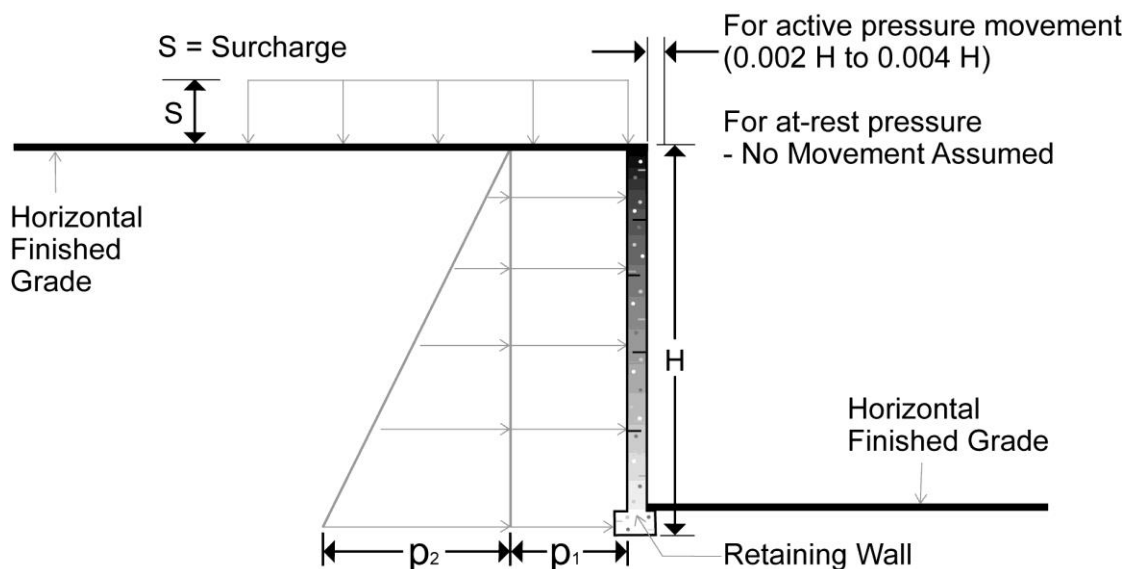
Earth Pressure Conditions	Lateral Earth Pressure Coefficient	Equivalent Fluid Density (pcf)	Surcharge Pressure, $p_1$ (psf)	Earth Pressure, $p_2$ (psf)
Active ( $K_a$ )	0.33	40	$(0.33)S$	$(40)H$
At-Rest ( $K_o$ )	0.50	60	$(0.50)S$	$(60)H$
Passive ( $K_p$ )	3.00	300	---	---

Topic <sup>1</sup>	Overview Statement <sup>2</sup>
<b>Lateral Earth Pressures</b>	Based on materials encountered during the exploration and various possible earth pressure conditions, lateral earth pressure coefficients and equivalent fluid densities have been calculated.
<b>Pavements</b>	Pavements may be constructed on a zone of engineered fill, provided the owner is willing to accept the risk of movement.

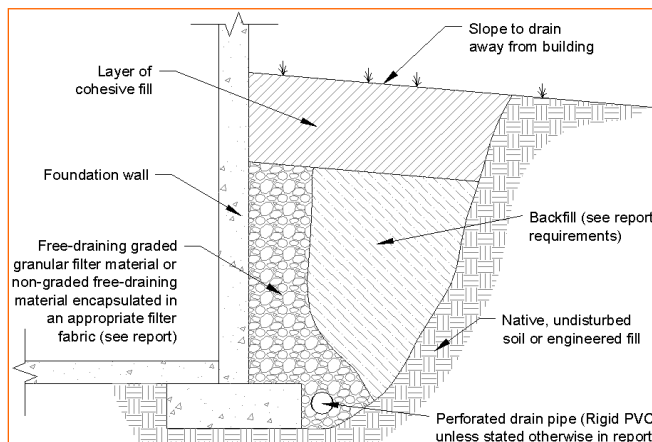
free-draining aggregate should be encapsulated in a filter fabric. The granular fill should extend to within 2 feet of final grade, where it should be capped with compacted cohesive fill to reduce infiltration of surface water into the drain system.

As an alternative to free-draining granular fill, a prefabricated drainage structure may be used. A prefabricated drainage structure is a plastic drainage core or mesh covered with filter fabric to prevent soil intrusion that is fastened to the wall prior to placing backfill.

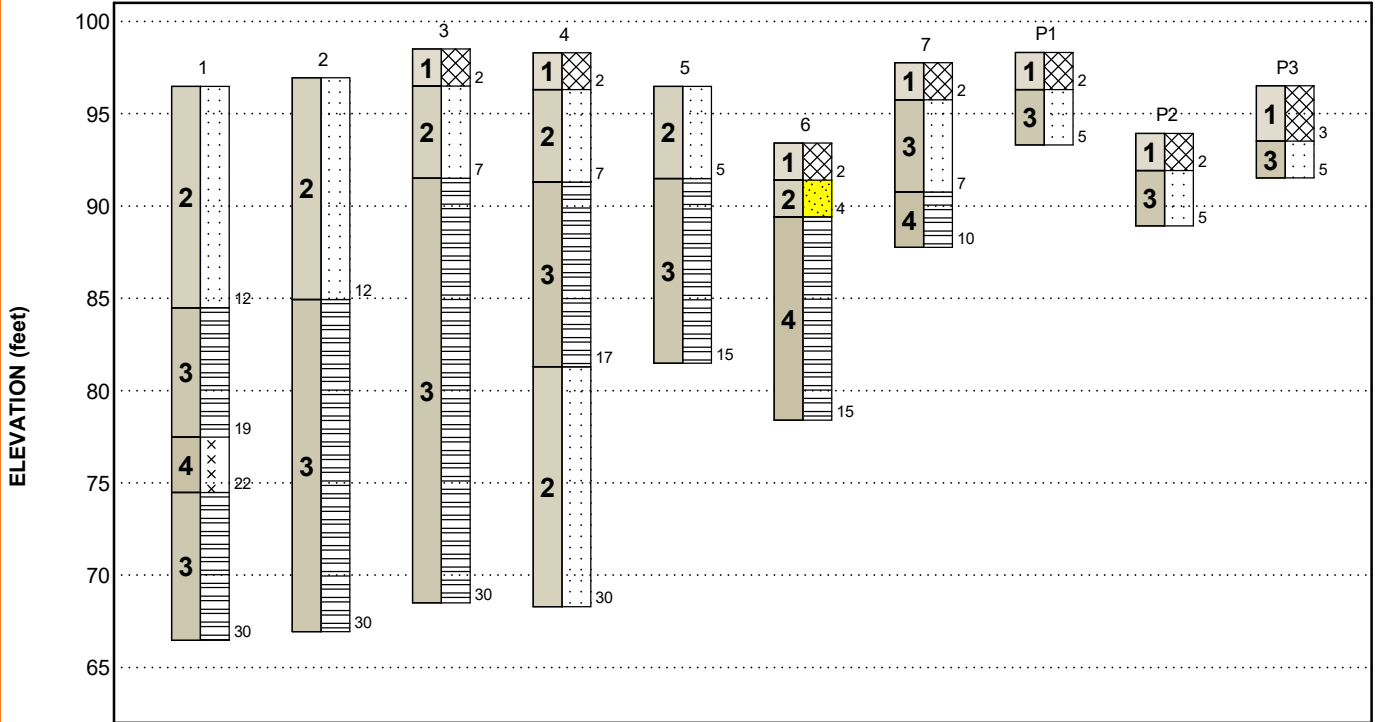
**GEOMODEL**

This is not a cross section. This is intended to display the Geotechnical Model only. See individual logs for more detailed conditions.

Model Layer	Layer Name	General Description
1	Existing Fill	Fill materials consisting of lean clay with varying amounts of sand and gravel and sand with varying amounts of clay, silt, and gravel, variable densities
2	Native Sand	Native sand soils; dense
3	Sandstone Bedrock	Sandstone bedrock with varying amounts of silt and clay; soft to hard
4	Claystone Bedrock	Claystone bedrock with varying amounts of sand and silt; soft to hard
5	Siltstone	Siltstone, trace sand; hard

We have developed a general characterization of the subsurface conditions based upon our review of the subsurface exploration, laboratory data, geologic setting, and our understanding of the project. This characterization, termed GeoModel, forms the basis of our geotechnical calculations and evaluation of site preparation and foundation options. Conditions encountered at each exploration point are indicated on the individual logs. The individual logs can be found in the **Exploration Results** section and the GeoModel can be found in the **Figures** section of this report. As noted in **General Comments**, the characterization is based upon widely spaced exploration points across the site, and variations are likely.

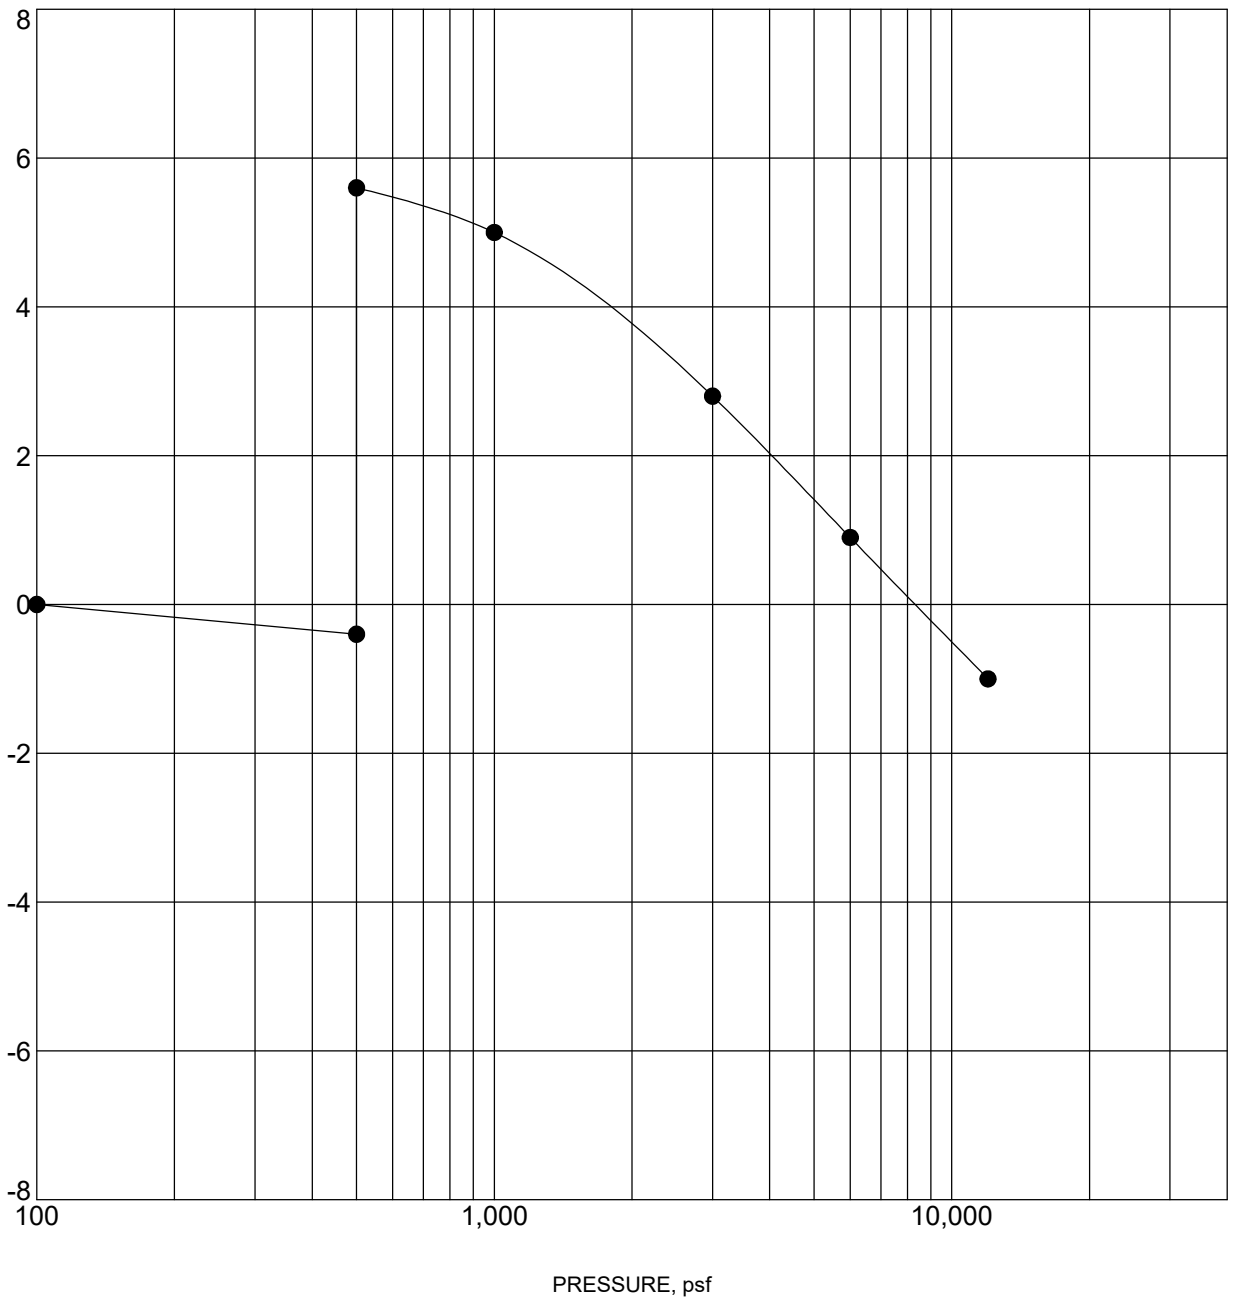
# SWELL CONSOLIDATION TEST

Specimen Identification		Classification	$\gamma_d$ , pcf	WC, %
●	3      9 - 10 ft	CLAYSTONE	122	9.4

NOTES: Water was added at 500 psf.

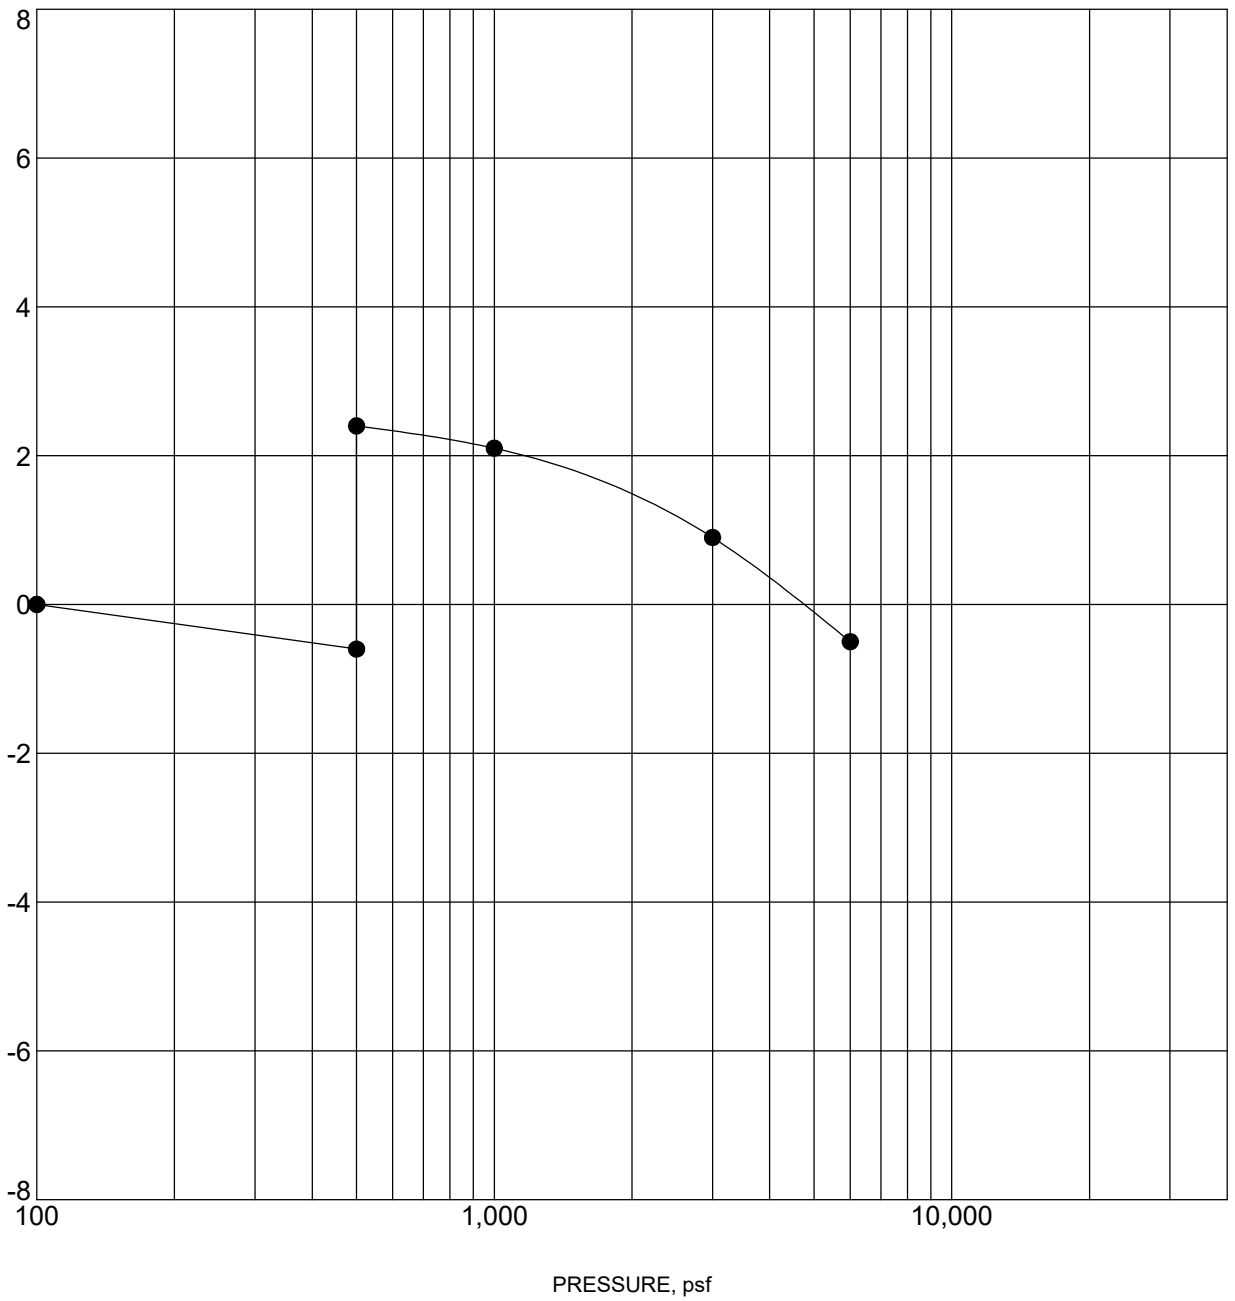
# SWELL CONSOLIDATION TEST

Specimen Identification			Classification	$\gamma_d$ , pcf	WC, %
●	3	14 - 15 ft	CLAYSTONE	109	19.0

NOTES: Water was added at 500 psf.

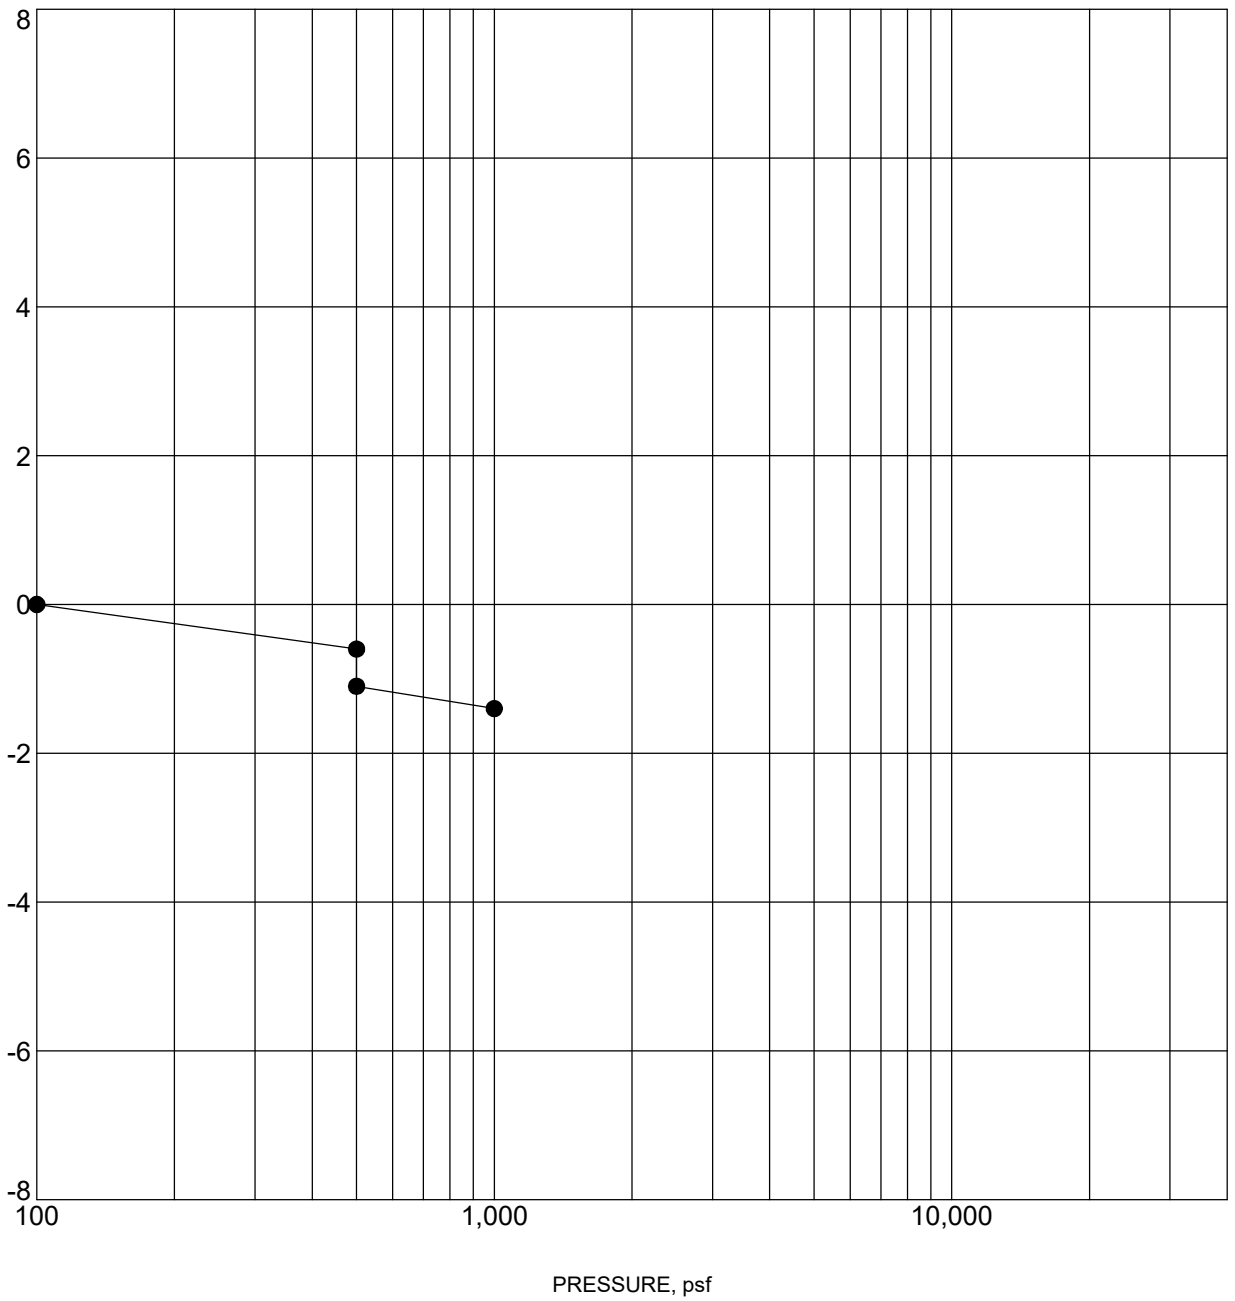
# SWELL CONSOLIDATION TEST

Specimen Identification		Classification	$\gamma_d$ , pcf	WC, %
●	4      9 - 10 ft	CLAYSTONE	108	18.4

NOTES: Water was added at 500 psf.

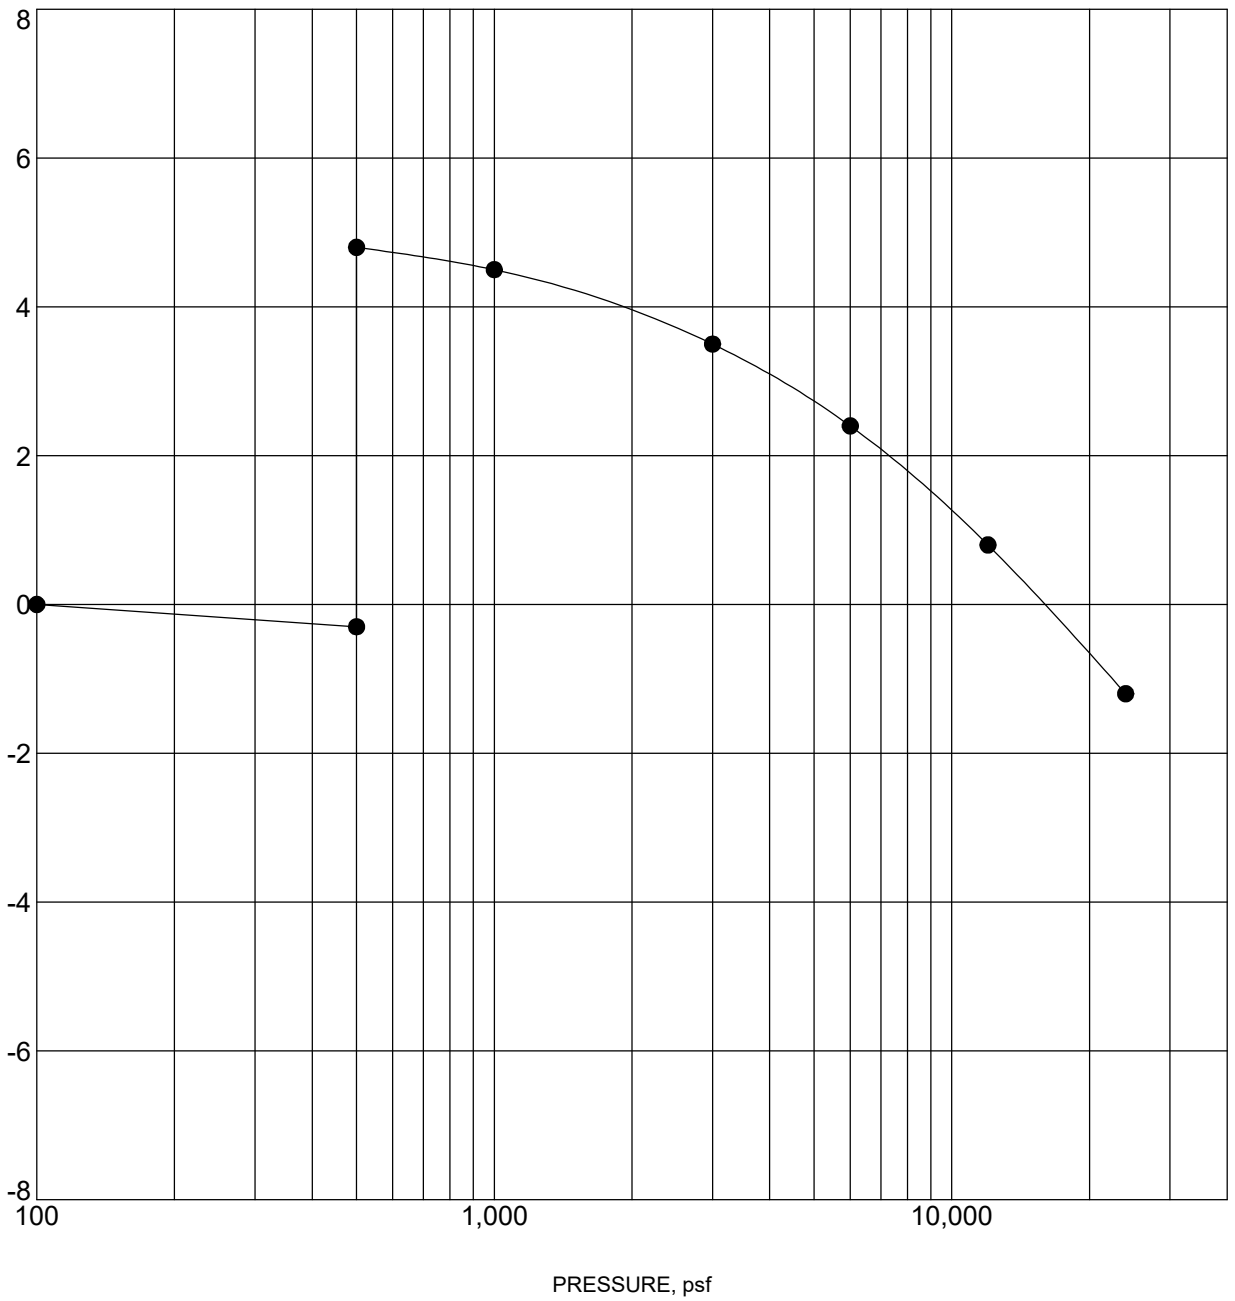
# SWELL CONSOLIDATION TEST

Specimen Identification		Classification	$\gamma_d$ , pcf	WC, %
●	5 9 - 10 ft	CLAYSTONE	105	21.8

NOTES: Water was added at 500 psf.

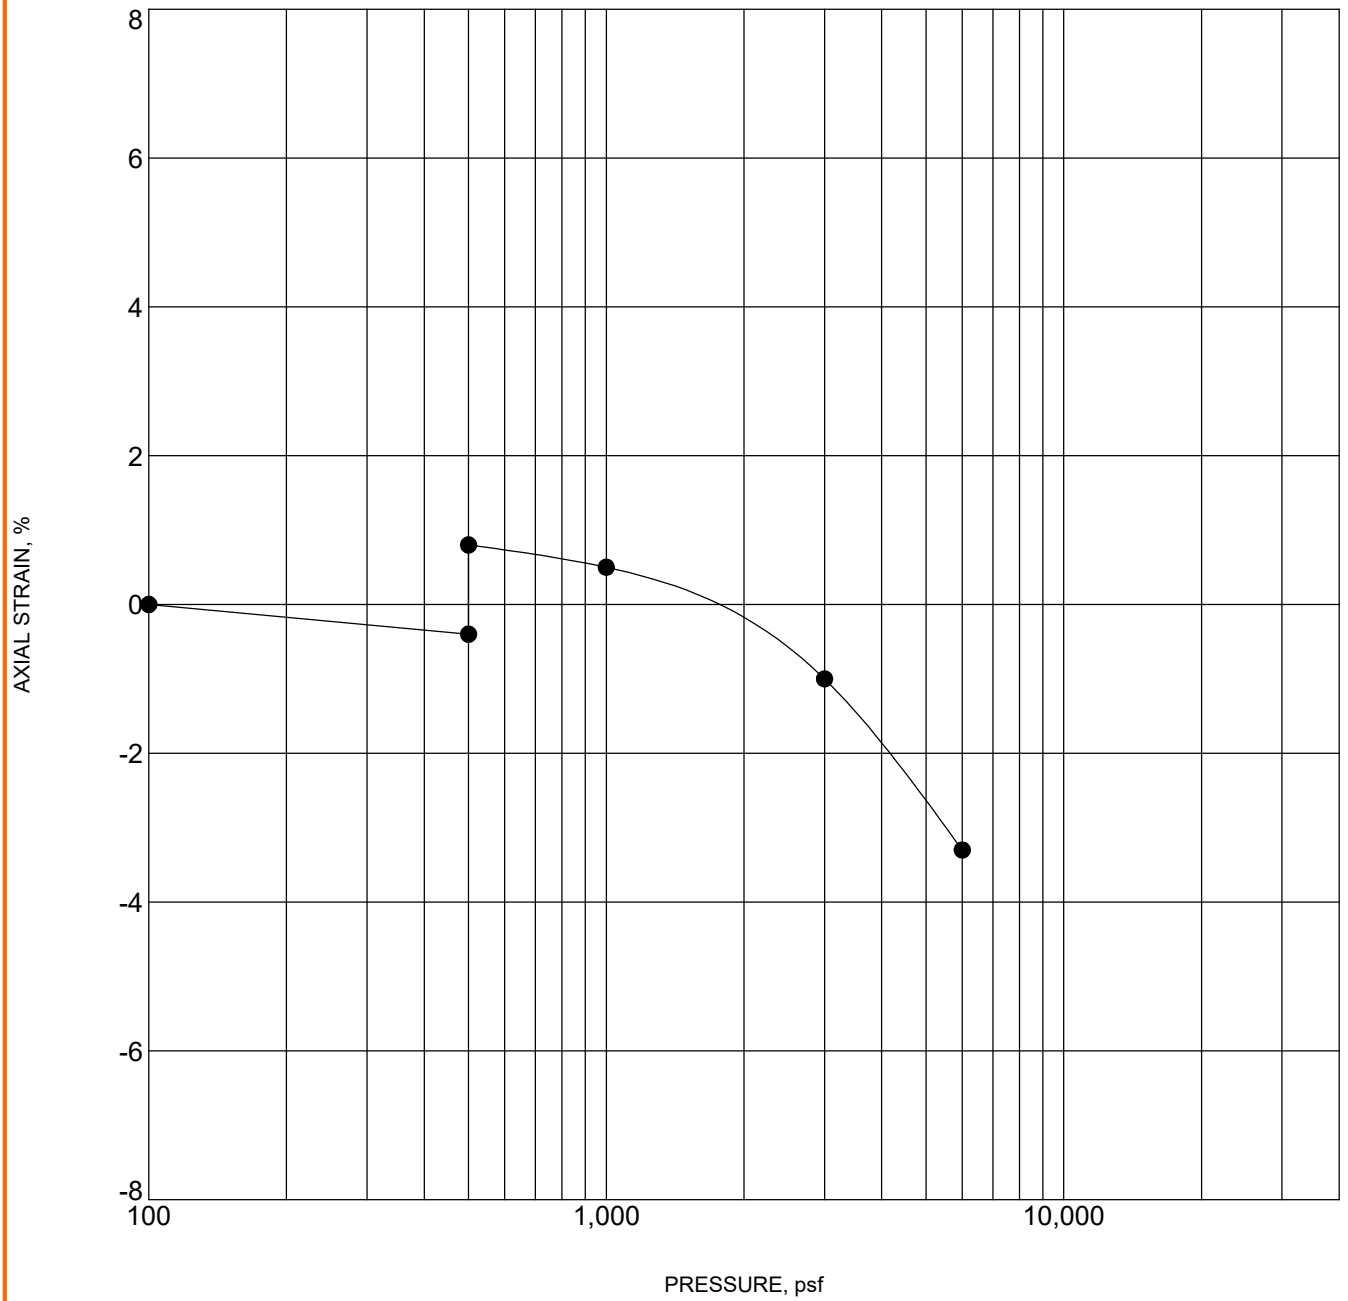
# SWELL CONSOLIDATION TEST

Specimen Identification			Classification	$\gamma_d$ , pcf	WC, %
●	6	4 - 5 ft	CLAYSTONE	111	10.2

NOTES: Water was added at 500 psf.

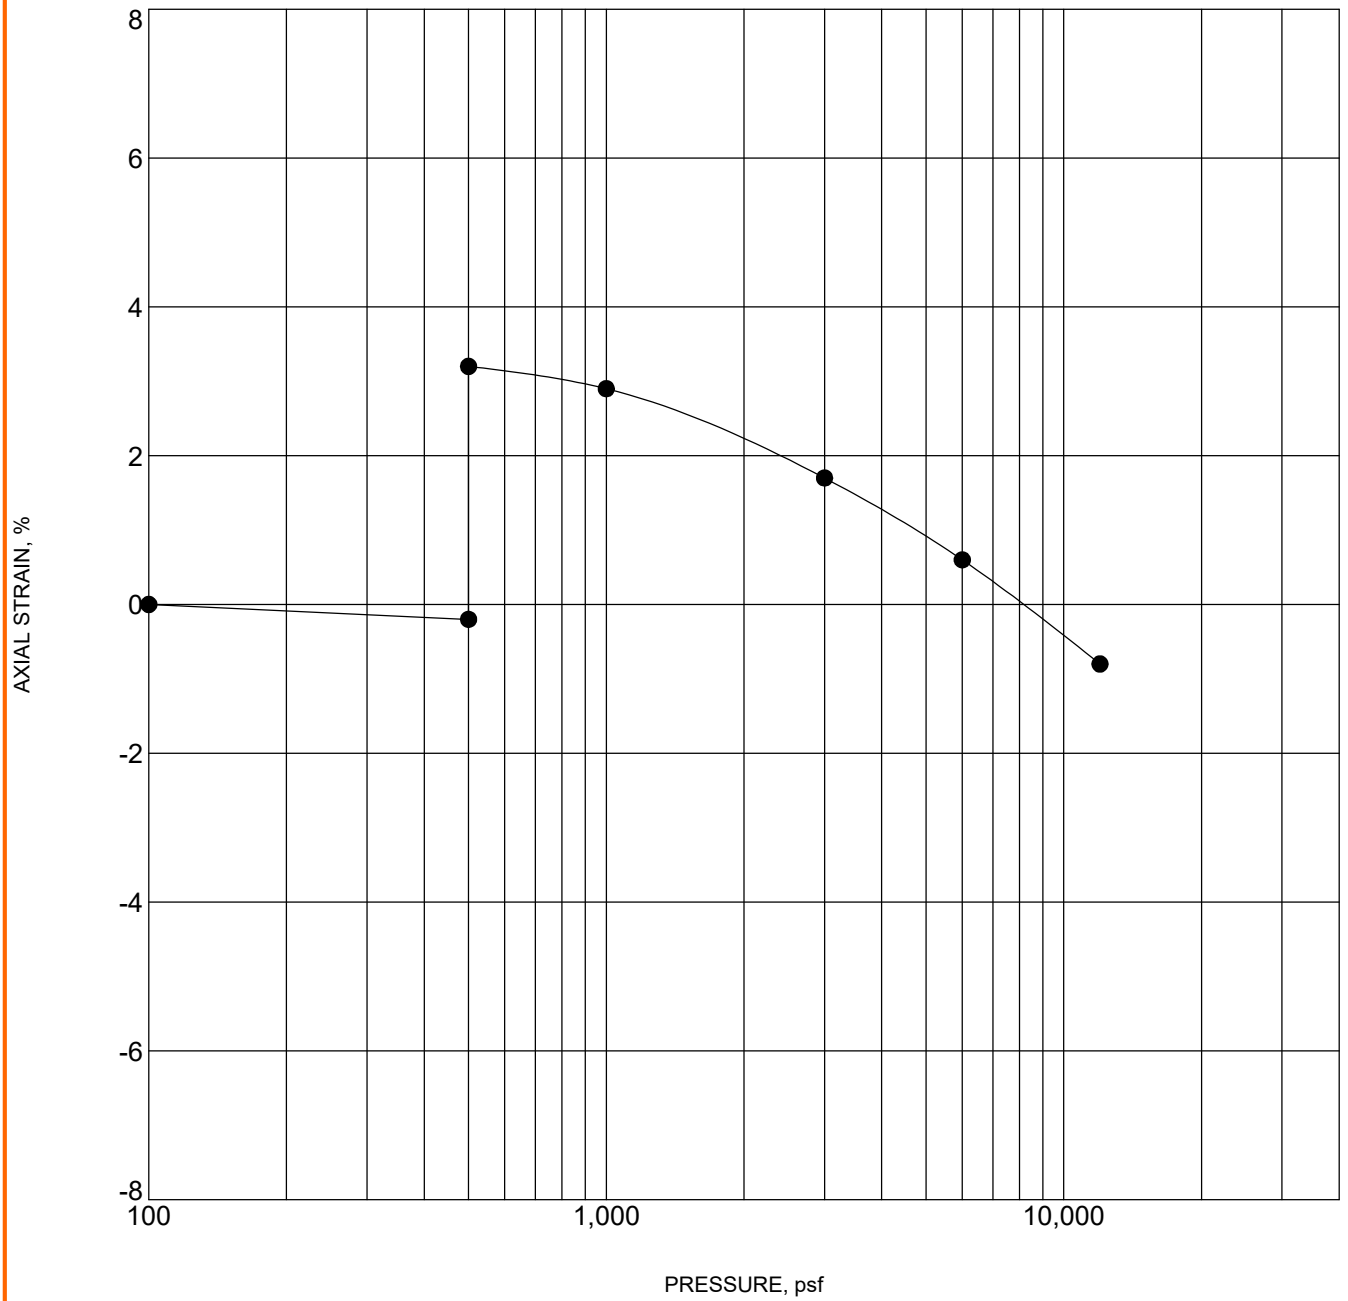
# SWELL CONSOLIDATION TEST

Specimen Identification		Classification	$\gamma_d$ , pcf	WC, %
●	7      9 - 10 ft	CLAYSTONE	111	18.4

NOTES: Water was added at 500 psf.

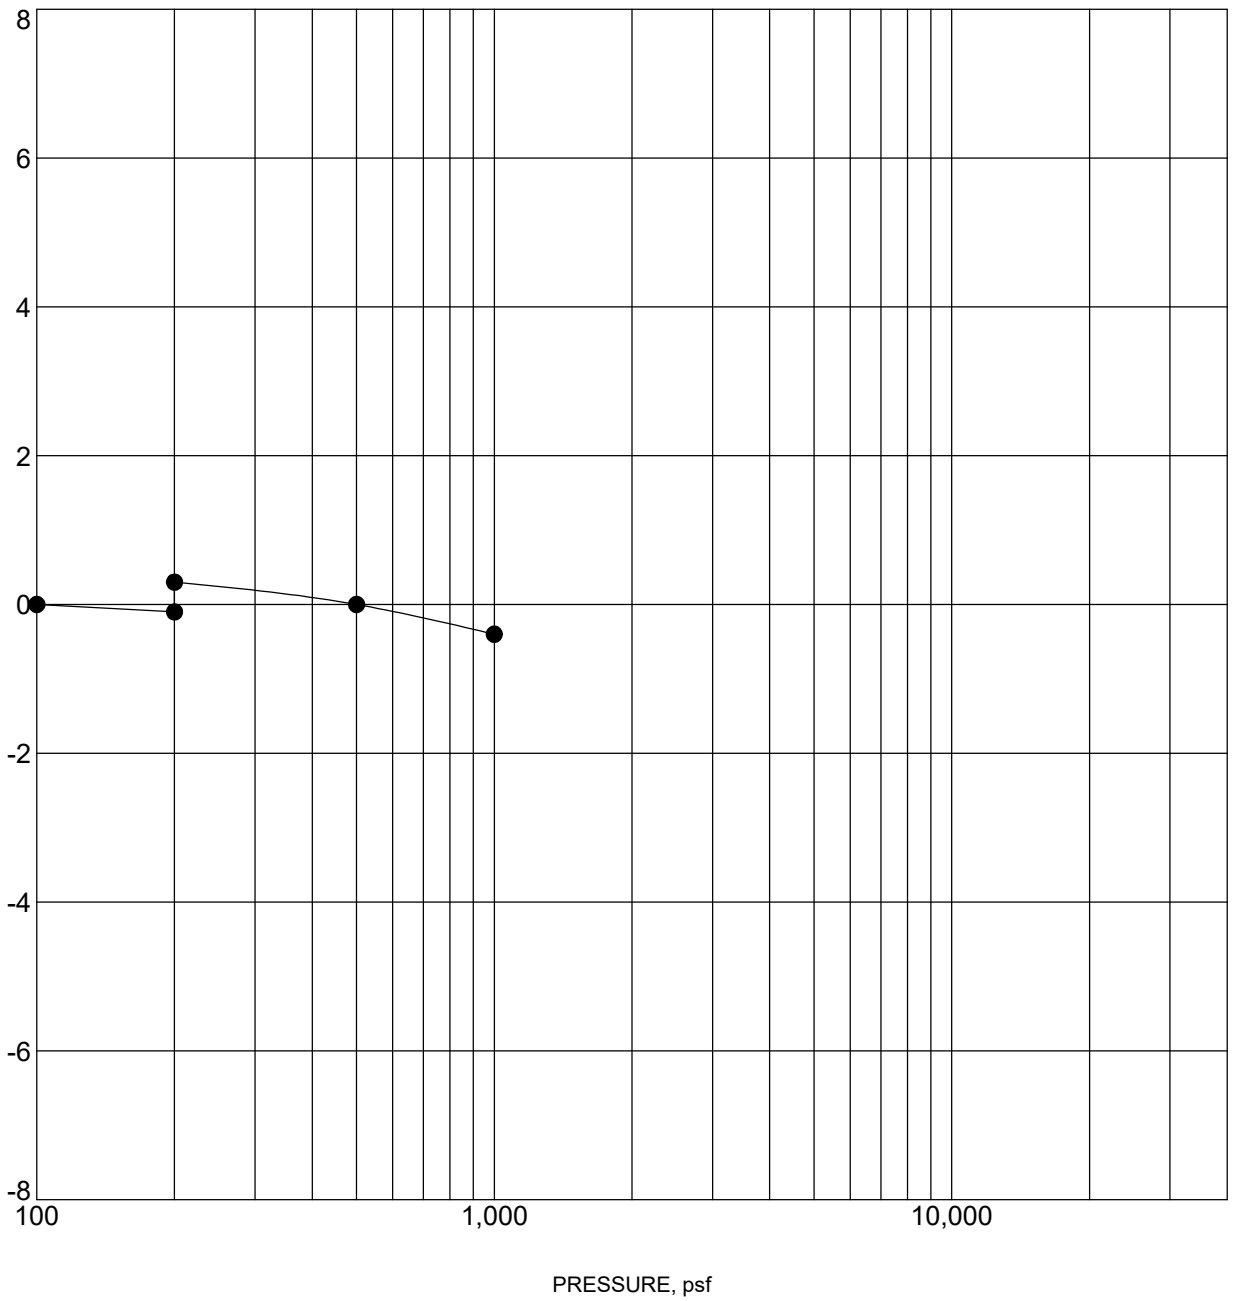
# SWELL CONSOLIDATION TEST

Specimen Identification		Classification	$\gamma_d$ , pcf	WC, %
●	P3 2 - 3 ft	FILL - CLAYEY SAND (SC)	93	21.7

NOTES: Water was added at 200 psf.

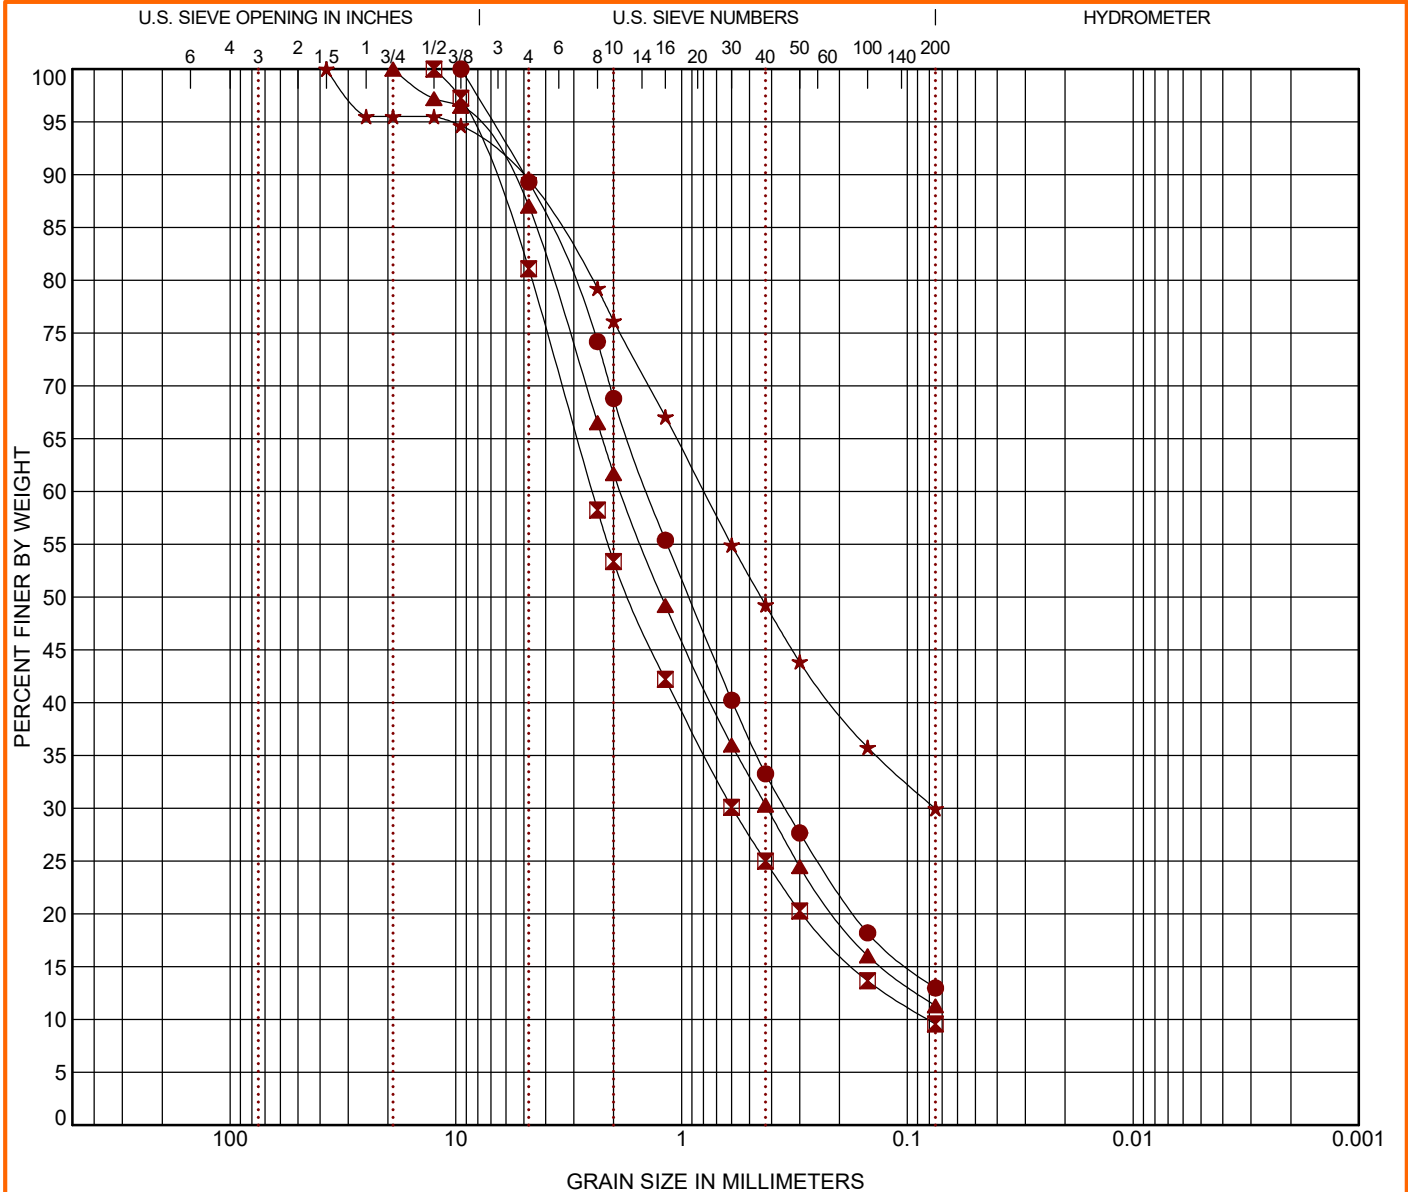
ASTM D422 / ASTM C136

COBBLES	GRAVEL		SAND			SILT OR CLAY
	coarse	fine	coarse	medium	fine

Boring ID	Depth	USCS Classification	AASHTO Classification	WC (%)	LL	PL	PI	Cc	Cu
● 1	2 - 3	SILTY SAND (SM)	A-1-b (0)		NP	NP	NP		
■ 2	9 - 10	WELL-GRADED SAND with SILT and GRAVEL (SW-SM)	A-1-b (0)	9.4	NP	NP	NP	1.77	30.86
▲ 5	2 - 3	WELL-GRADED SAND with SILT (SW-SM)	A-1-b (0)	6.9	NP	NP	NP	1.51	29.99
★ P1	0 - 5	CLAYEY SAND (SC)	A-2-6 (2)		40	16	24

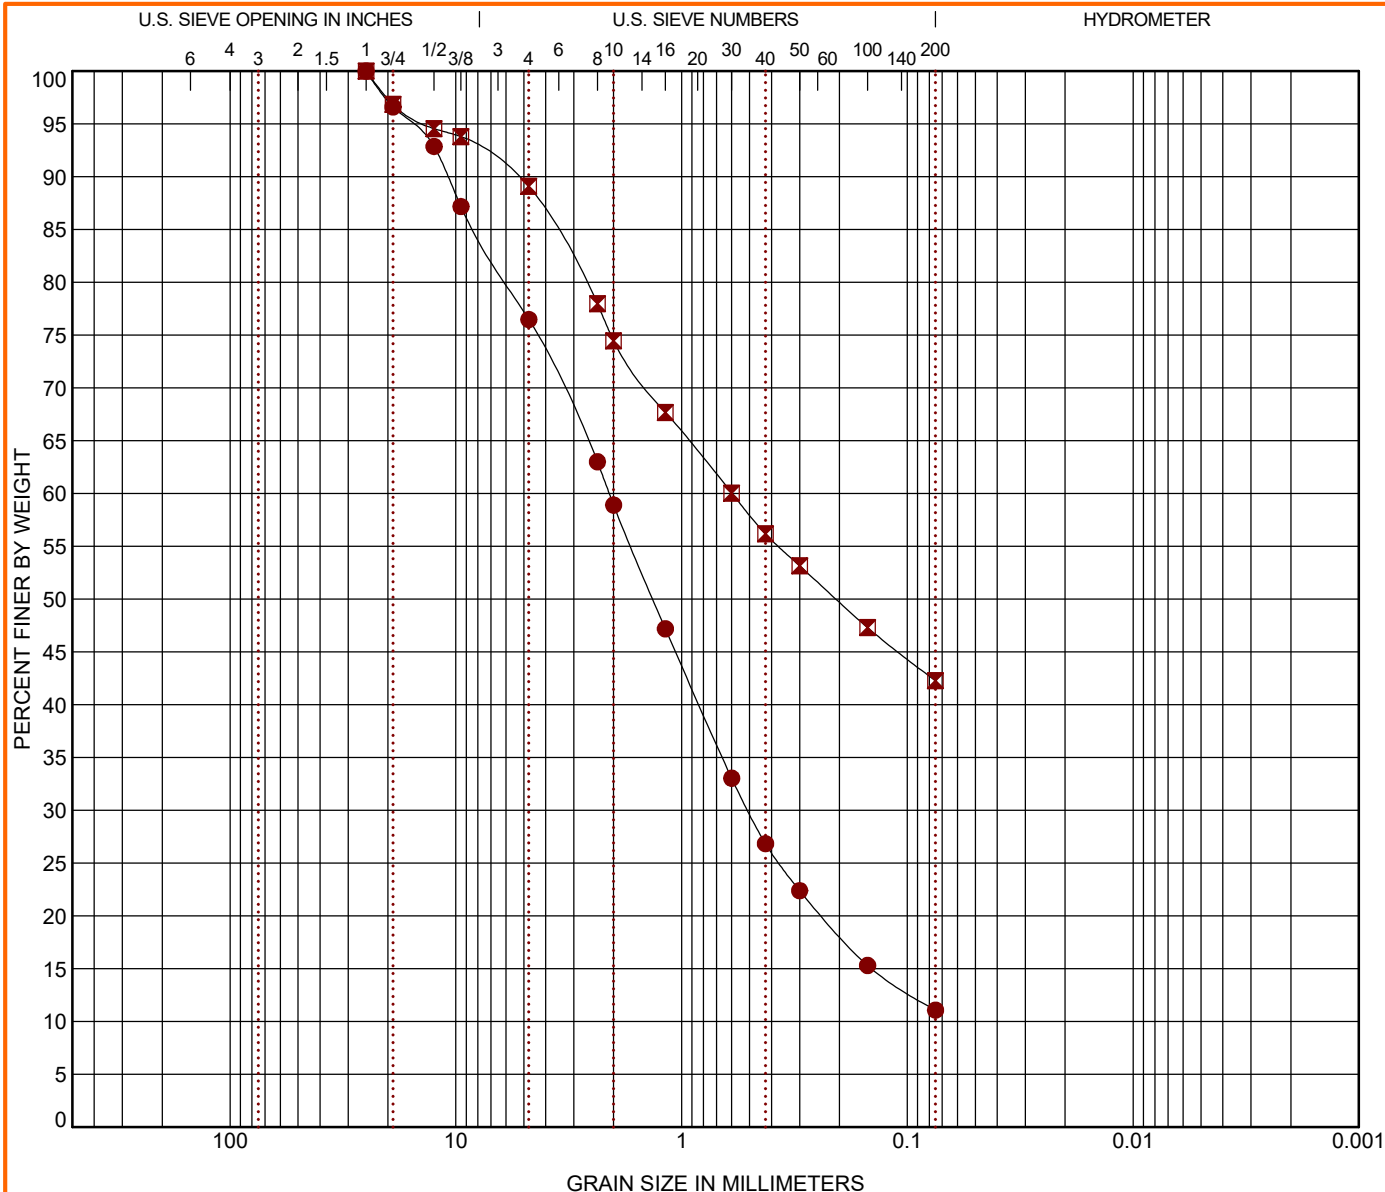
# GRAIN SIZE DISTRIBUTION

COBBLES	GRAVEL		SAND			SILT OR CLAY
	coarse	fine	coarse	medium	fine

Boring ID	Depth	USCS Classification	AASHTO Classification	WC (%)	LL	PL	PI	Cc	Cu
● P2	2 - 3	WELL-GRADED SAND with SILT and GRAVEL (SW-SM)	A-1-b (0)		NP	NP	NP	1.95	33.22
■ P3	0 - 5	CLAYEY SAND (SC)	A-7-6 (7)		55	26	29
