Geotechnical Engineering Report

**Proposed McDonald's Restaurant #5-1004
Southeast of East Stroh Road and South Parker Road
Parker, Colorado**

March 24, 2022
Terracon Project No. 25225006

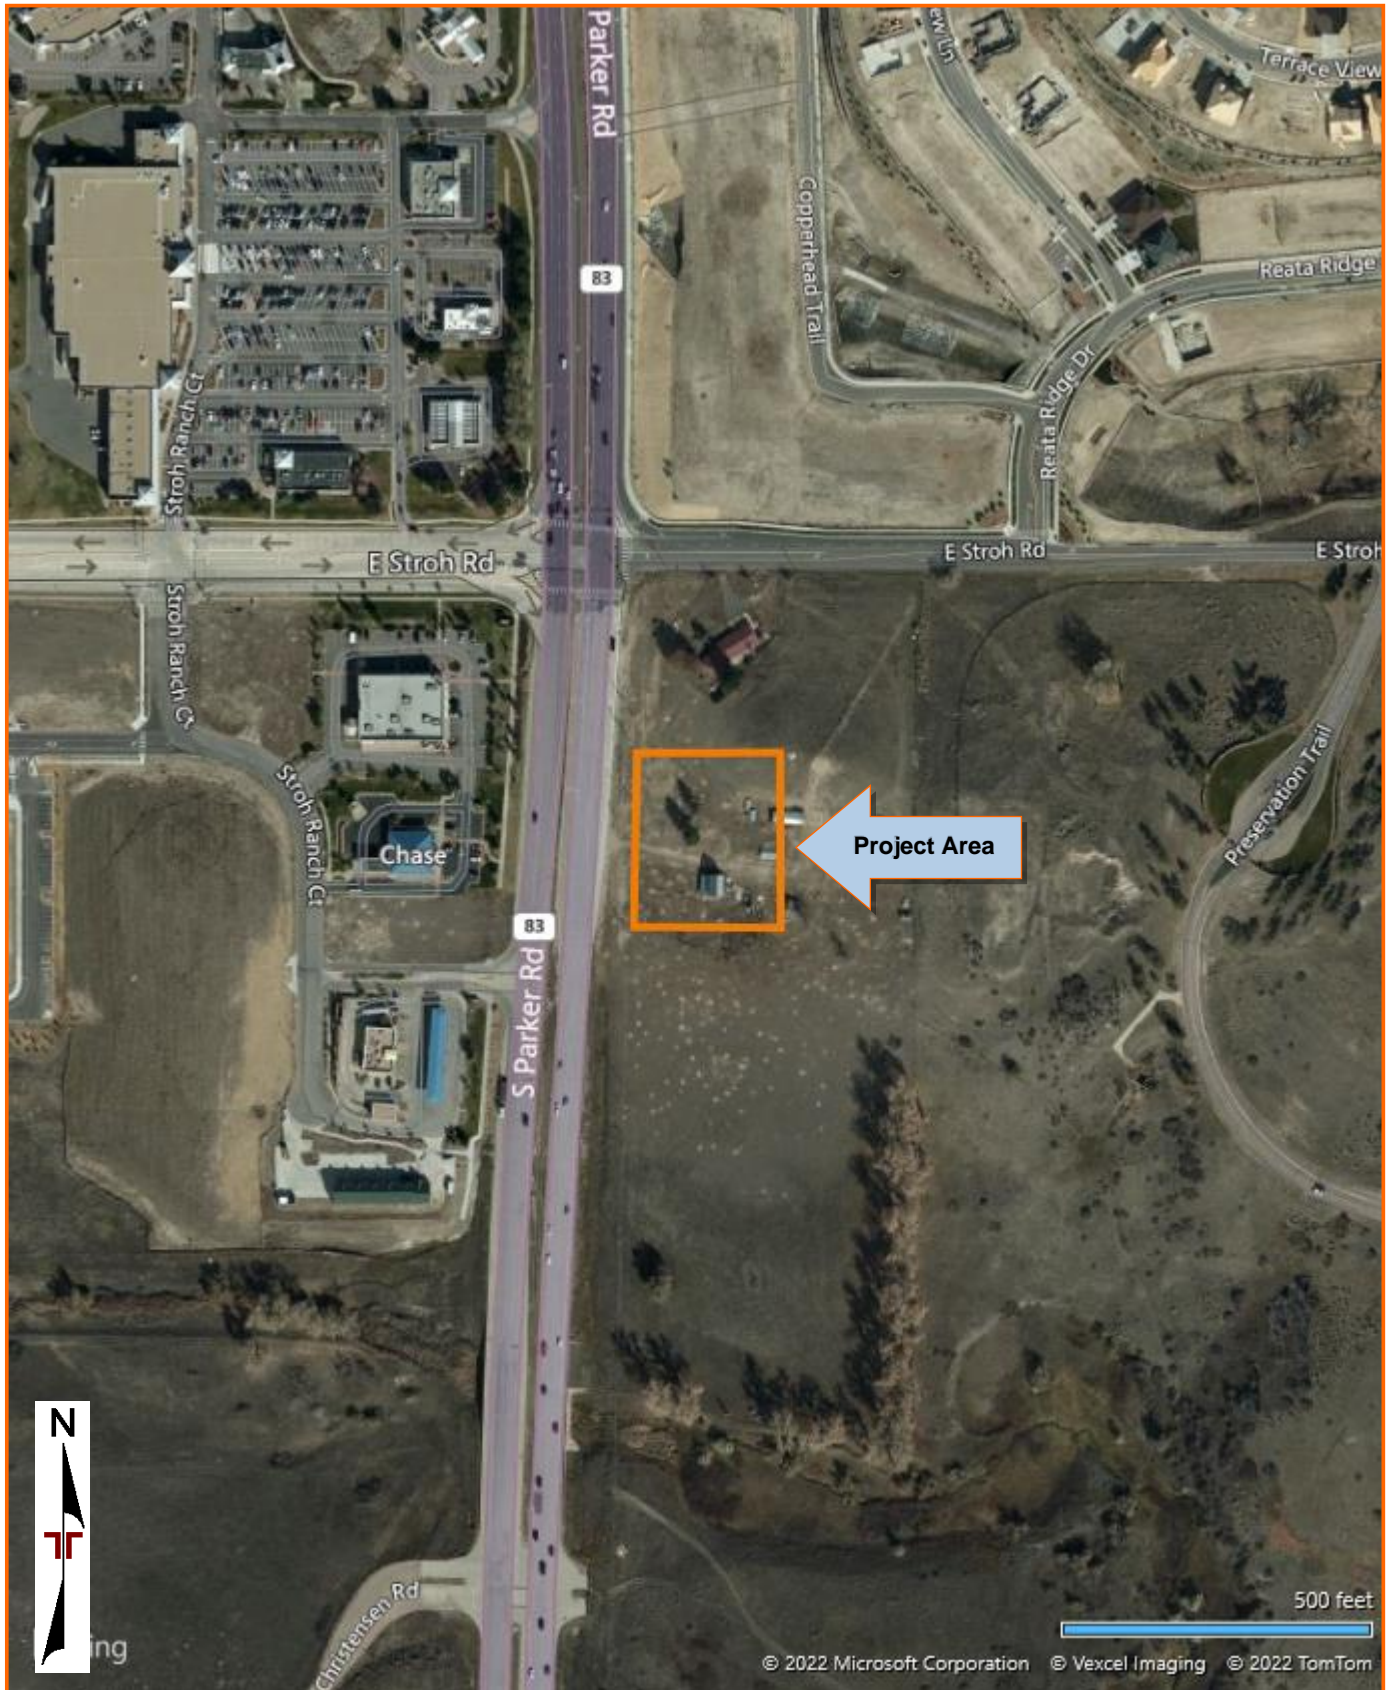
EXPLORATION PLAN WITH AERIAL IMAGE

DIAGRAM IS FOR GENERAL LOCATION ONLY, AND IS NOT INTENDED FOR CONSTRUCTION PURPOSES
