Geotechnical Evaluation Report

Les Schwab Tire Center

Sliceroo Drive and South Red Sky Drive

VIVID Project No.: D23-1-321

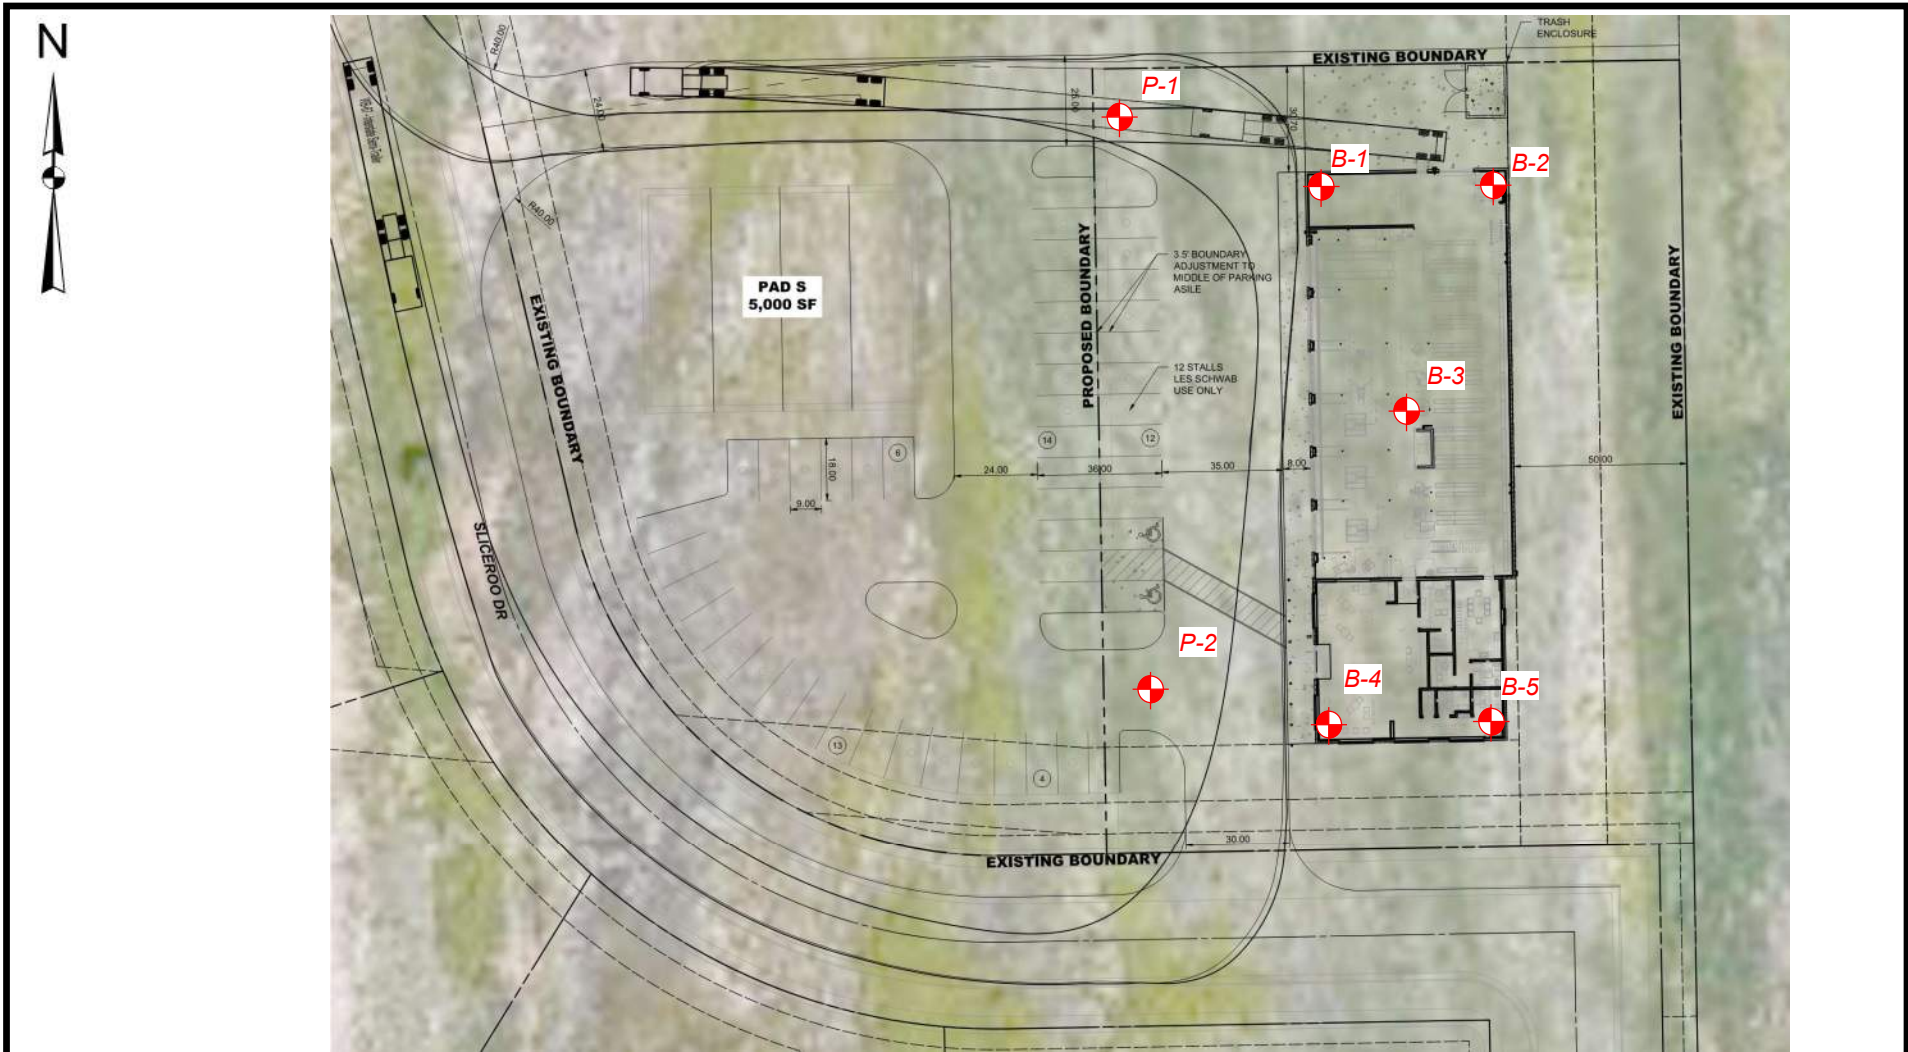
REFERENCE:
Overall Site Plan
Provided By: Cushing Terrell
Dated: September 1, 2022

VIVID explored the subsurface conditions by drilling, logging, and sampling seven exploratory borings at the proposed site as shown on Figure 2. These borings were drilled to depths ranging from approximately 10 to 30 feet below the existing ground surface. The general profile encountered in our borings consisted of the following:
