# SUBMITTAL

Submittal number	77.0	Date	11/13/2019
Project	TRAILS AT CROWFOOT F1 & 9	6954 N. CROWFOOT VALLEY RD. PARKER, CO 80134	
Project number	201810		
Spec section			
Subsection		Status	Open
Current action	Submitted	Ball in court	
Topic	North Pinery Parkway Backfill Reports

Please see attached Backfill reports for North Pinery Parkway Storm, Water Line, and Sanitary Sewer

10333 E Dry Creek Rd Englewood, CO 80112 Tel: (720) 482-9526 Fax: (720) 482-9546	Revisions	No.	Date	Appr.	Date
<b>CVL</b> CONSULTANTS					
HR 935 LLC 7335 South Arroyo CENTENNIAL, CO 80112					
TRAILS AT CROWFOOT FILING 1 CONSTRUCTION DRAWINGS STORM PLAN & PROFILE NORTH PINERY PARKWAY					
SCALE: AS SHOWN	KID	FILE NO:	8130283701	DRAWN BY:	JU
CHECKED BY:	JU	DATE:	APRIL 2017		
SHEET NUMBER	68		12/03/2018

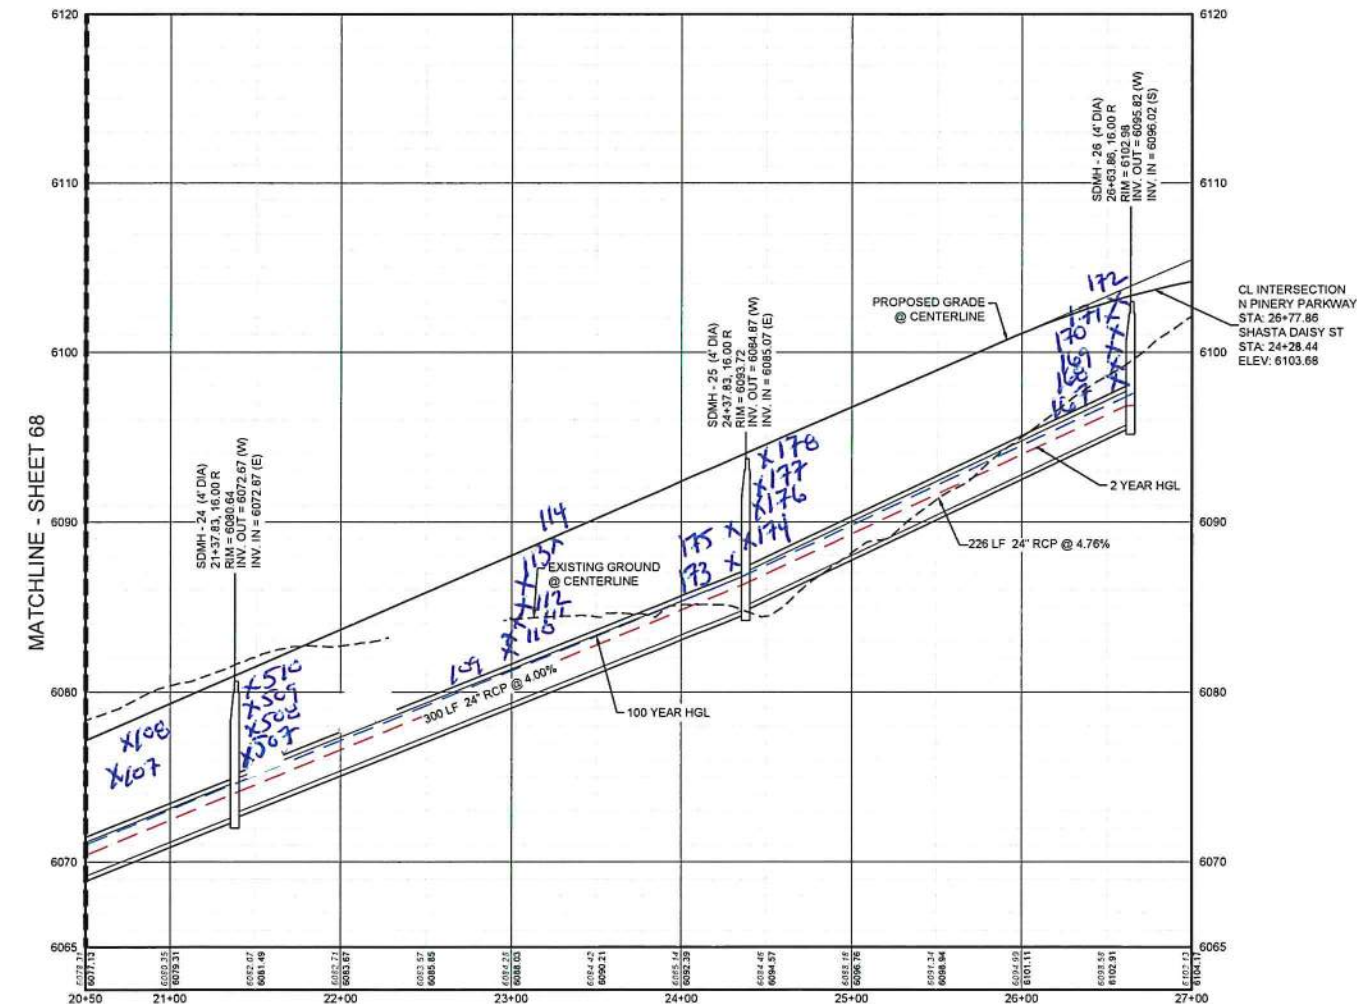
PROFILE: N PINERY PARKWAY STA: 20+50.00 TO 27+00.00  
HORIZONTAL: 1" = 50'  
VERTICAL: 1" = 5'

1. PROFILED STORM DRAINAGE INFRASTRUCTURE INCLUDES THE 2-YEAR AND 100-YEAR HGL FOR INFRASTRUCTURE DESIGNED FOR THE 100-YEAR STORM. INFRASTRUCTURE DESIGNED ONLY FOR THE 2-YEAR STORM WILL ONLY SHOW A 2-YEAR HGL.

**STORM DRAINAGE INFRASTRUCTURE NOTES:**
