# Preliminary Geotechnical Evaluation Proposed Multi-Family Development Compark South – Portion of Tract G Compark Village South, Filing No. 1 Parker, Colorado

March 29, 2021 | Project No. 502090001

Subject: Preliminary Geotechnical Evaluation  
Proposed Multi-Family Development  
Compark South – Portion of Tract G  
Compark Village South, Filing No. 1  
Parker, Colorado

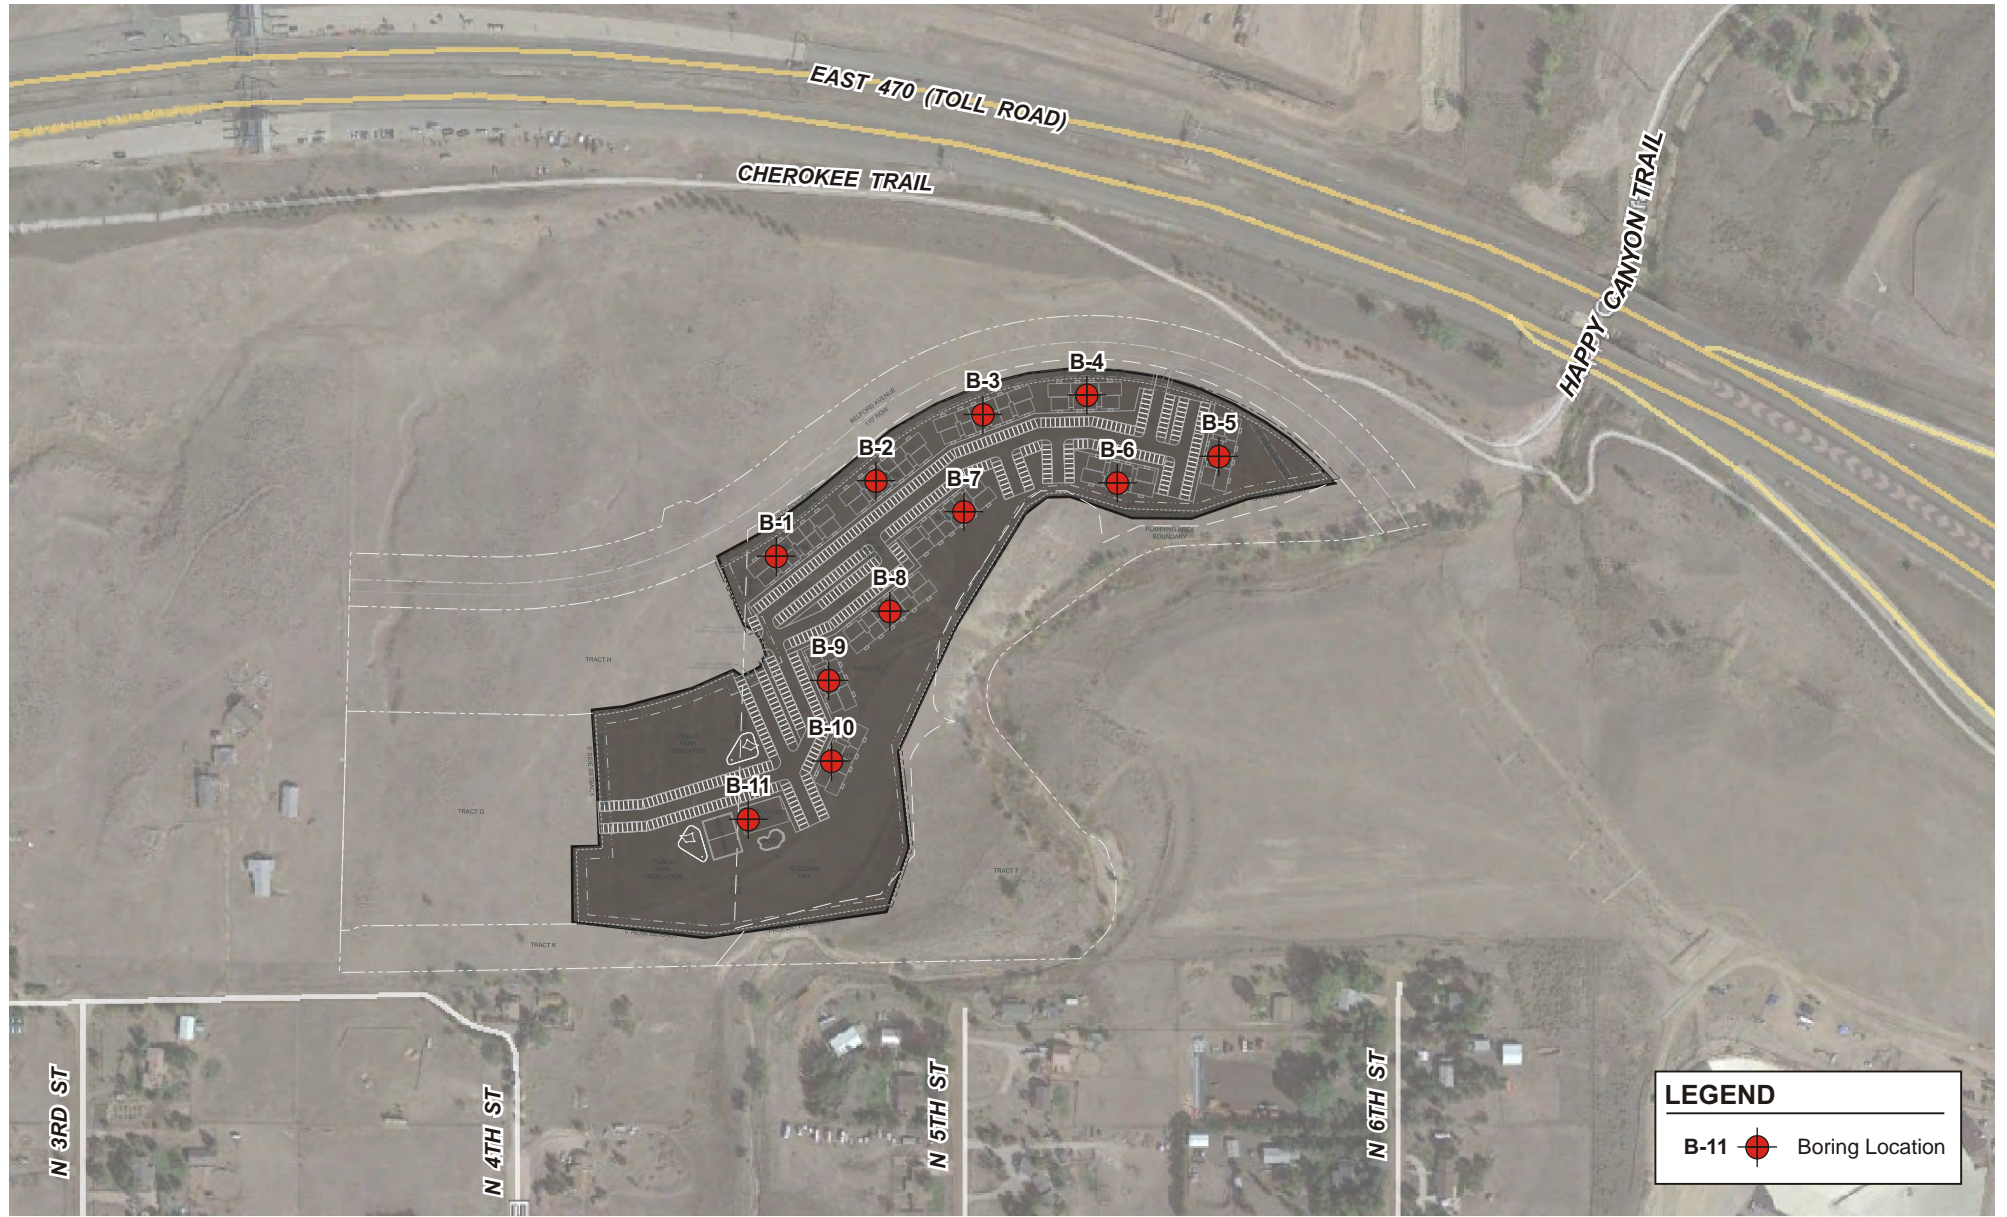
NOTE: DIMENSIONS, DIRECTIONS AND LOCATIONS ARE APPROXIMATE.

On February 22 and 23, 2021, Ninyo & Moore conducted a subsurface exploration at the site to evaluate the existing subsurface conditions and to collect soil samples for laboratory testing. The evaluation consisted of the drilling, logging, and sampling of 11 small-diameter using a truck-mounted drill rig equipped with 4-inch diameter solid-stem augers. The borings were performed within the proposed building footprints to depths ranging between approximately 19.5 and 39.5 feet bgs. The approximate locations of the borings are presented on Figure 2. Relatively undisturbed and

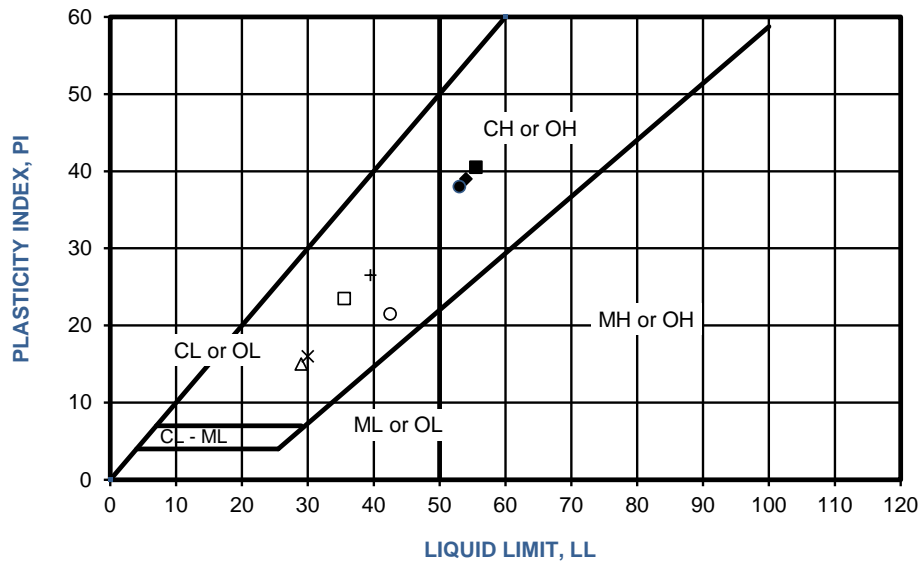
FIGURE B-1

SYMBOL	LOCATION	DEPTH (ft)	LIQUID LIMIT	PLASTIC LIMIT	PLASTICITY INDEX	USCS CLASSIFICATION (Fraction Finer Than No. 40 Sieve)	EQUIVALENT USCS
●	B-1	2.0-3.0	53	15	38	CH	CH
■	B-1	4.0-5.0	56	15	41	CH	CH
◆	B-1	9.0-10.0	54	15	39	CH	CH
○	B-2	2.0-3.0	43	21	22	CL	SC
□	B-3	4.0-4.8	36	12	24	CL	CL
△	B-4	9.0-10.0	29	14	15	CL	SC
X	B-4	34.0-35.0	30	14	16	CL	SC
+	B-5	4.0-5.0	40	13	27	CL	SC

PERFORMED IN GENERAL ACCORDANCE WITH ASTM D 4318

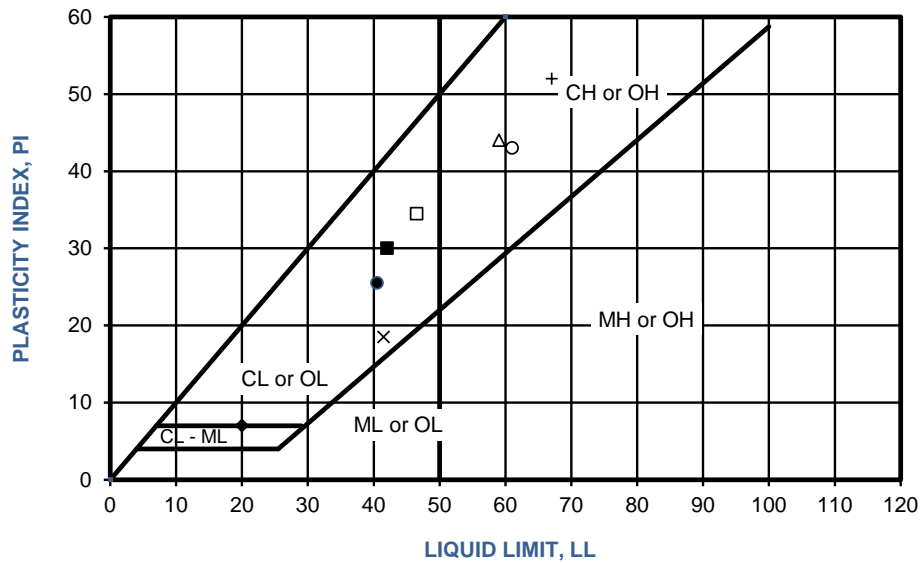
FIGURE B-2

SYMBOL	LOCATION	DEPTH (ft)	LIQUID LIMIT	PLASTIC LIMIT	PLASTICITY INDEX	USCS CLASSIFICATION (Fraction Finer Than No. 40 Sieve)	EQUIVALENT USCS
●	B-5	14.0-15.0	41	15	26	CL	CL
■	B-6	4.0-5.0	42	12	30	CL	CL
◆	B-7	9.0-10.0	20	13	7	CL	SC
○	B-7	19.0-19.7	61	18	43	CH	CH
□	B-8	2.0-3.0	47	12	35	CL	CL
△	B-8	4.0-5.0	59	15	44	CH	CH
X	B-8	9.0-10.0	42	23	19	CL	SC
+	B-8	24.0-25.0	67	15	52	CH	CH

PERFORMED IN GENERAL ACCORDANCE WITH ASTM D 4318

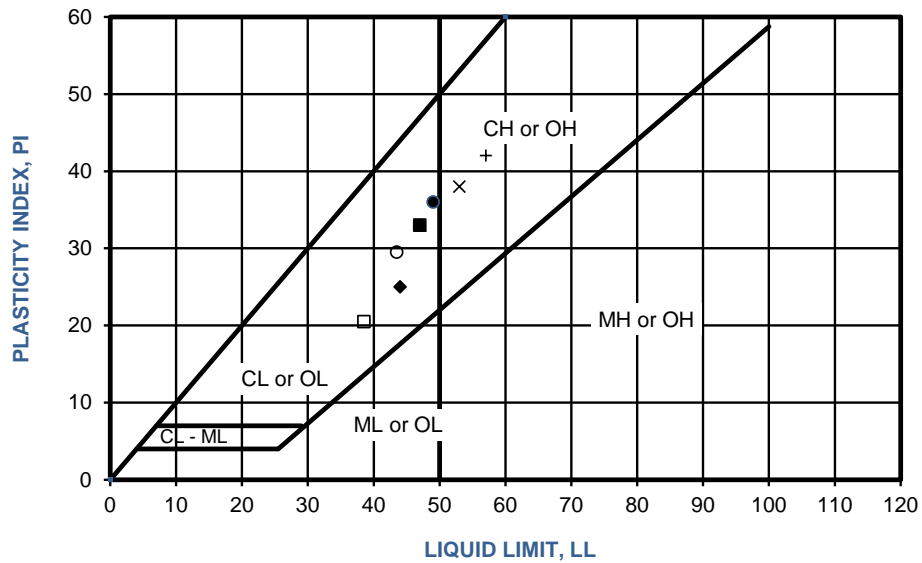
FIGURE B-3

SYMBOL	LOCATION	DEPTH (ft)	LIQUID LIMIT	PLASTIC LIMIT	PLASTICITY INDEX	USCS CLASSIFICATION (Fraction Finer Than No. 40 Sieve)	EQUIVALENT USCS
●	B-9	4.0-5.0	49	13	36	CL	CL
■	B-9	29.0-30.0	47	14	33	CL	CL
◆	B-9	34.0-34.7	44	19	25	CL	SC
○	B-10	34.0-35.0	44	14	30	CL	CL
□	B-11	2.0-3.0	39	18	21	CL	SC
△	B-11	9.0-10.0	47	14	33	CL	SC
X	B-11	24.0-25.0	53	15	38	CH	CH
+	B-11	39.0-39.5	57	15	42	CH	CH

PERFORMED IN GENERAL ACCORDANCE WITH ASTM D 4318

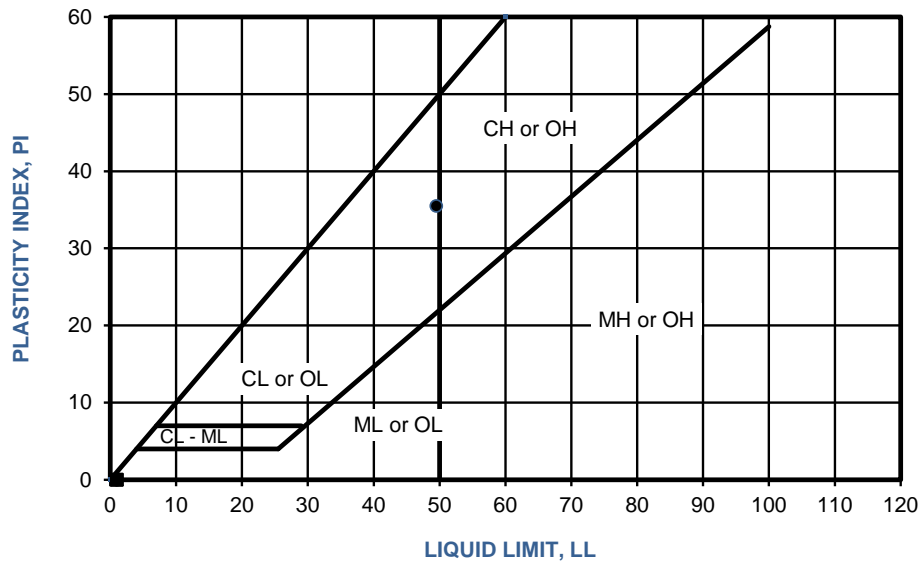
FIGURE B-4

SYMBOL	LOCATION	DEPTH (ft)	LIQUID LIMIT	PLASTIC LIMIT	PLASTICITY INDEX	USCS CLASSIFICATION (Fraction Finer Than No. 40 Sieve)	EQUIVALENT USCS
•	B-1, B-8, B-9	0.0-5.0	50	14	36	CL	SC

PERFORMED IN GENERAL ACCORDANCE WITH ASTM D 4318

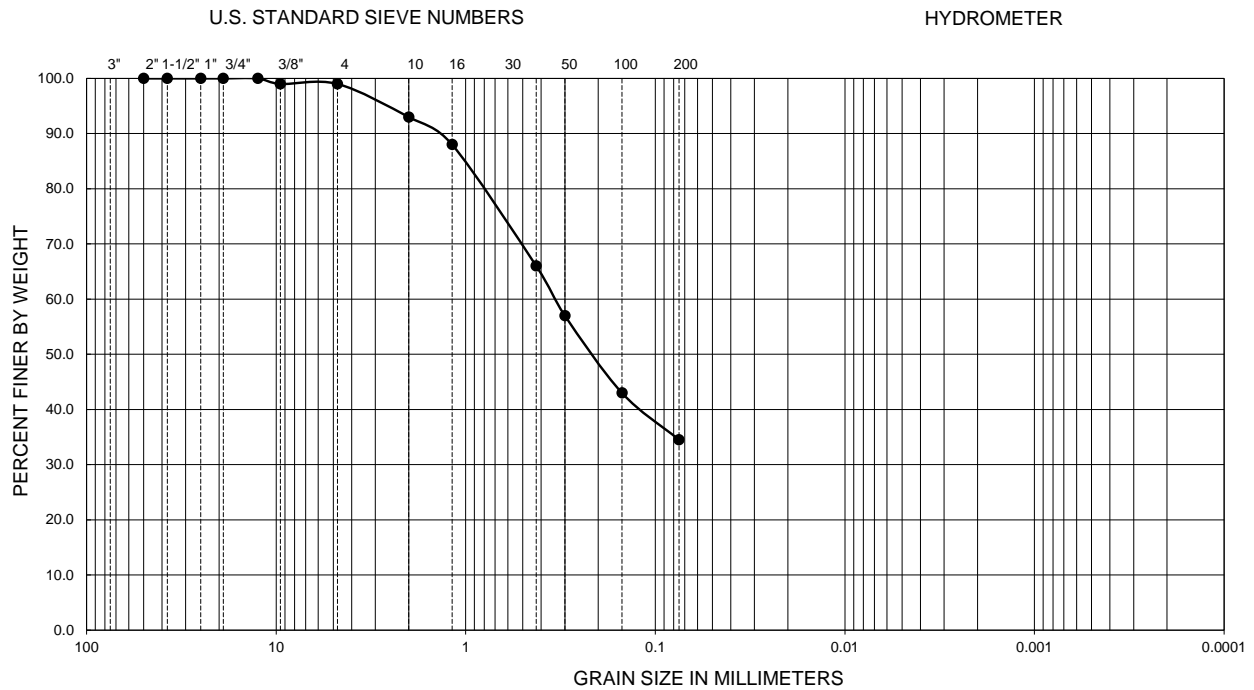
FIGURE B-9

Symbol	Sample Location	Depth (ft)	Liquid Limit	Plastic Limit	Plasticity Index	D <sub>10</sub>	D <sub>30</sub>	D <sub>60</sub>	C <sub>u</sub>	C <sub>c</sub>	Passing No. 200 (percent)	Equivalent USCS
●	B-3	9.0-10.0	--	--	--	--	--	--	--	--	34	SC

PERFORMED IN GENERAL ACCORDANCE WITH ASTM D 6913

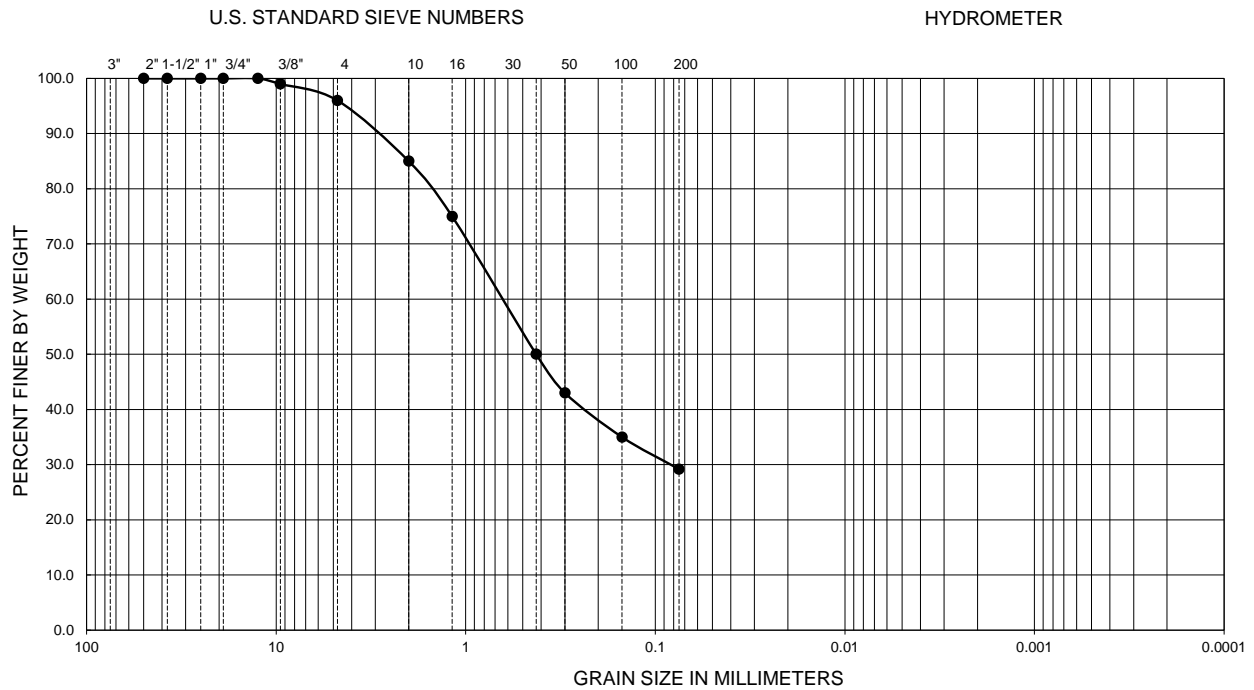
FIGURE B-10

Symbol	Sample Location	Depth (ft)	Liquid Limit	Plastic Limit	Plasticity Index	D <sub>10</sub>	D <sub>30</sub>	D <sub>60</sub>	C <sub>u</sub>	C <sub>c</sub>	Passing No. 200 (percent)	Equivalent USCS
●	B-4	24.0-25.0	--	--	--	--	--	--	--	--	29	SC

PERFORMED IN GENERAL ACCORDANCE WITH ASTM D 6913

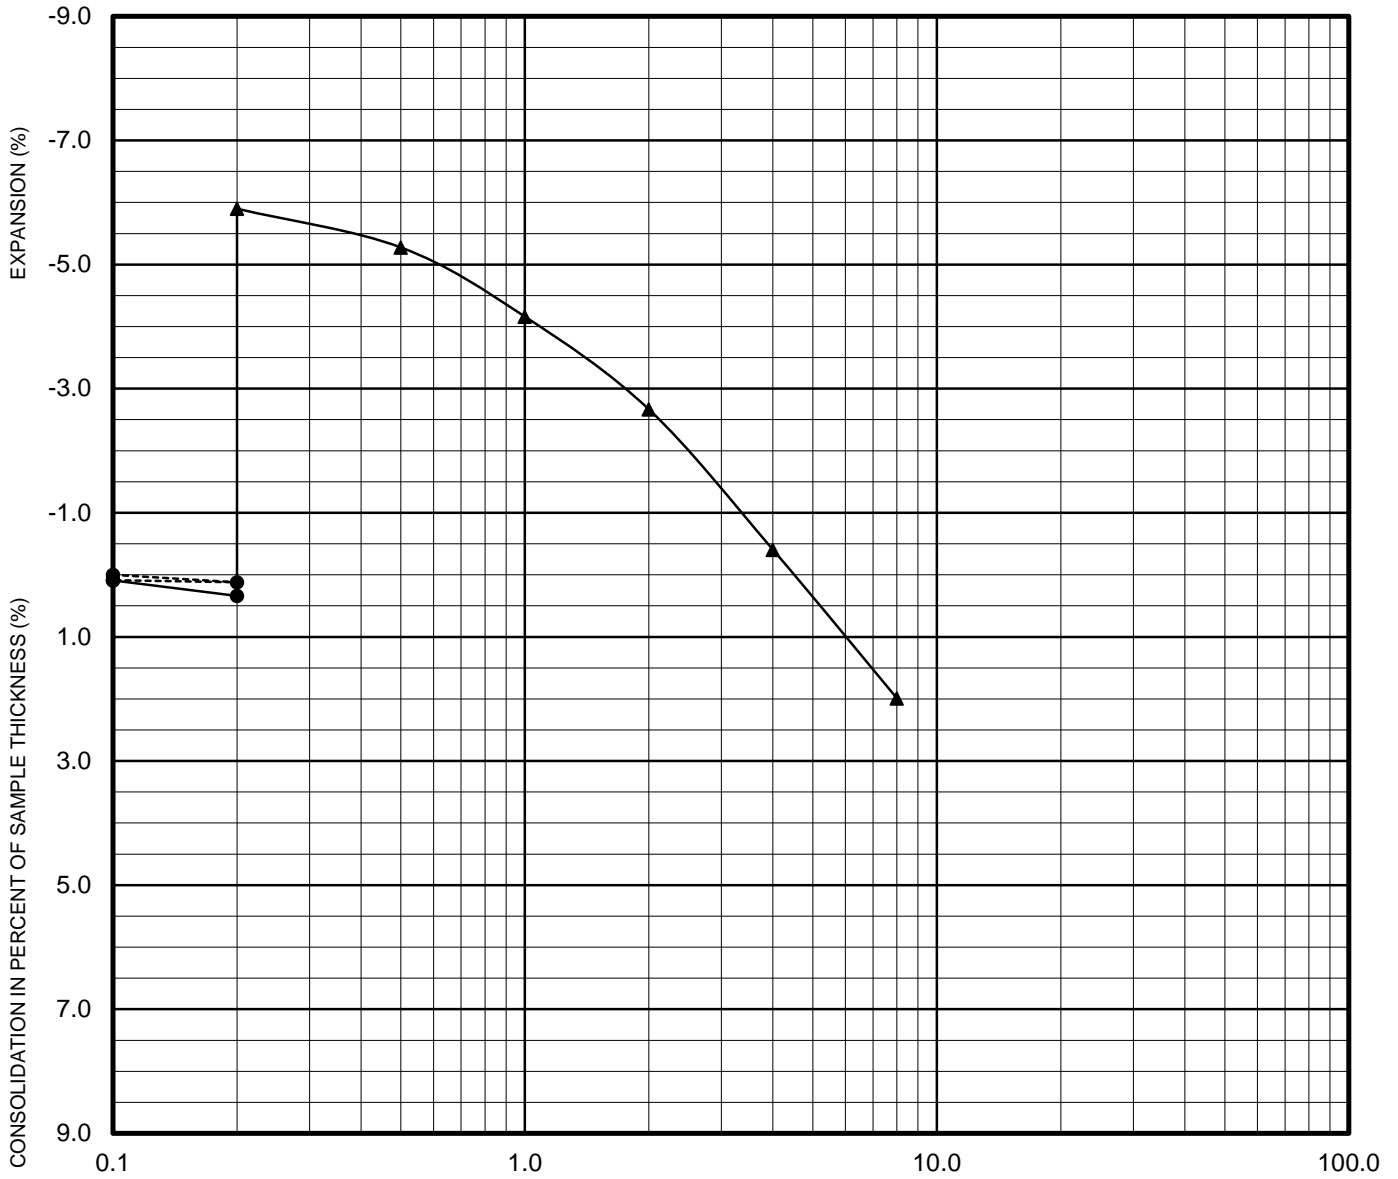
- Seating Cycle
- Loading Prior to Inundation
- ▲— Loading After Inundation
- ▲-- Rebound Cycle

Moisture Increase (%): 5.2  
 Swell Percentage (%): 6.2  
 Swell Pressure (psf): 4,800

**CONSOLIDATION TEST RESULTS**  
 PROPOSED MULTI-FAMILY DEVELOPMENT  
 COMPARK SOUTH, PARKER, COLORADO

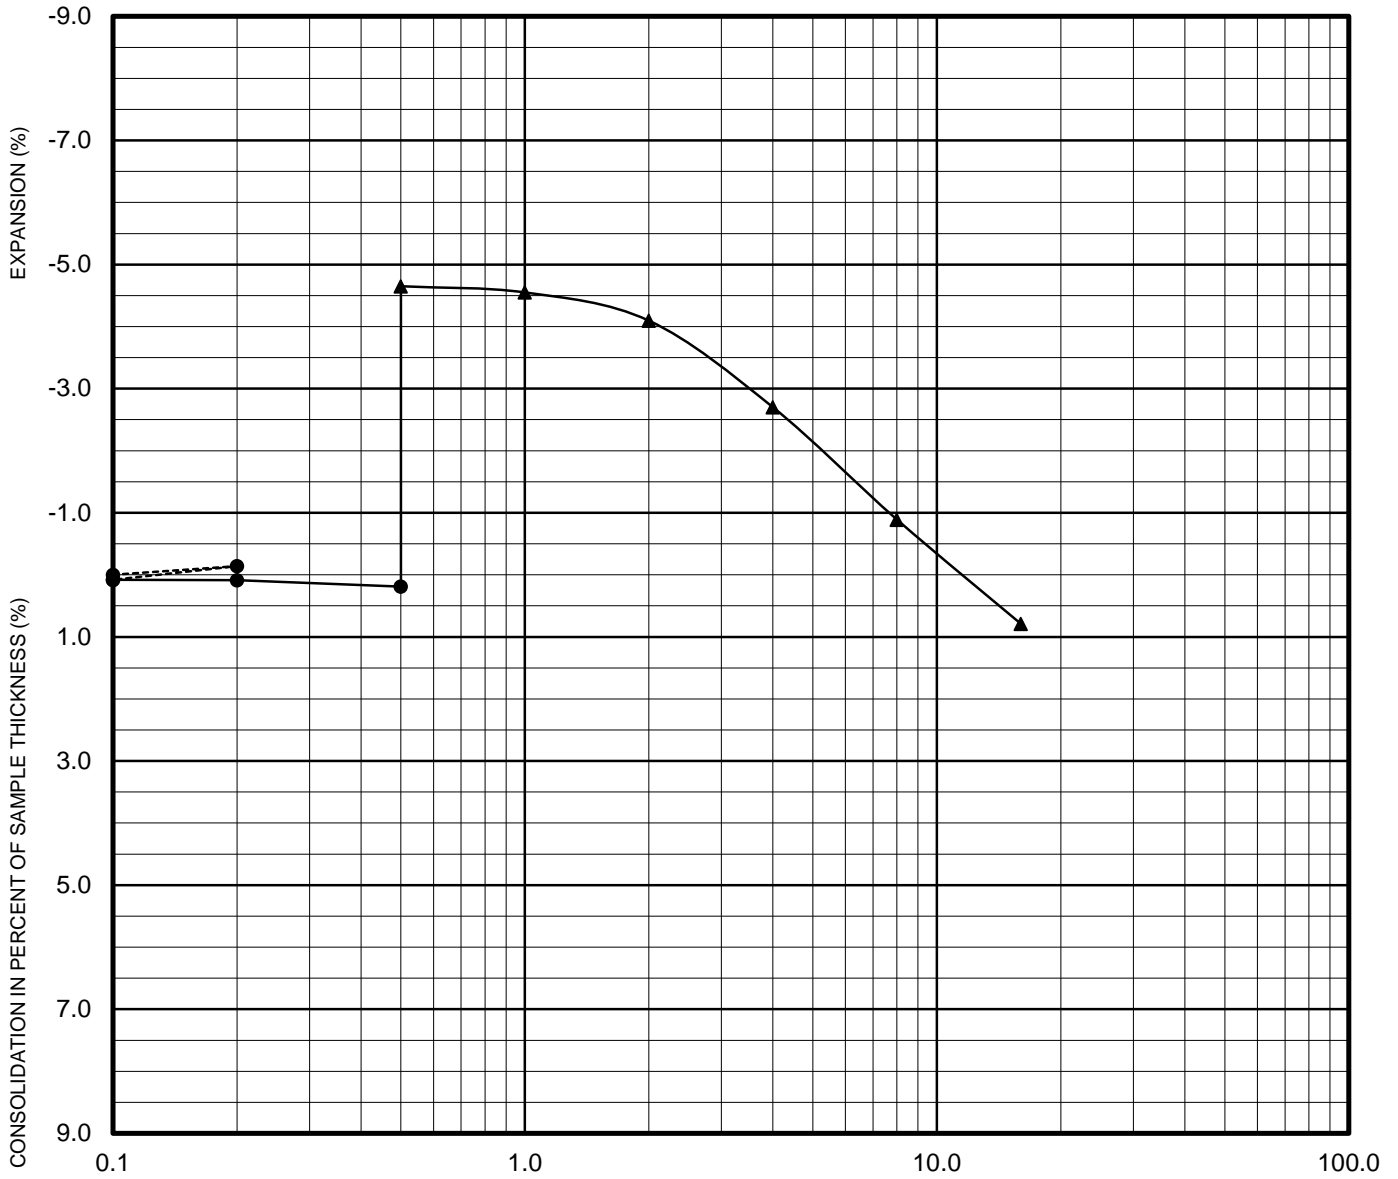
- Seating Cycle
- Loading Prior to Inundation
- ▲— Loading After Inundation
- ▲-- Rebound Cycle

Moisture Increase (%): 3.2  
 Swell Percentage (%): 4.8  
 Swell Pressure (psf): 12,100

**CONSOLIDATION TEST RESULTS**  
 PROPOSED MULTI-FAMILY DEVELOPMENT  
 COMPARK SOUTH, PARKER, COLORADO

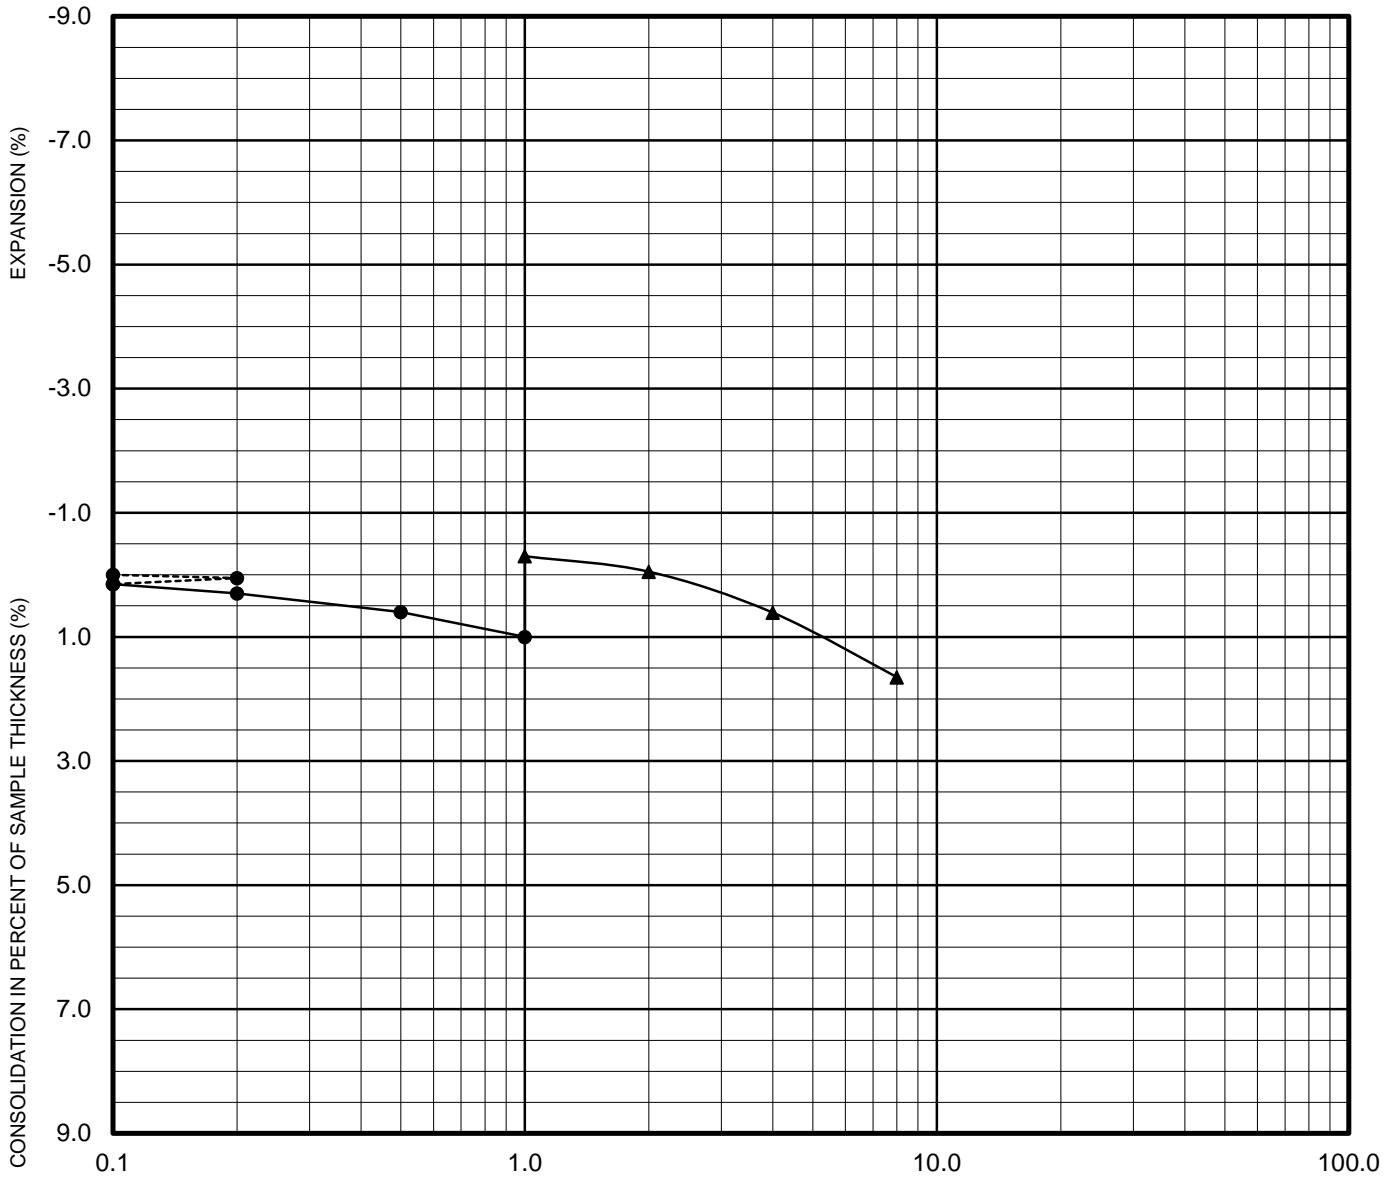
- Seating Cycle
- Loading Prior to Inundation
- ▲— Loading After Inundation
- ▲-- Rebound Cycle

Moisture Increase (%): 4.6  
Swell Percentage (%): 1.3  
Swell Pressure (psf): 4,300

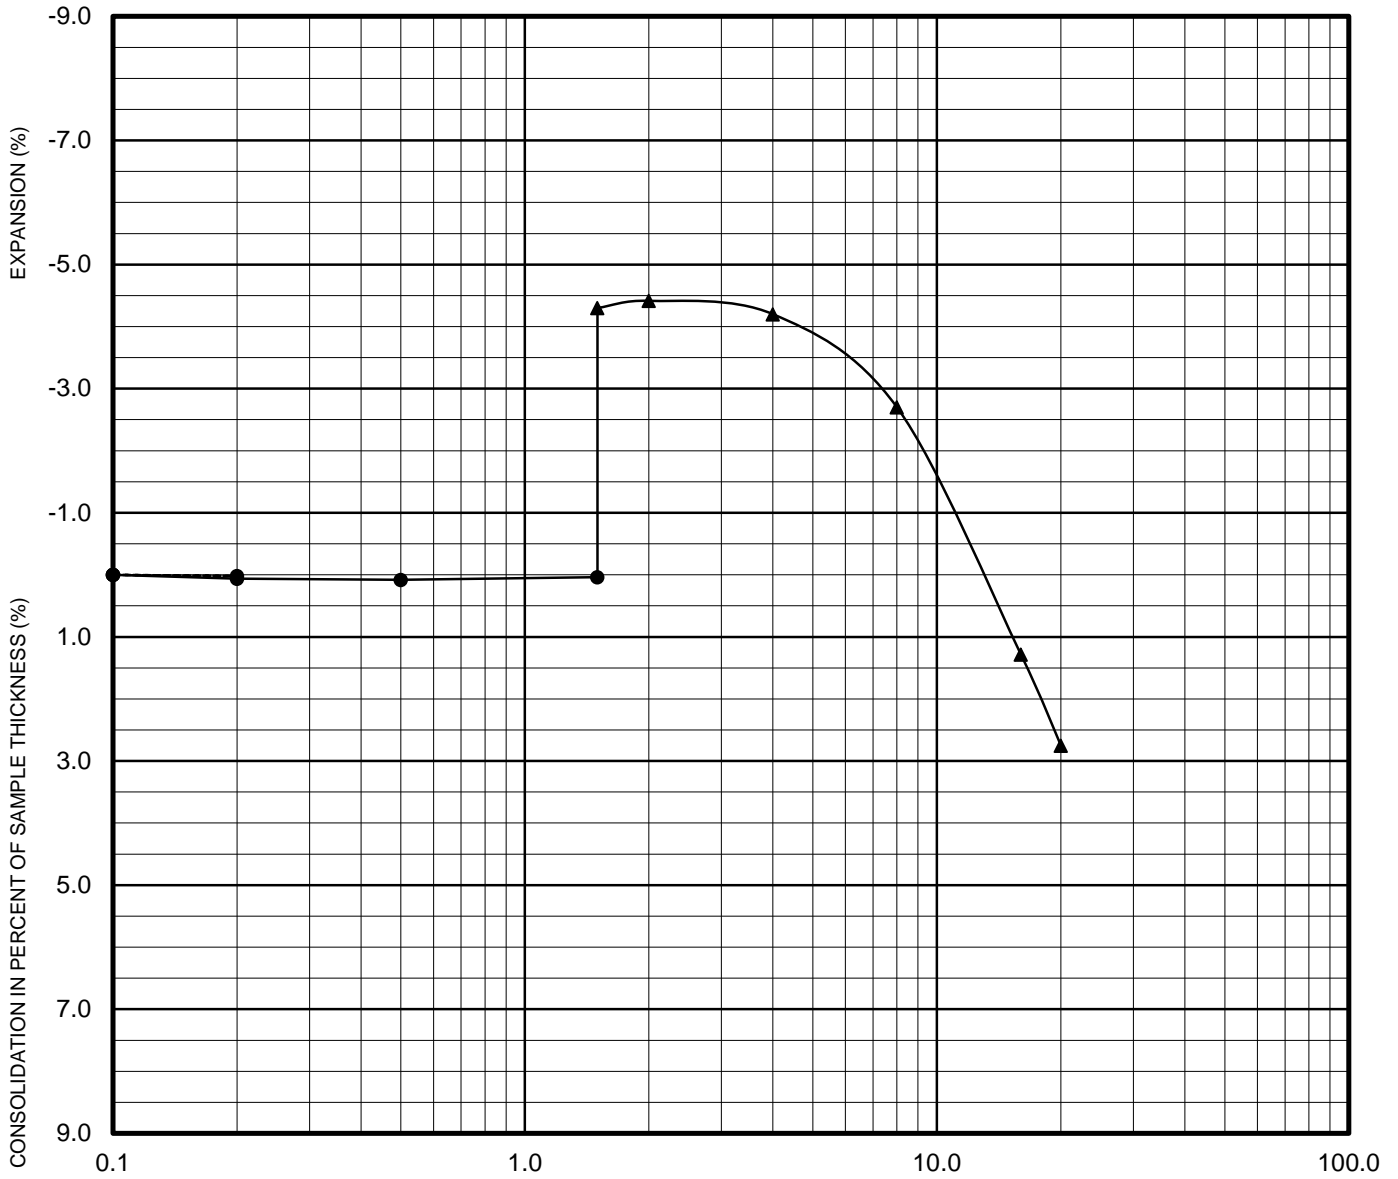
- Seating Cycle
- Loading Prior to Inundation
- ▲— Loading After Inundation
- ▲-- Rebound Cycle

Moisture Increase (%): 3.7  
 Swell Percentage (%): 4.3  
 Swell Pressure (psf): 11,600

**CONSOLIDATION TEST RESULTS**  
 PROPOSED MULTI-FAMILY DEVELOPMENT  
 COMPARK SOUTH, PARKER, COLORADO

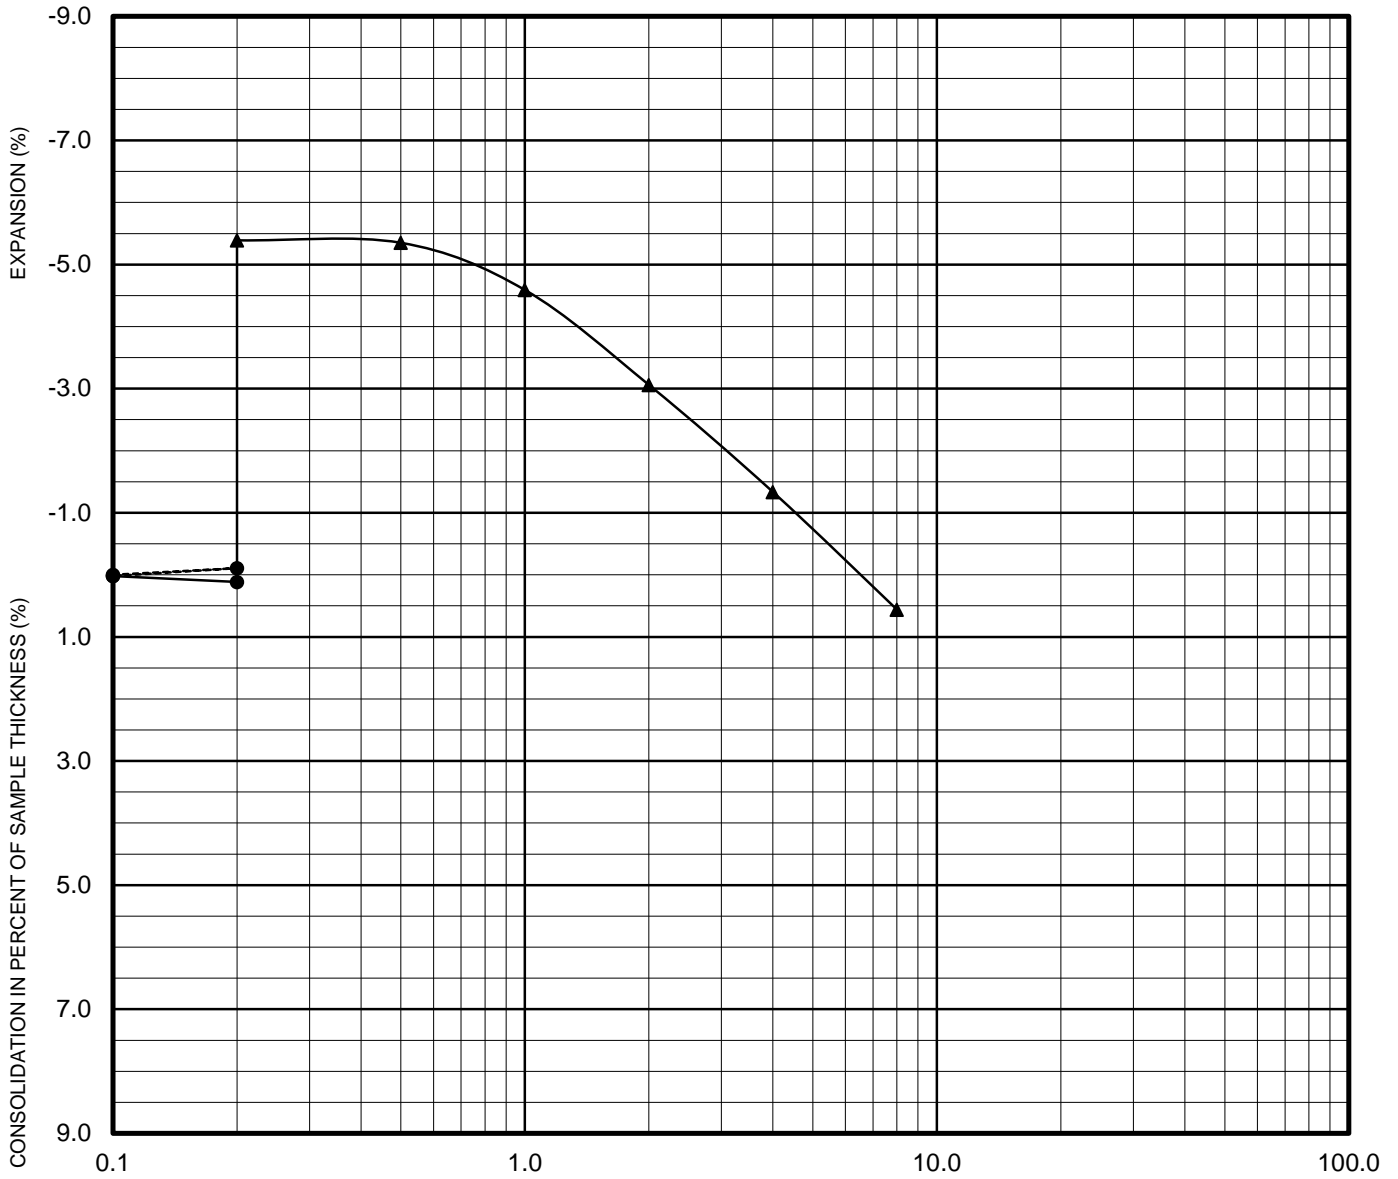
- Seating Cycle
- Loading Prior to Inundation
- ▲— Loading After Inundation
- ▲-- Rebound Cycle

Moisture Increase (%): 6.9  
 Swell Percentage (%): 5.5  
 Swell Pressure (psf): 6,800

**CONSOLIDATION TEST RESULTS**  
 PROPOSED MULTI-FAMILY DEVELOPMENT  
 COMPARK SOUTH, PARKER, COLORADO

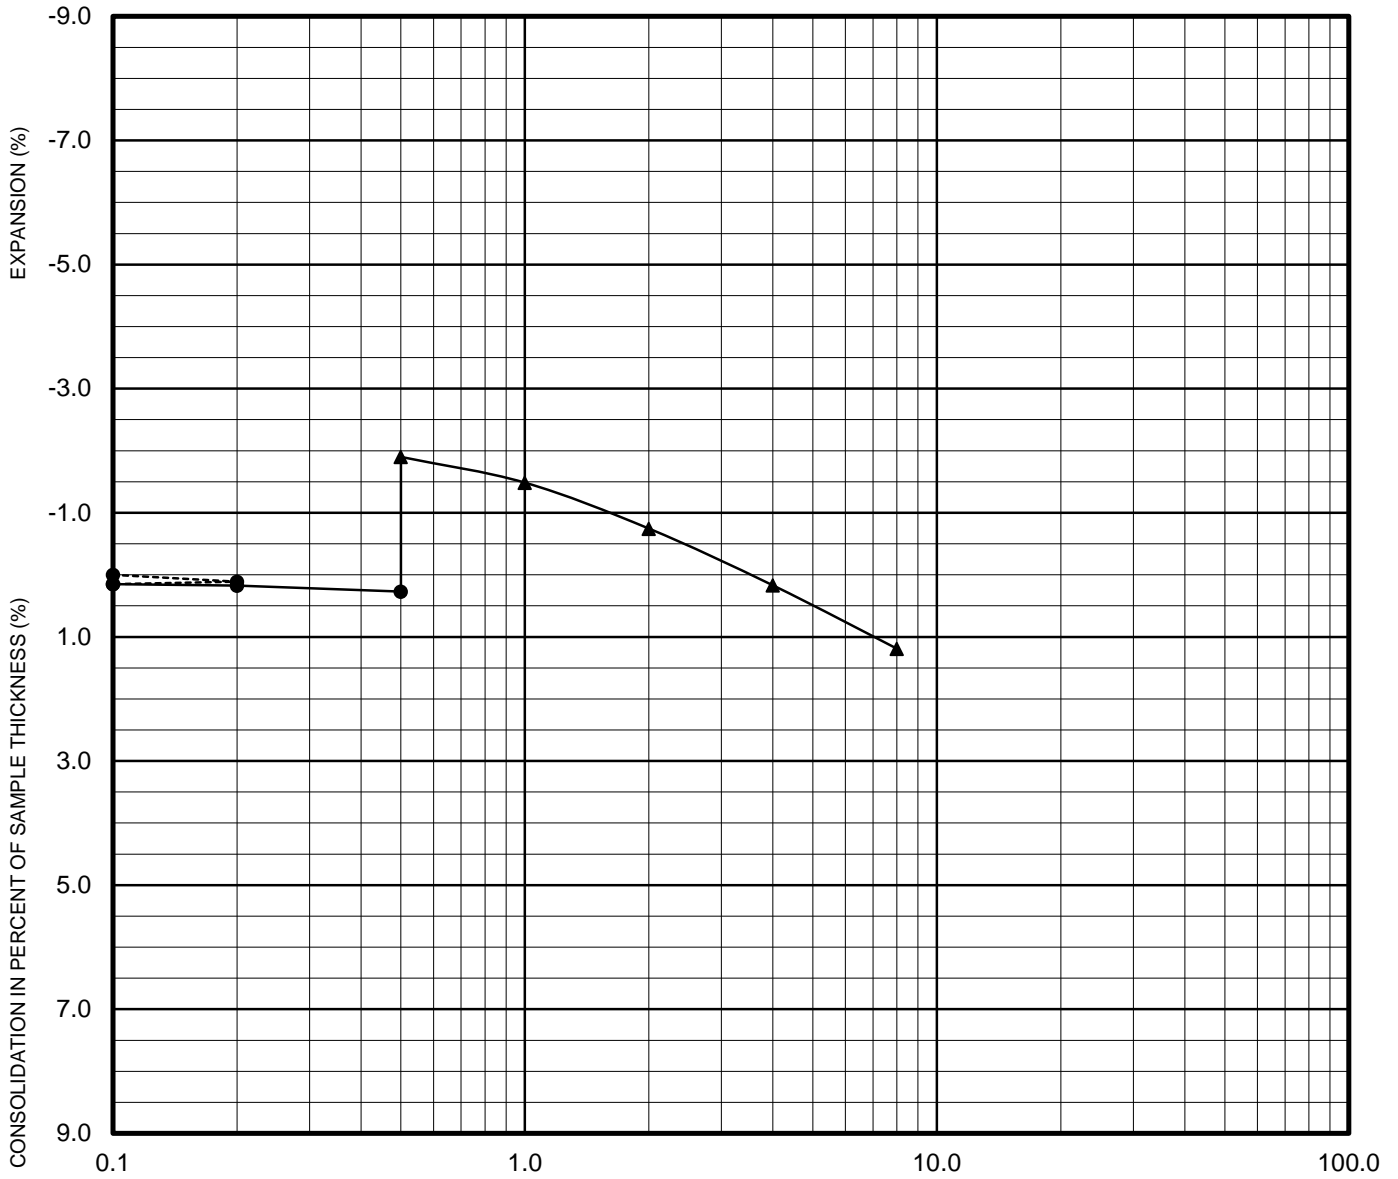
- Seating Cycle
- Loading Prior to Inundation
- ▲— Loading After Inundation
- ▲-- Rebound Cycle

Moisture Increase (%): 8.6  
 Swell Percentage (%): 2.2  
 Swell Pressure (psf): 3,700

**CONSOLIDATION TEST RESULTS**  
 PROPOSED MULTI-FAMILY DEVELOPMENT  
 COMPARK SOUTH, PARKER, COLORADO

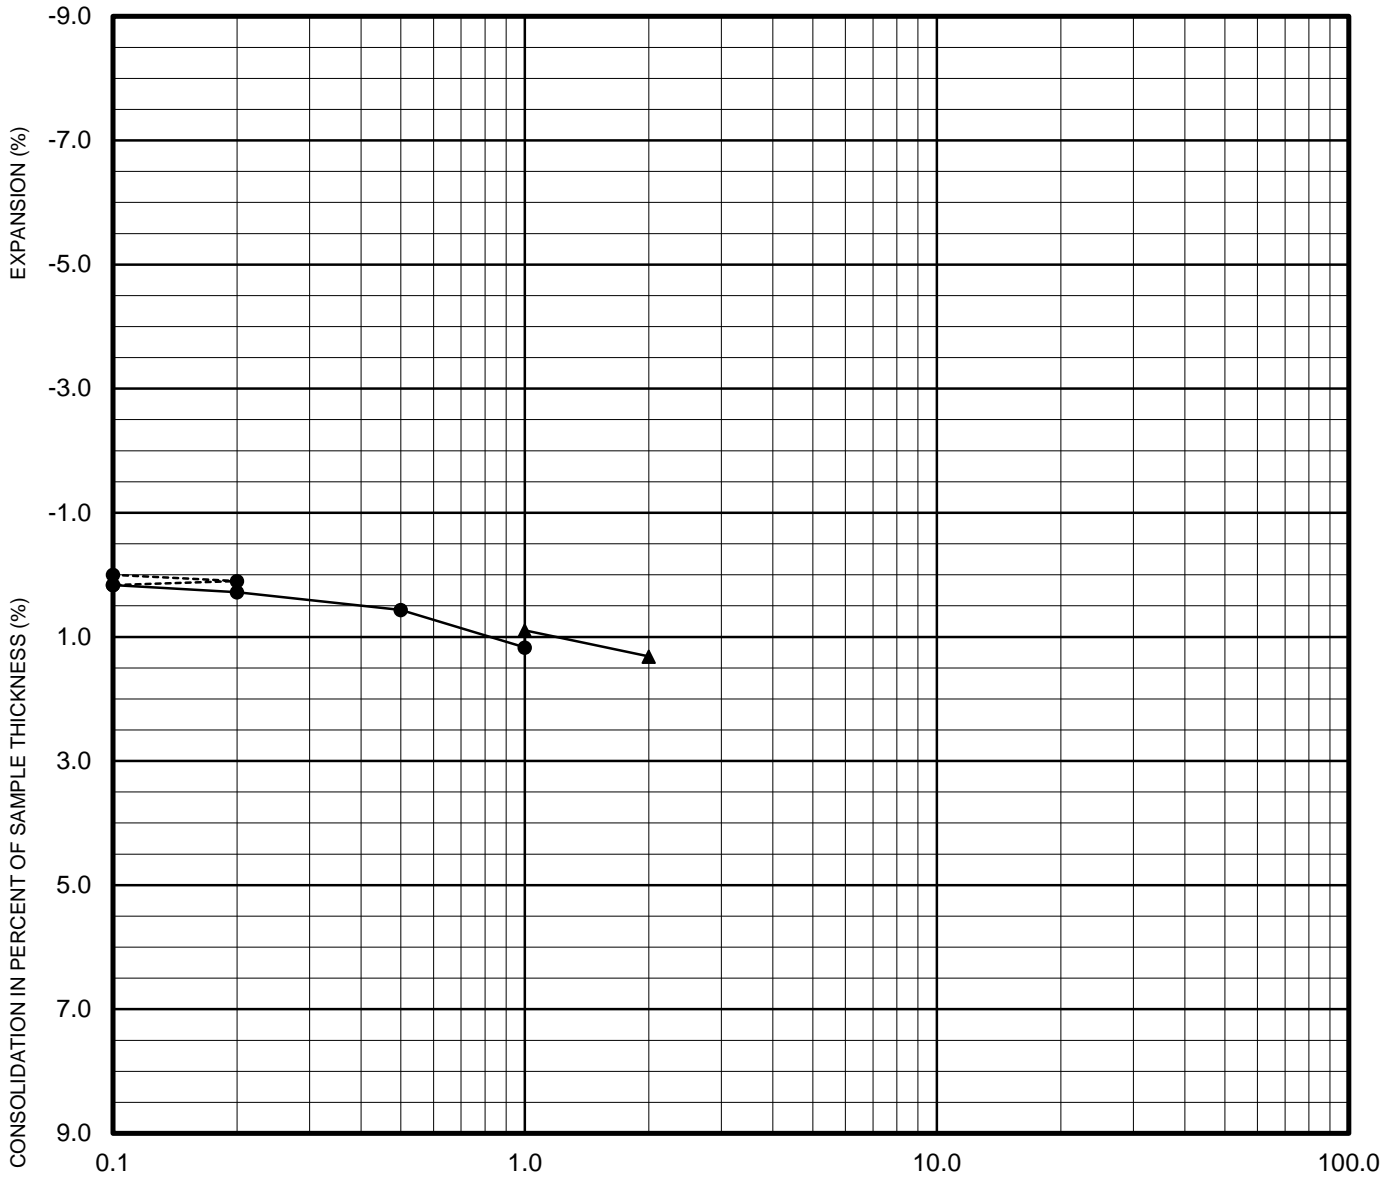
- Seating Cycle
- Loading Prior to Inundation
- ▲— Loading After Inundation
- ▲-- Rebound Cycle

Moisture Increase (%): 3.9  
Swell Percentage (%): 0.3  
Swell Pressure (psf): 600

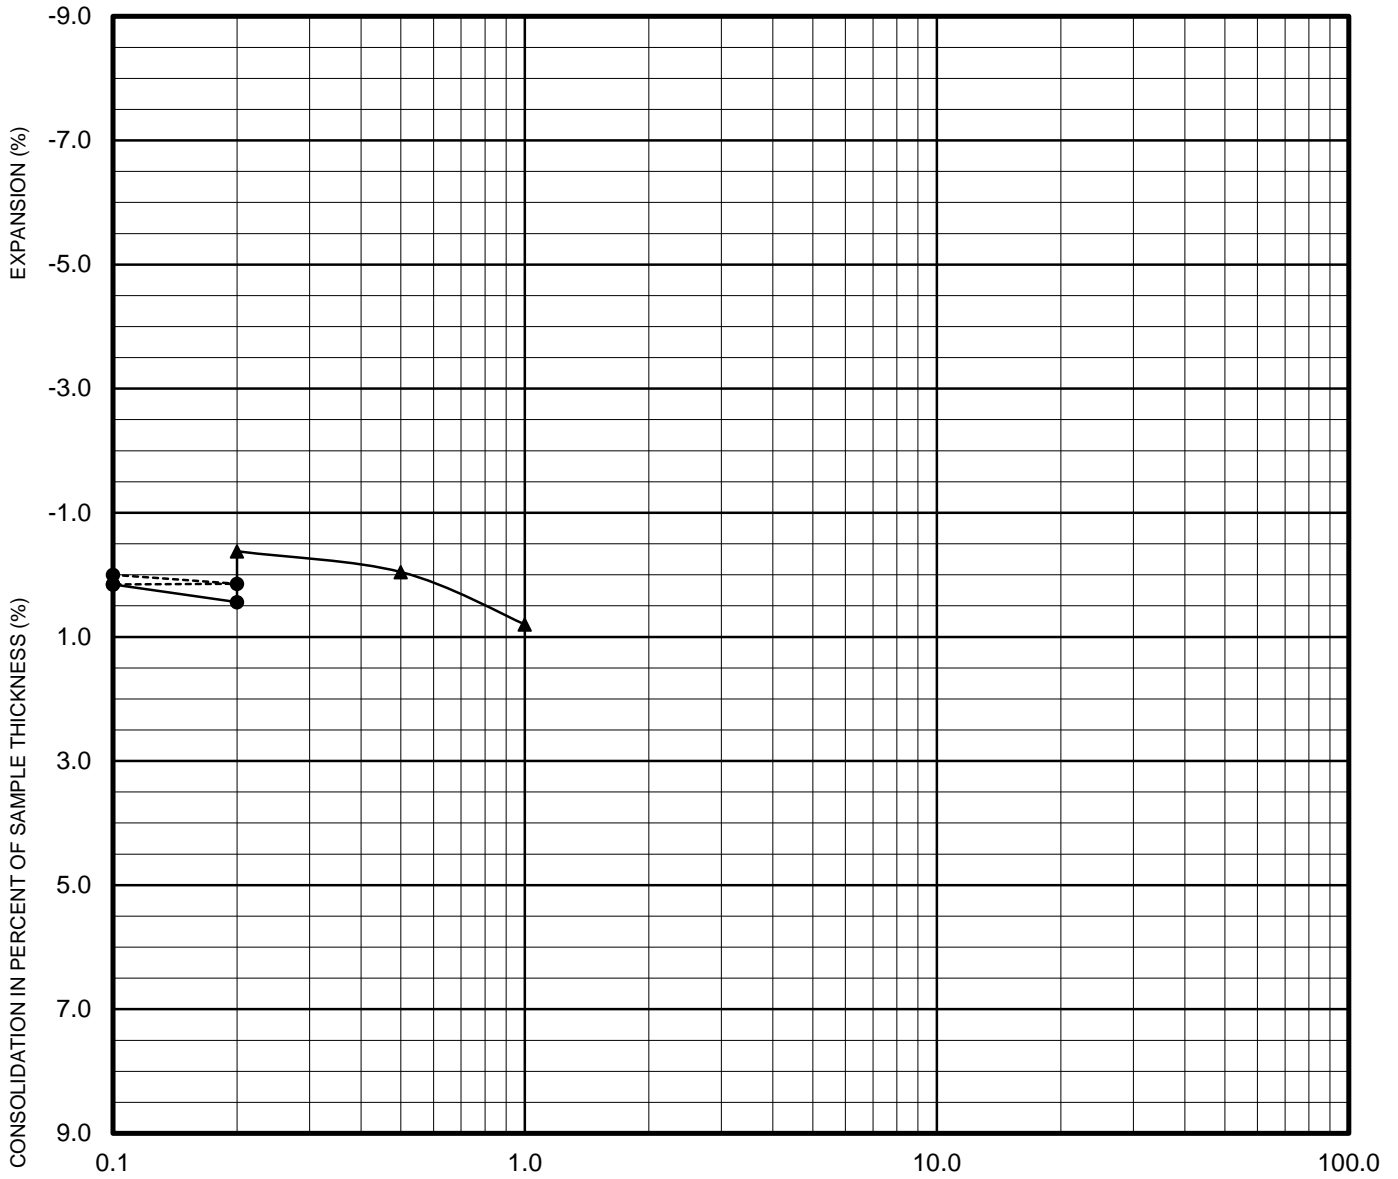
- Seating Cycle
- Loading Prior to Inundation
- ▲— Loading After Inundation
- ▲-- Rebound Cycle

Moisture Increase (%): 10.9  
Swell Percentage (%): 0.8  
Swell Pressure (psf): 600

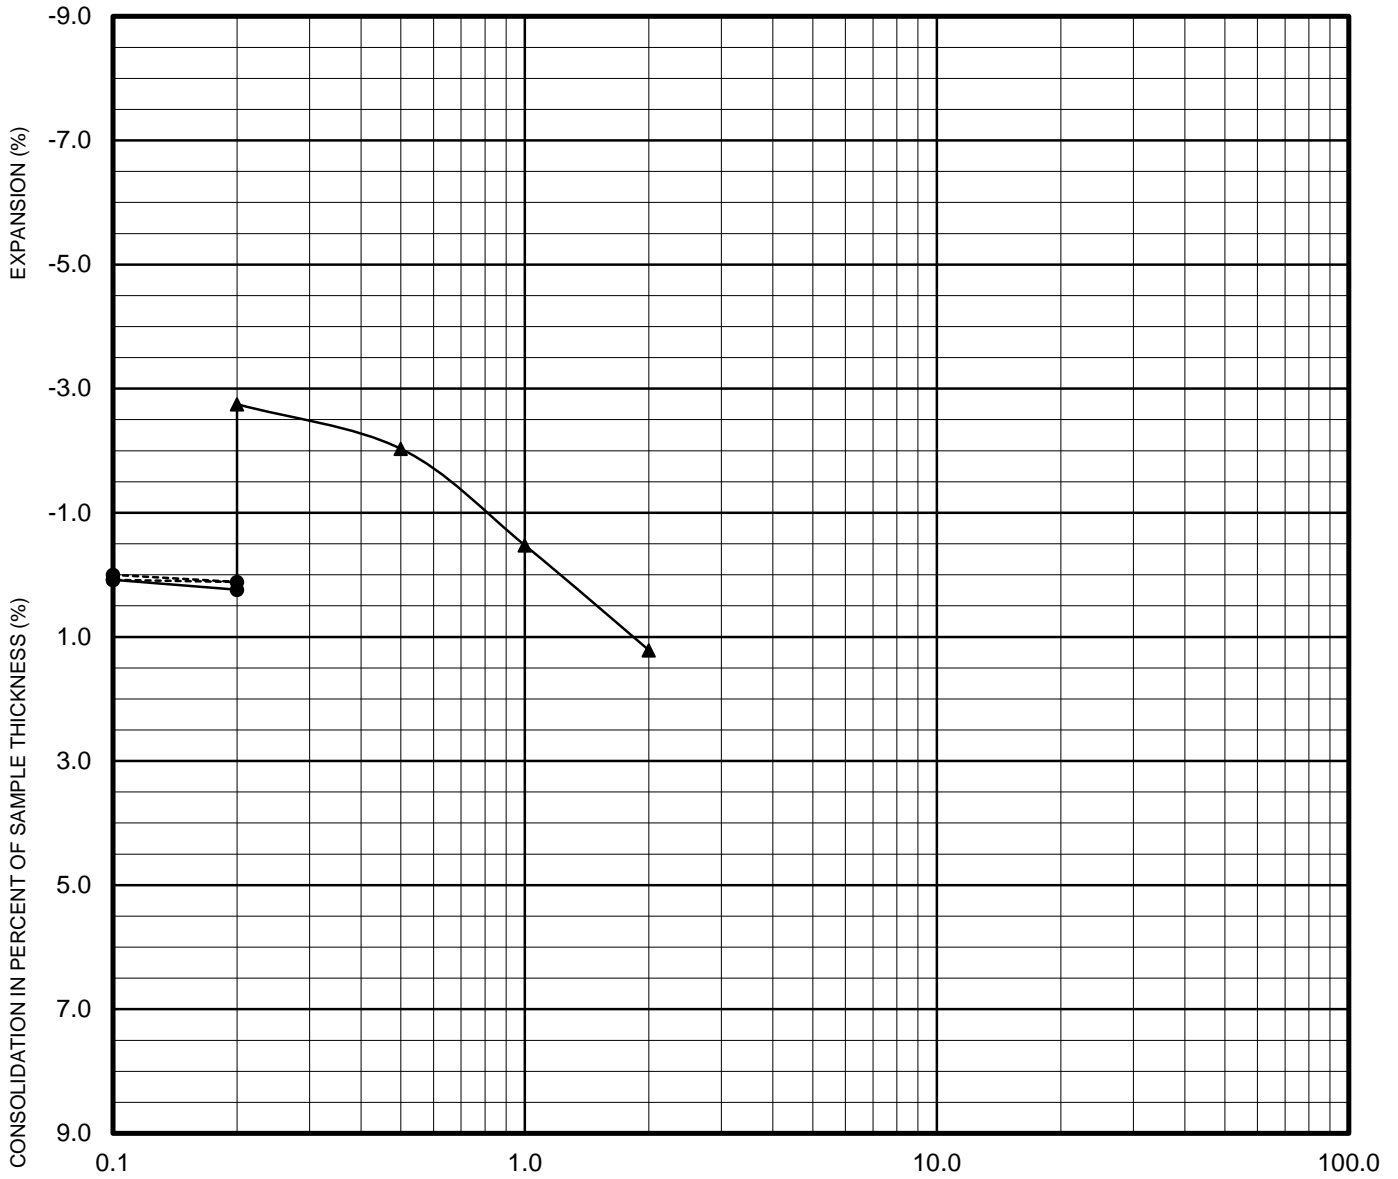
FIGURE B-19

- Seating Cycle
- Loading Prior to Inundation
- ▲— Loading After Inundation
- ▲-- Rebound Cycle

Moisture Increase (%): 12.5  
 Swell Percentage (%): 3.0  
 Swell Pressure (psf): 1,100
