# Preliminary Geotechnical Evaluation Proposed Multi-Family Development Compark South – Portion of Tract G Compark Village South, Filing No. 1 Parker, Colorado

March 29, 2021 | Project No. 502090001

Subject: Preliminary Geotechnical Evaluation  
Proposed Multi-Family Development  
Compark South – Portion of Tract G  
Compark Village South, Filing No. 1  
Parker, Colorado

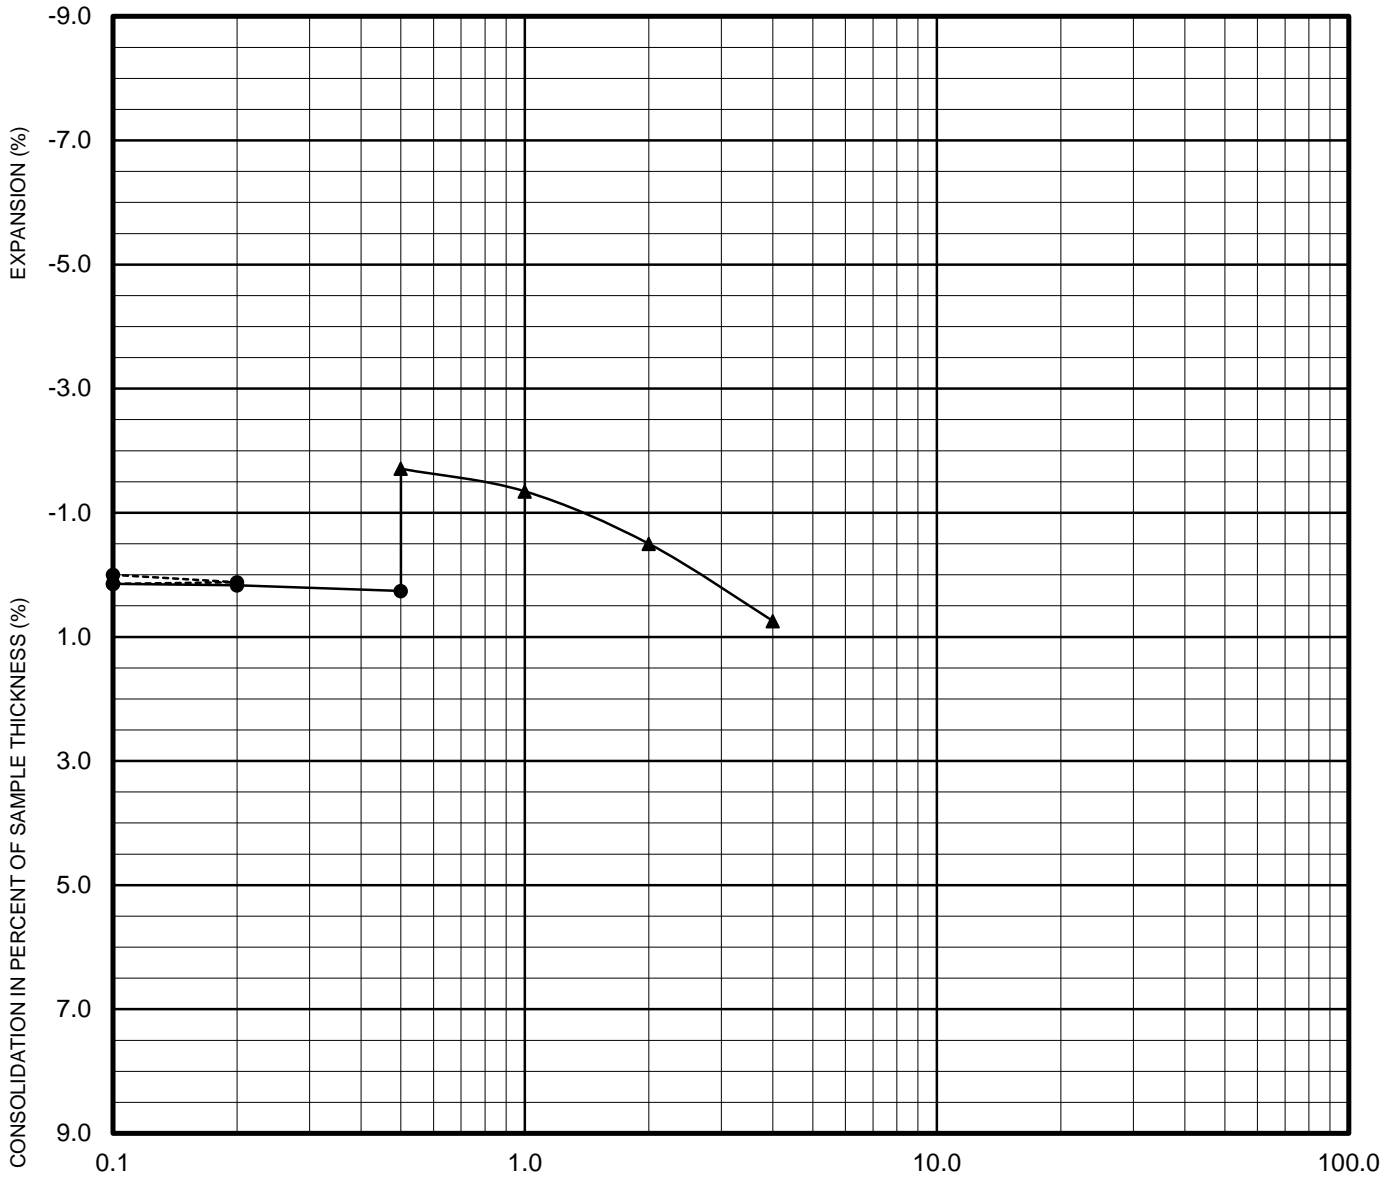
- Seating Cycle
- Loading Prior to Inundation
- ▲— Loading After Inundation
- ▲--- Rebound Cycle

Moisture Increase (%): 21.0  
Swell Percentage (%): 2.0  
Swell Pressure (psf): 2,600

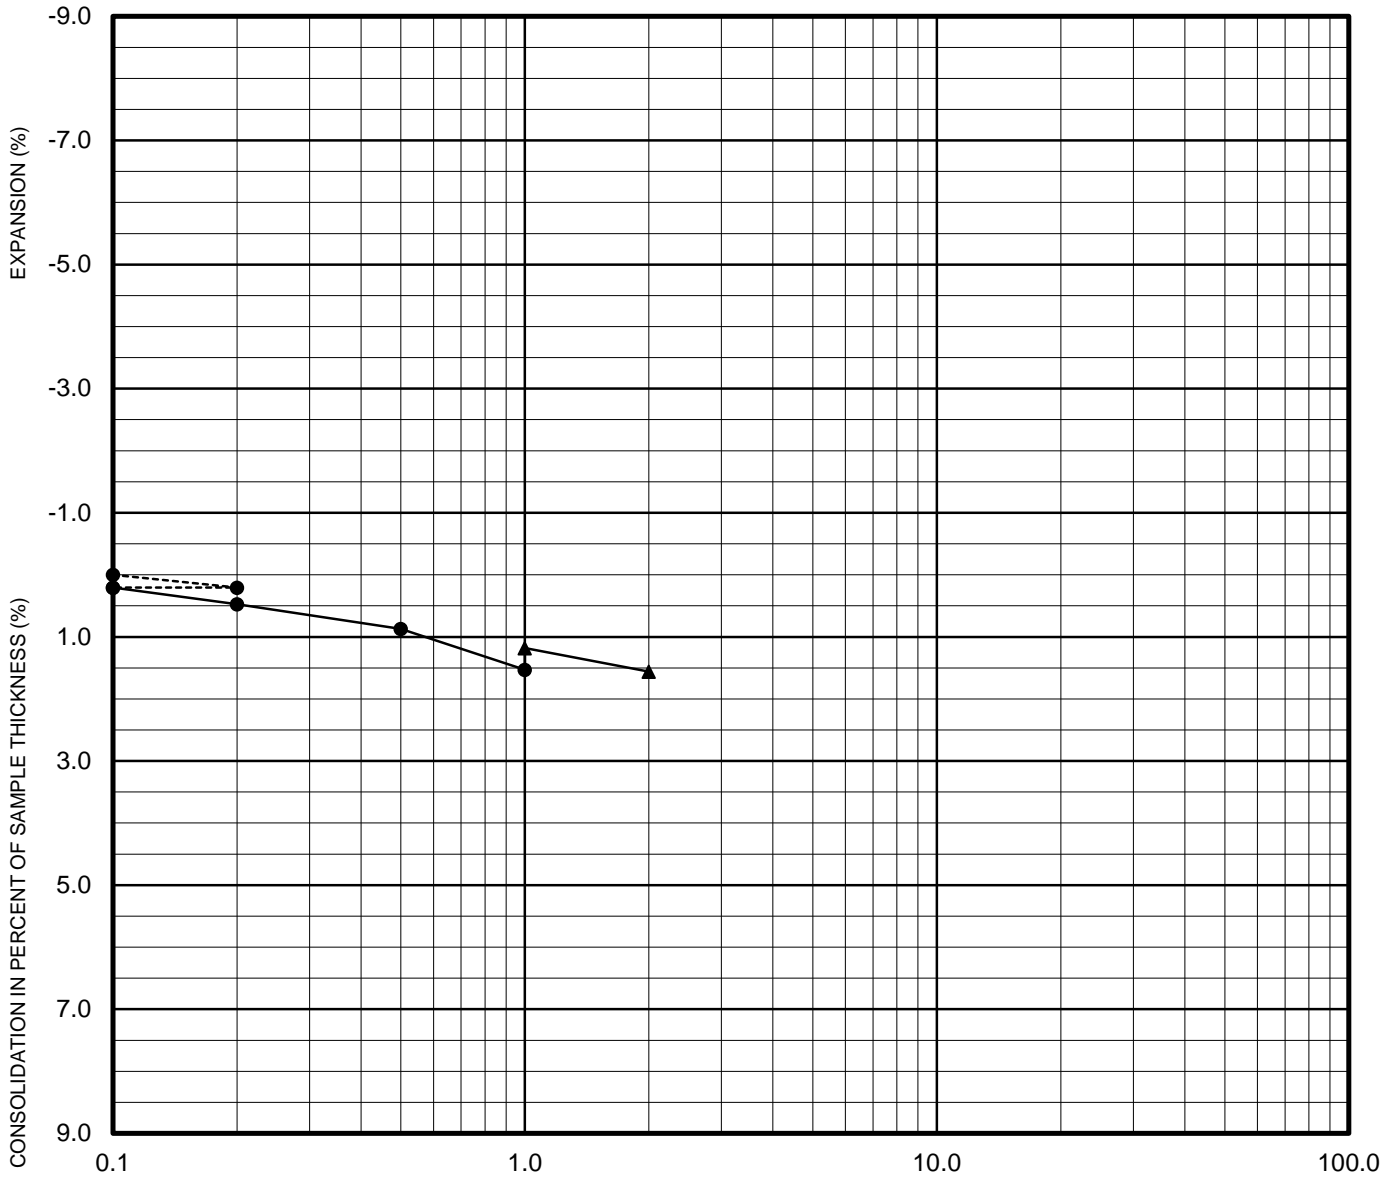
FIGURE B-21

- Seating Cycle
- Loading Prior to Inundation
- ▲— Loading After Inundation
- ▲-- Rebound Cycle

Moisture Increase (%): 1.4  
Swell Percentage (%): 0.4  
Swell Pressure (psf): 1,000

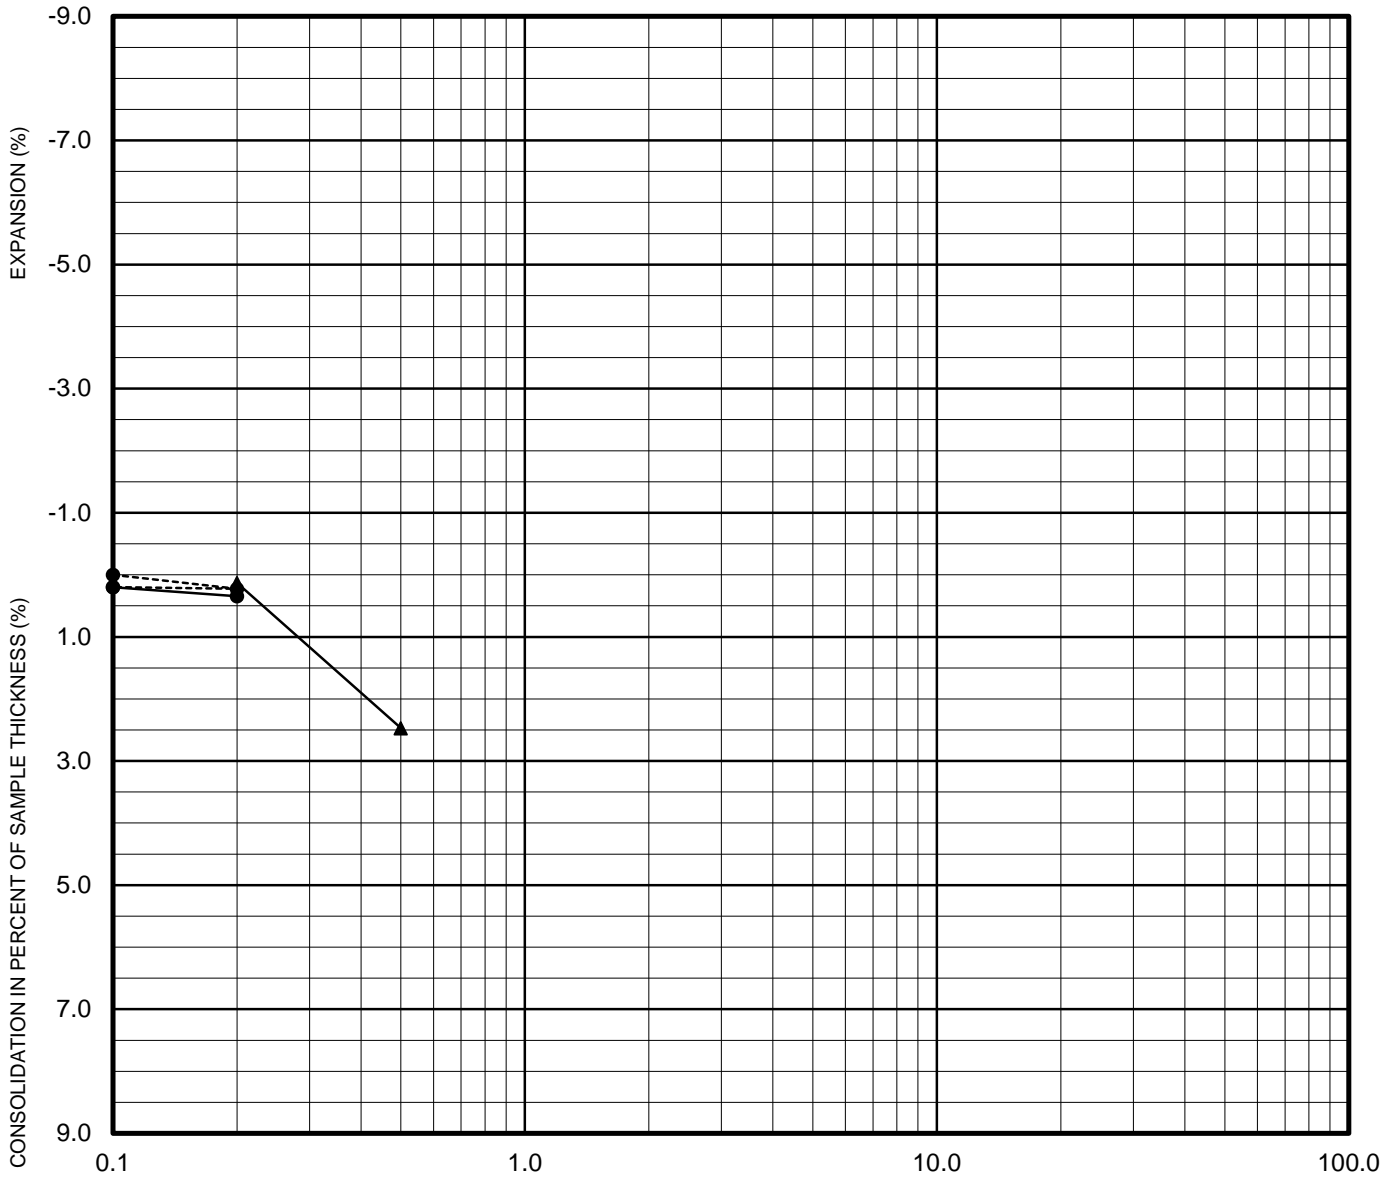
FIGURE B-22

- Seating Cycle
- Loading Prior to Inundation
- ▲— Loading After Inundation
- ▲-- Rebound Cycle

Moisture Increase (%): 15.5  
Swell Percentage (%): 0.2  
Swell Pressure (psf): 20

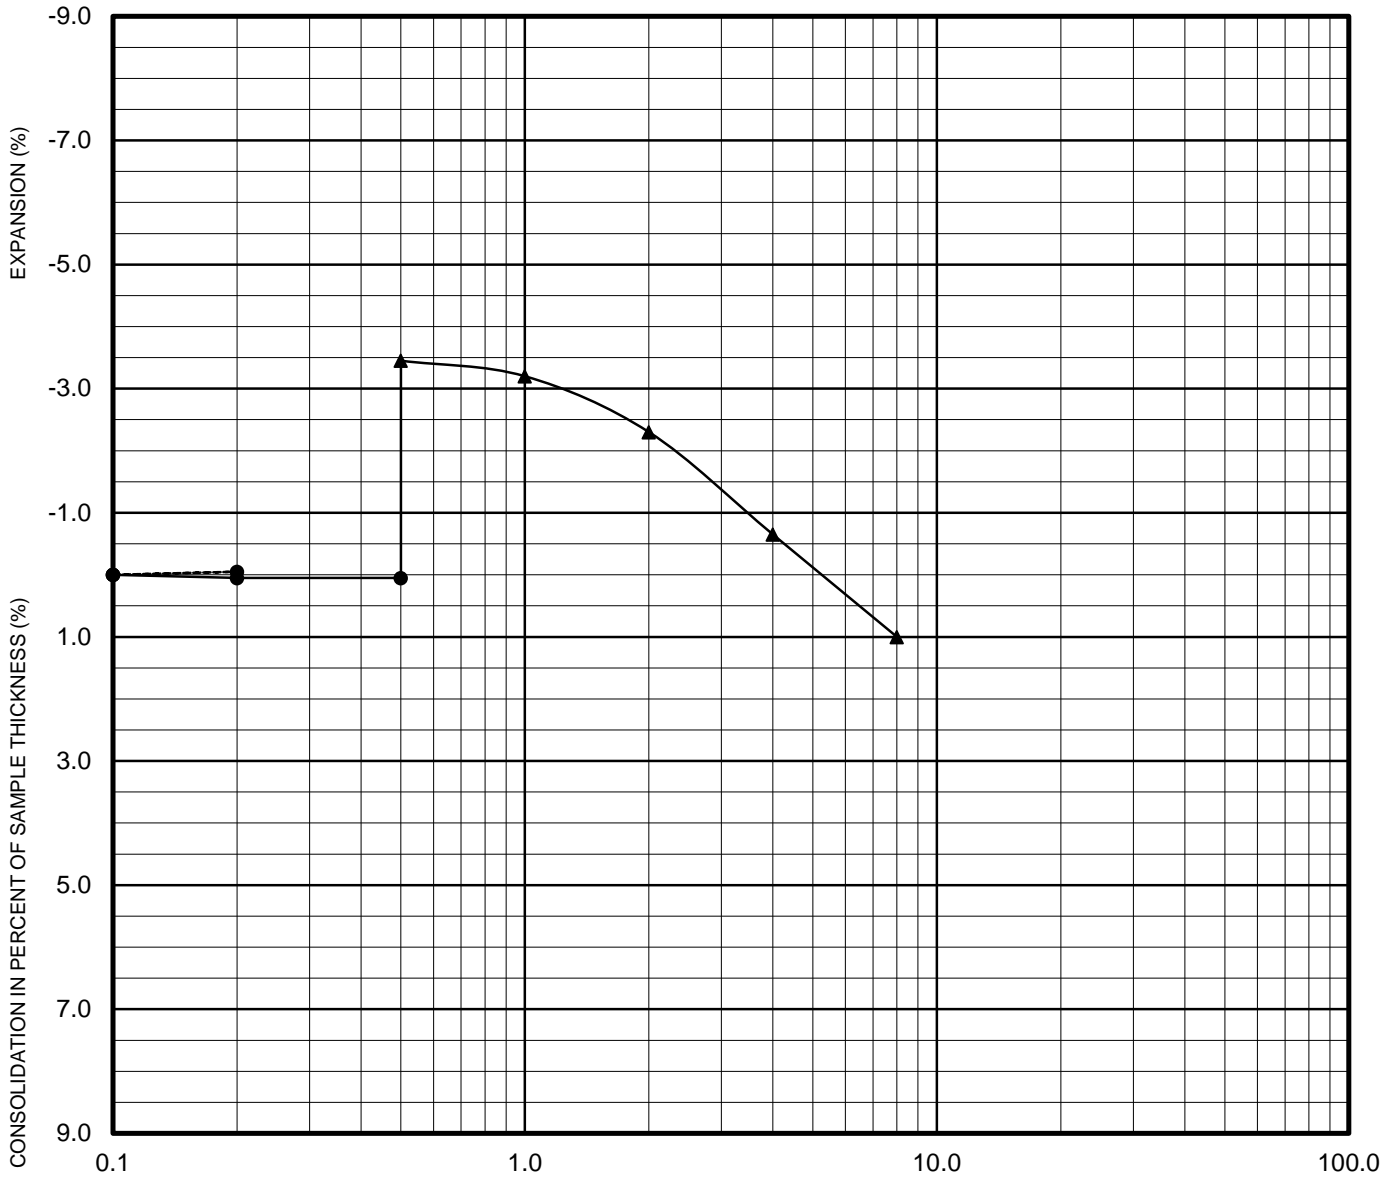
- Seating Cycle
- Loading Prior to Inundation
- ▲— Loading After Inundation
- ▲-- Rebound Cycle

Moisture Increase (%): 9.0  
Swell Percentage (%): 3.5  
Swell Pressure (psf): 4,900

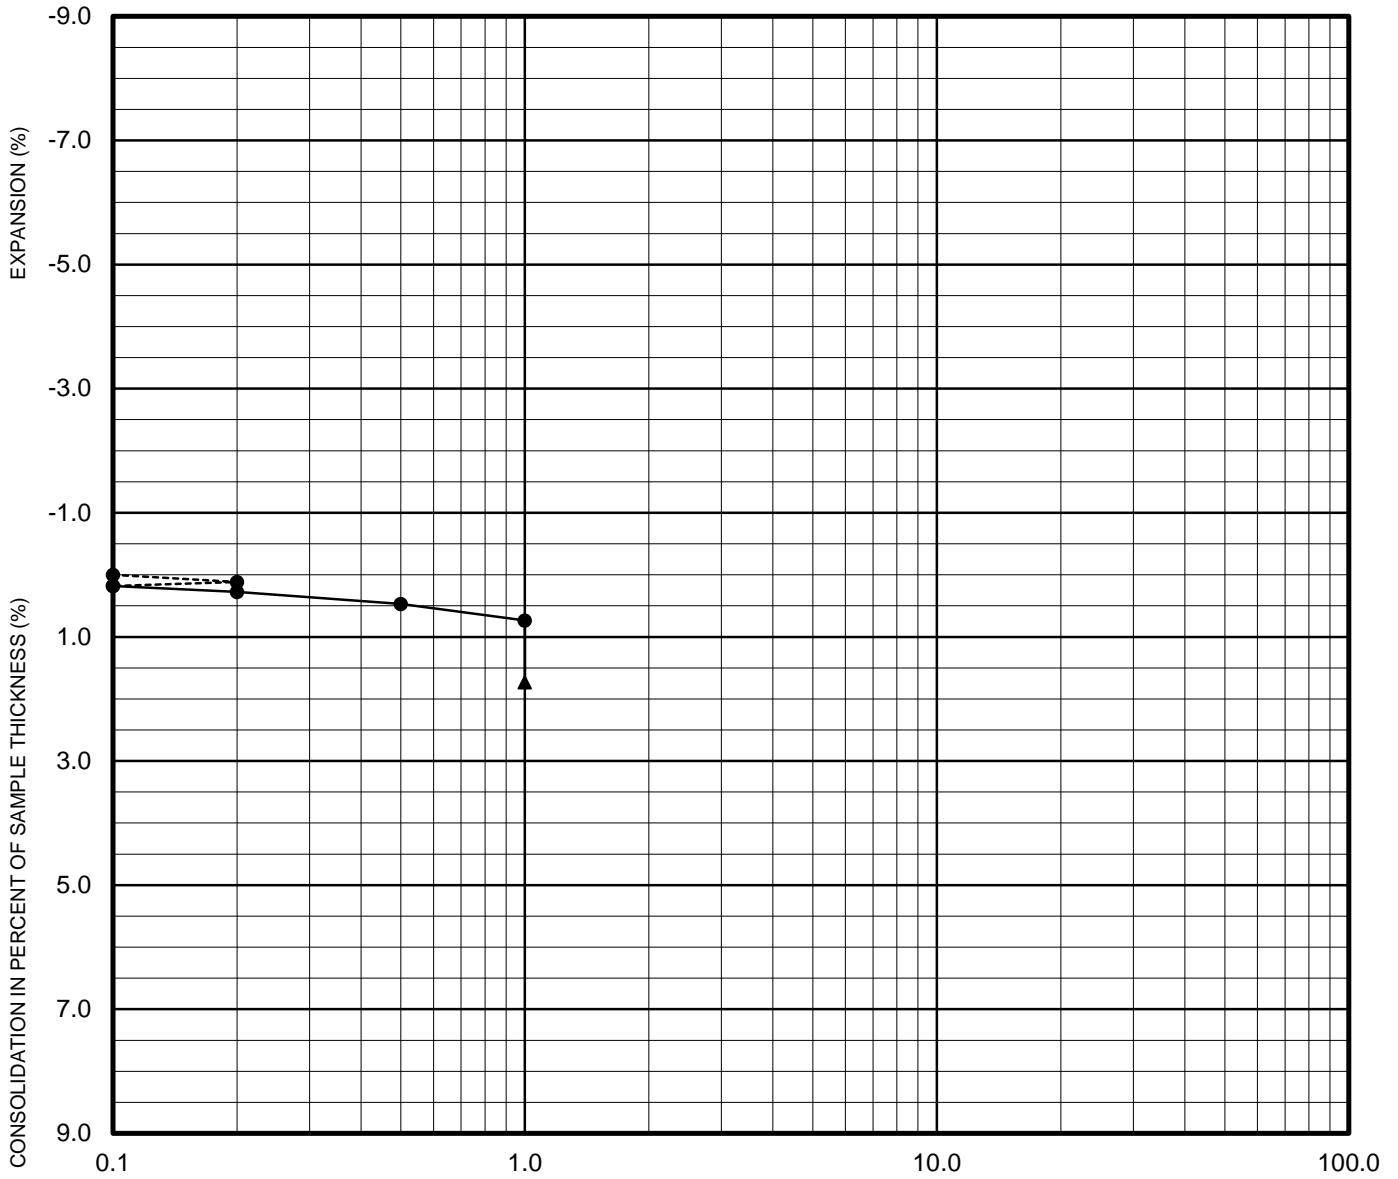
- Seating Cycle
- Loading Prior to Inundation
- ▲— Loading After Inundation
- ▲-- Rebound Cycle

Moisture Increase (%): 12.5  
Swell Percentage (%): -1.0  
Swell Pressure (psf): --

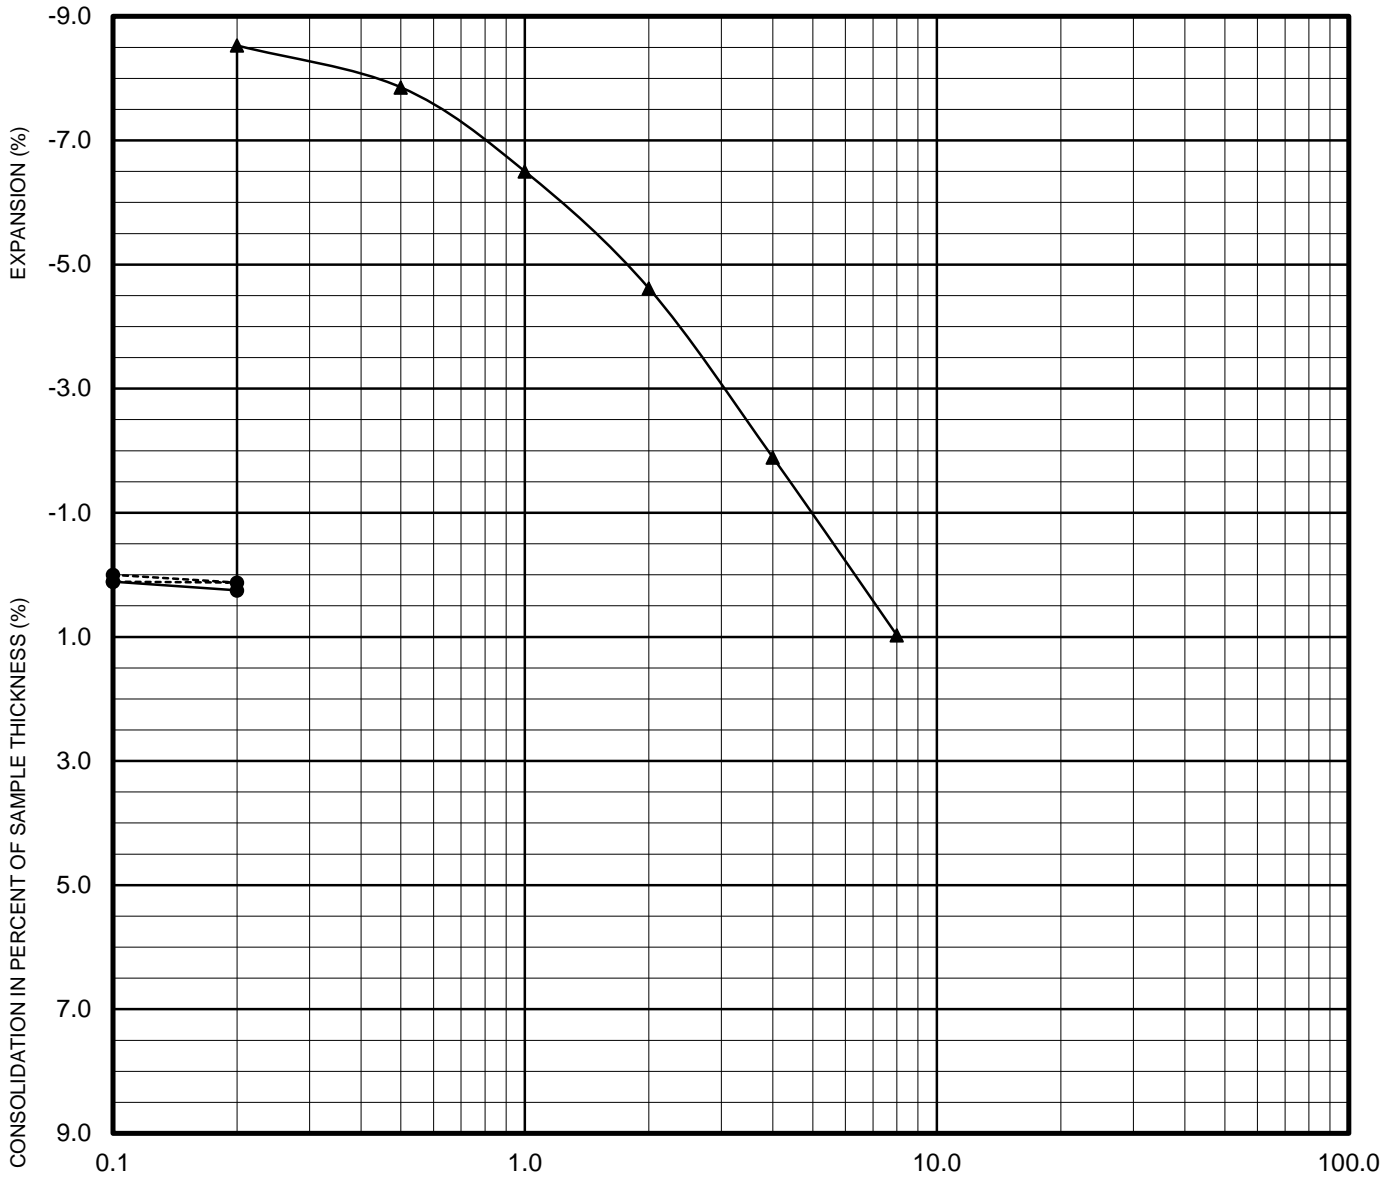
- Seating Cycle
- Loading Prior to Inundation
- ▲— Loading After Inundation
- ▲-- Rebound Cycle

Moisture Increase (%): 8.9  
 Swell Percentage (%): 8.8  
 Swell Pressure (psf): 6,600

**CONSOLIDATION TEST RESULTS**  
 PROPOSED MULTI-FAMILY DEVELOPMENT  
 COMPARK SOUTH, PARKER, COLORADO

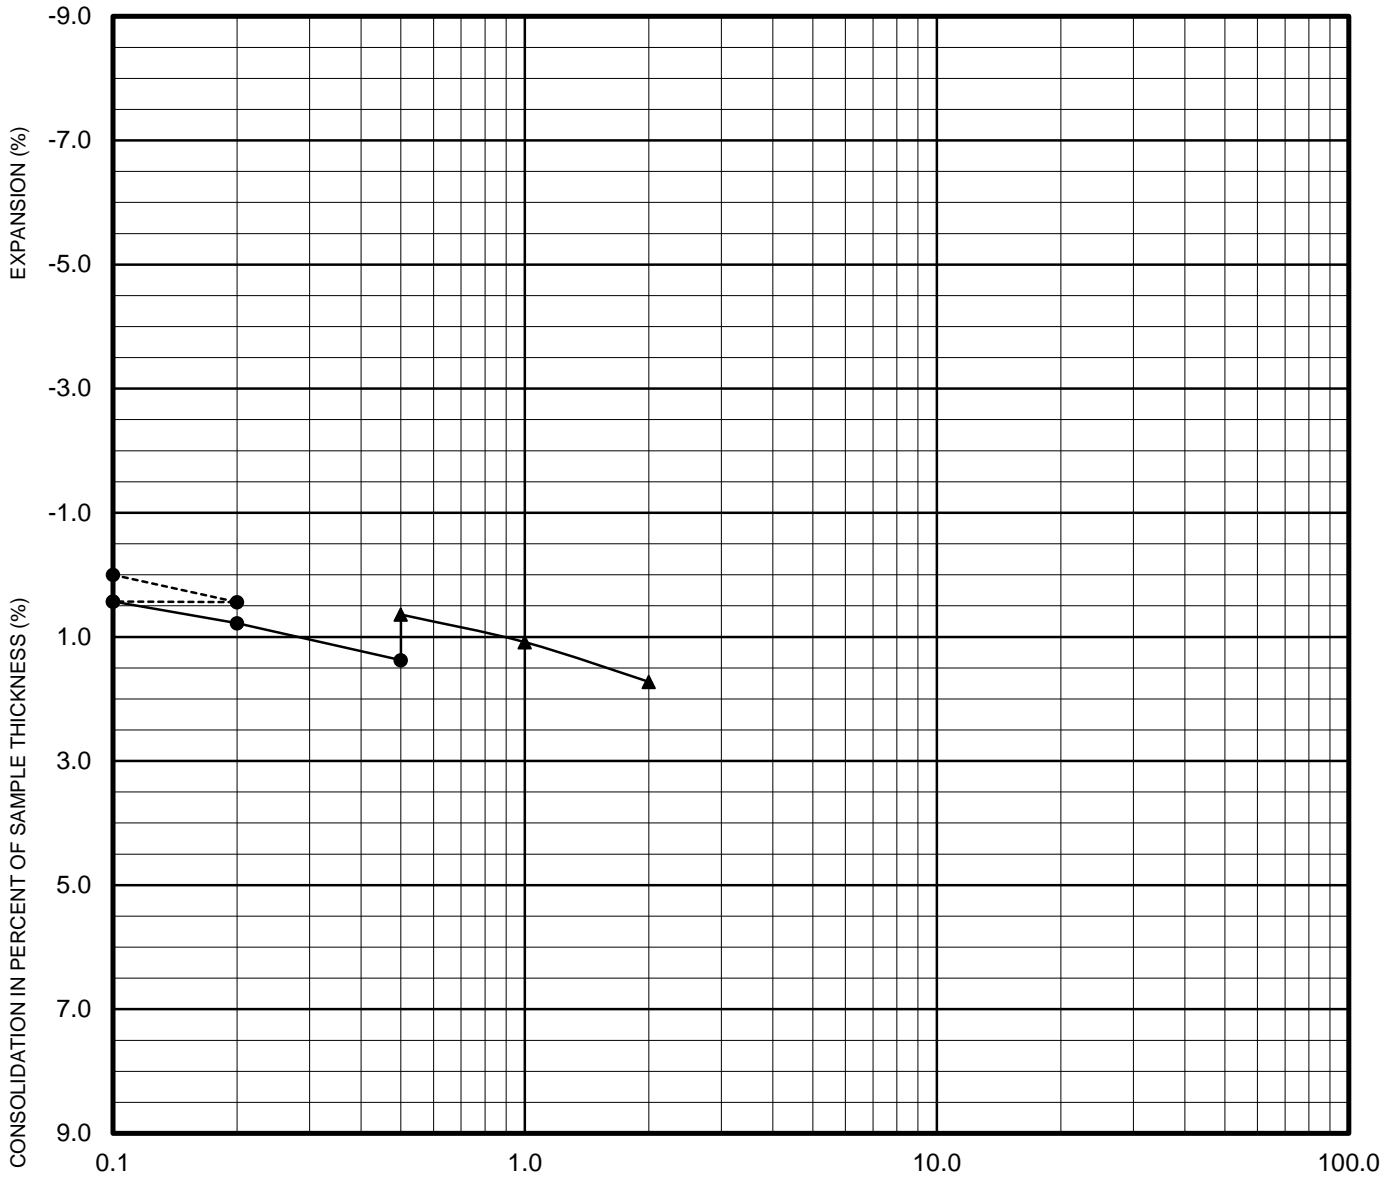
- Seating Cycle
- Loading Prior to Inundation
- ▲— Loading After Inundation
- ▲-- Rebound Cycle

Moisture Increase (%): 4.4  
 Swell Percentage (%): 0.7  
 Swell Pressure (psf): 900

**CONSOLIDATION TEST RESULTS**  
 PROPOSED MULTI-FAMILY DEVELOPMENT  
 COMPARK SOUTH, PARKER, COLORADO

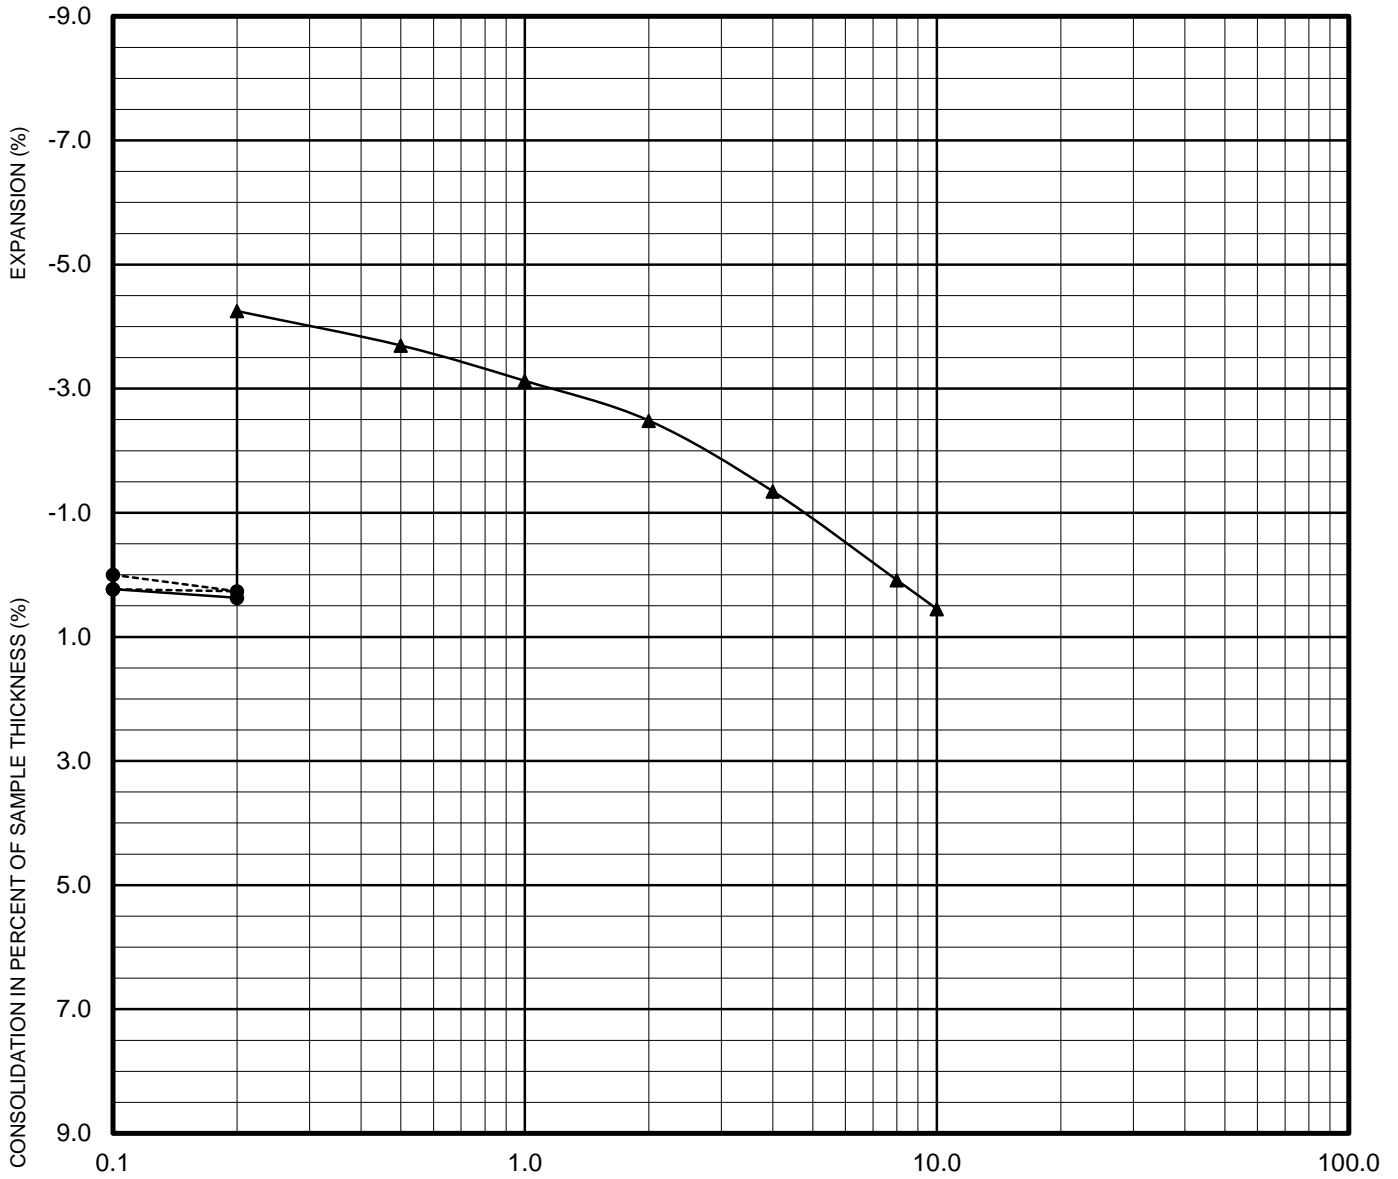
- Seating Cycle
- Loading Prior to Inundation
- ▲— Loading After Inundation
- ▲-- Rebound Cycle

Moisture Increase (%): 8.5  
 Swell Percentage (%): 4.6  
 Swell Pressure (psf): 9,000

**CONSOLIDATION TEST RESULTS**  
 PROPOSED MULTI-FAMILY DEVELOPMENT  
 COMPARK SOUTH, PARKER, COLORADO

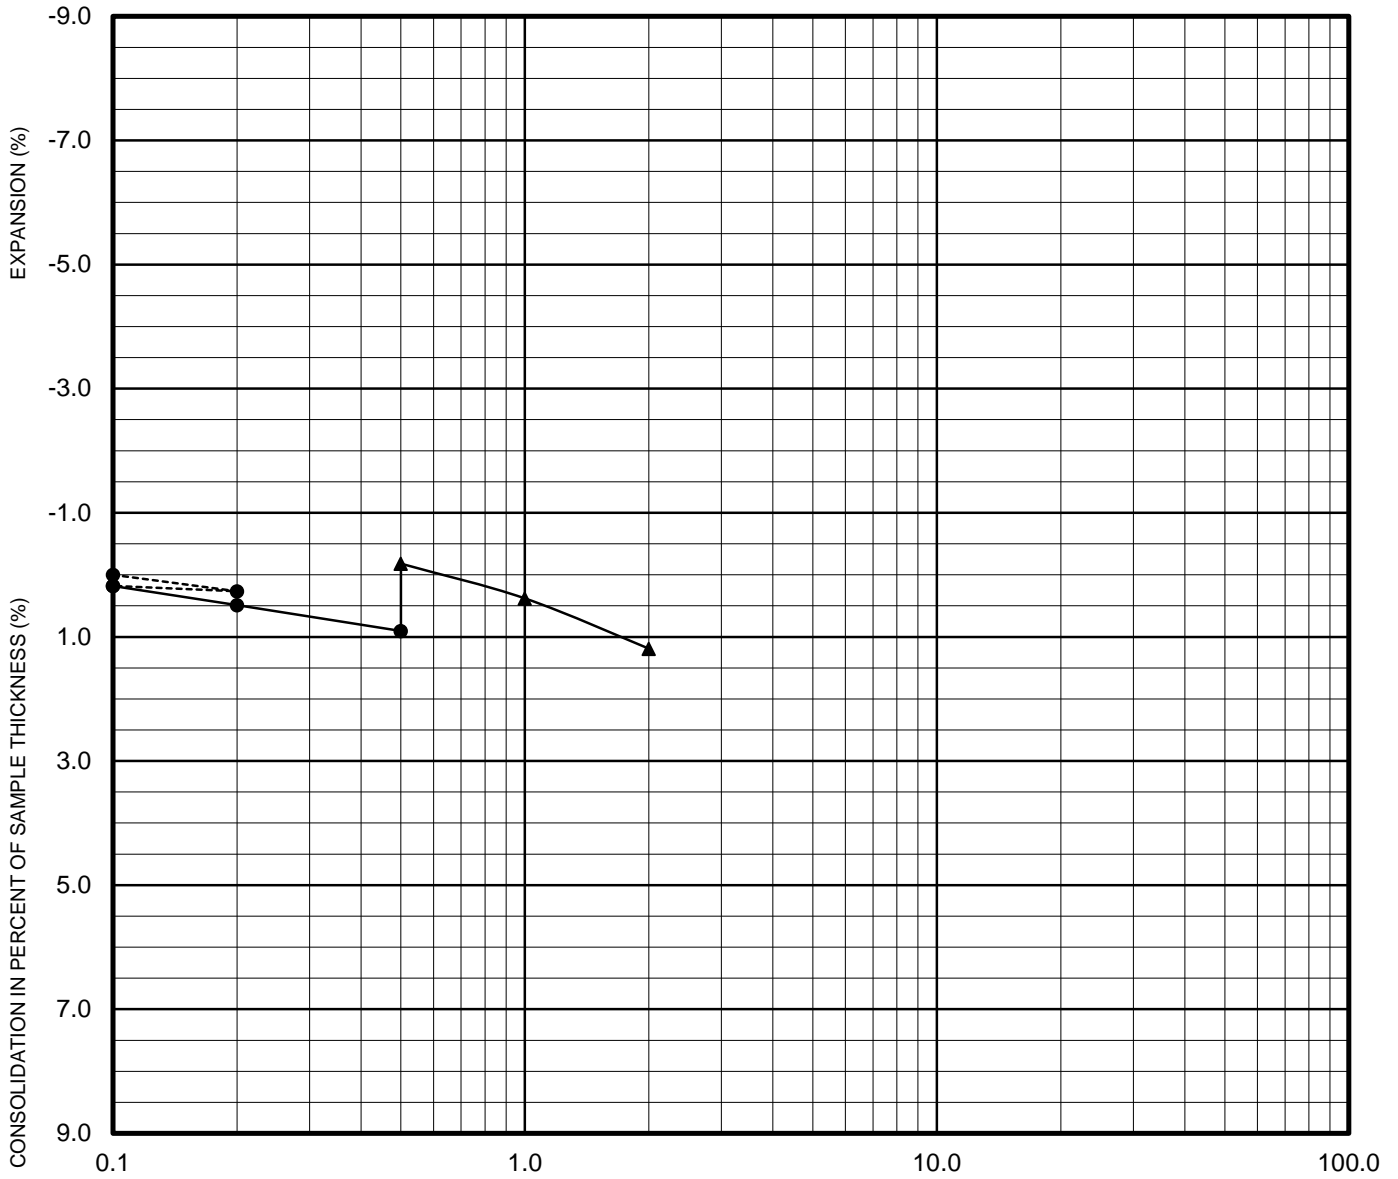
- Seating Cycle
- Loading Prior to Inundation
- ▲— Loading After Inundation
- ▲-- Rebound Cycle

Moisture Increase (%): 1.4  
Swell Percentage (%): 1.1  
Swell Pressure (psf): 1,100

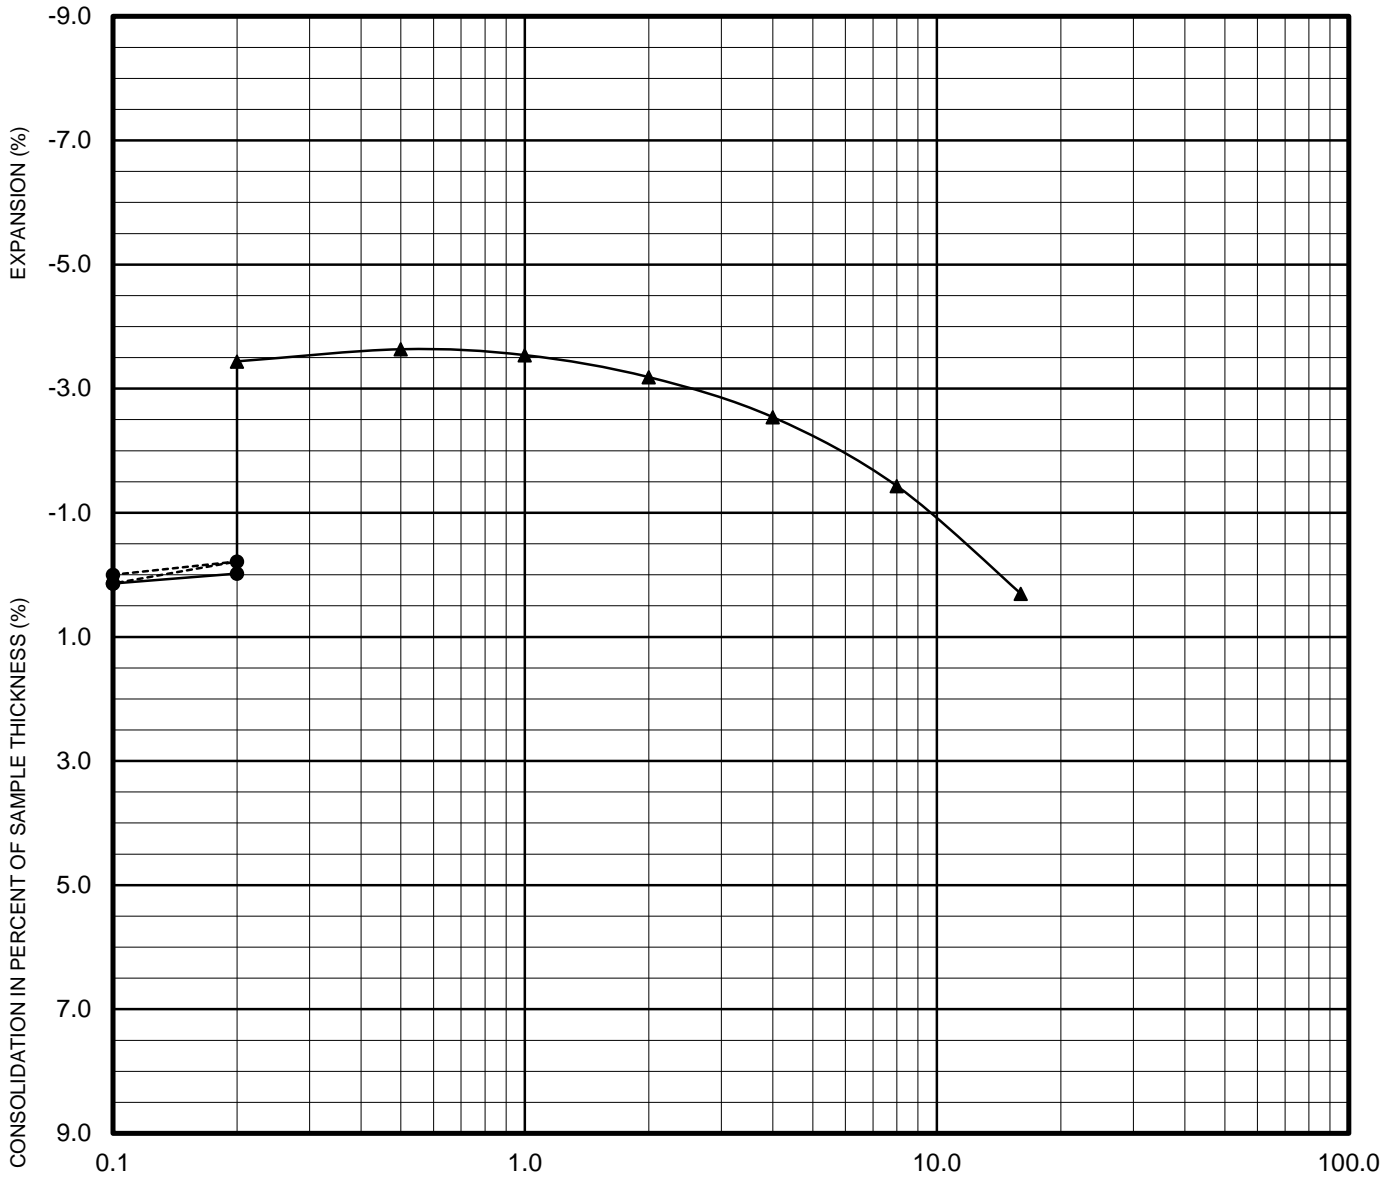
- Seating Cycle
- Loading Prior to Inundation
- ▲— Loading After Inundation
- ▲-- Rebound Cycle

Moisture Increase (%): 2.2  
Swell Percentage (%): 3.4  
Swell Pressure (psf): 13,800

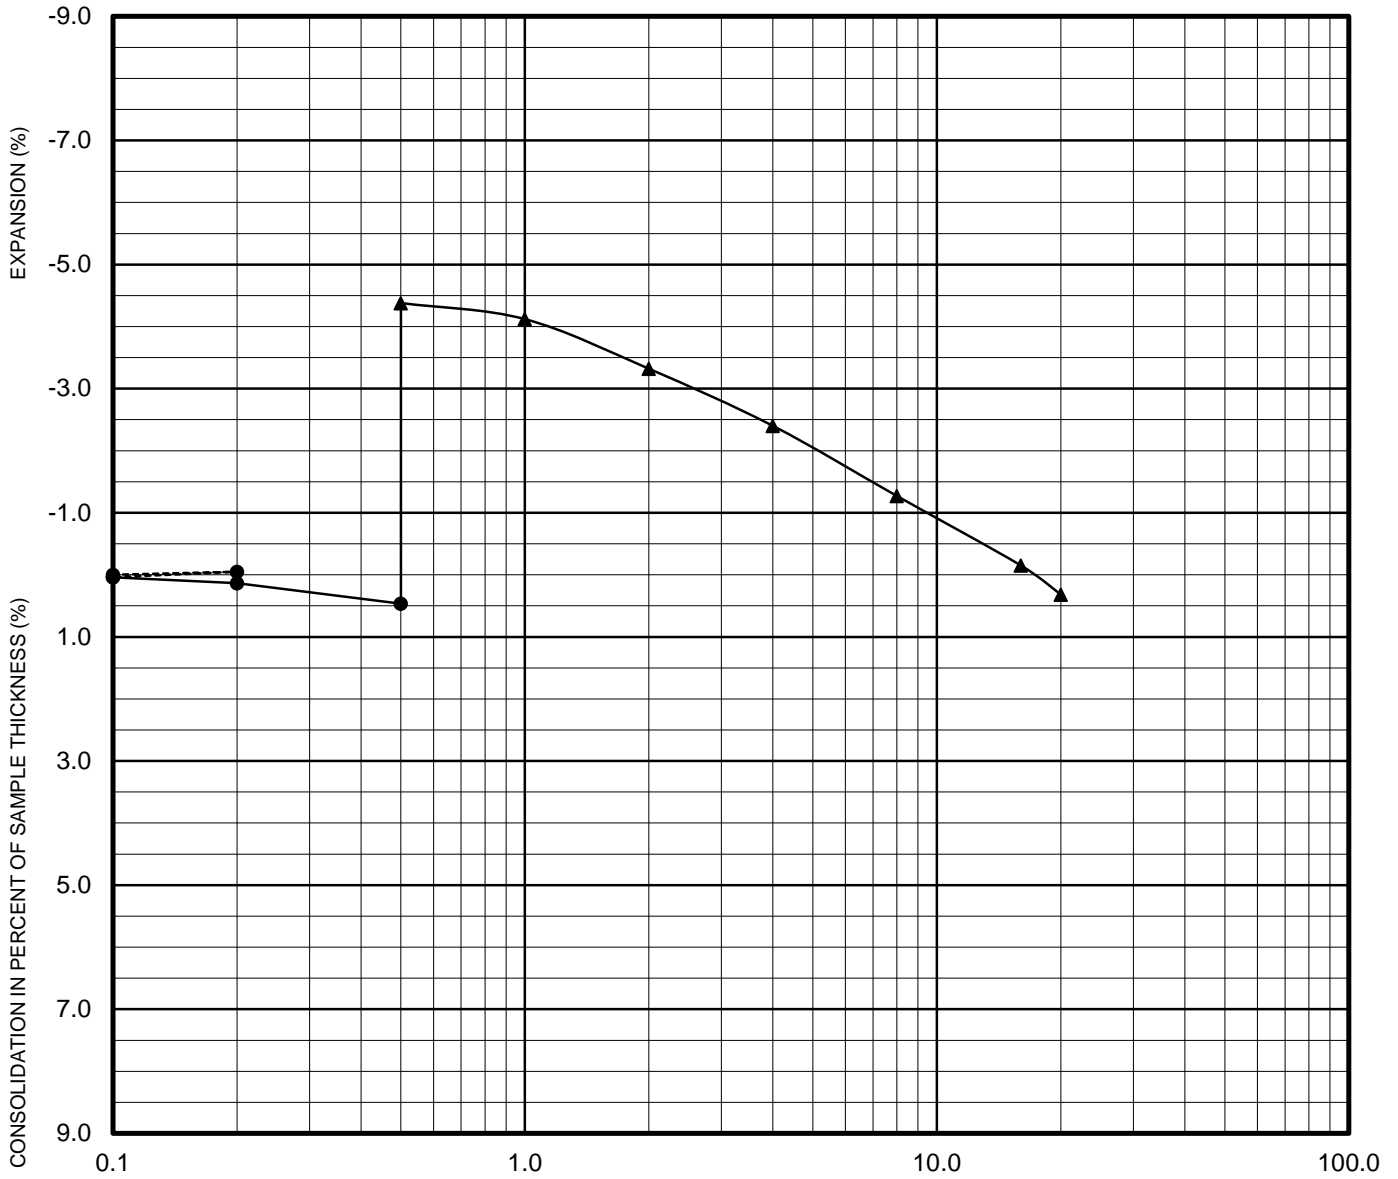
- Seating Cycle
- Loading Prior to Inundation
- ▲— Loading After Inundation
- ▲-- Rebound Cycle

Moisture Increase (%): 34.3  
 Swell Percentage (%): 4.9  
 Swell Pressure (psf): 19,500

**CONSOLIDATION TEST RESULTS**  
 PROPOSED MULTI-FAMILY DEVELOPMENT  
 COMPARK SOUTH, PARKER, COLORADO

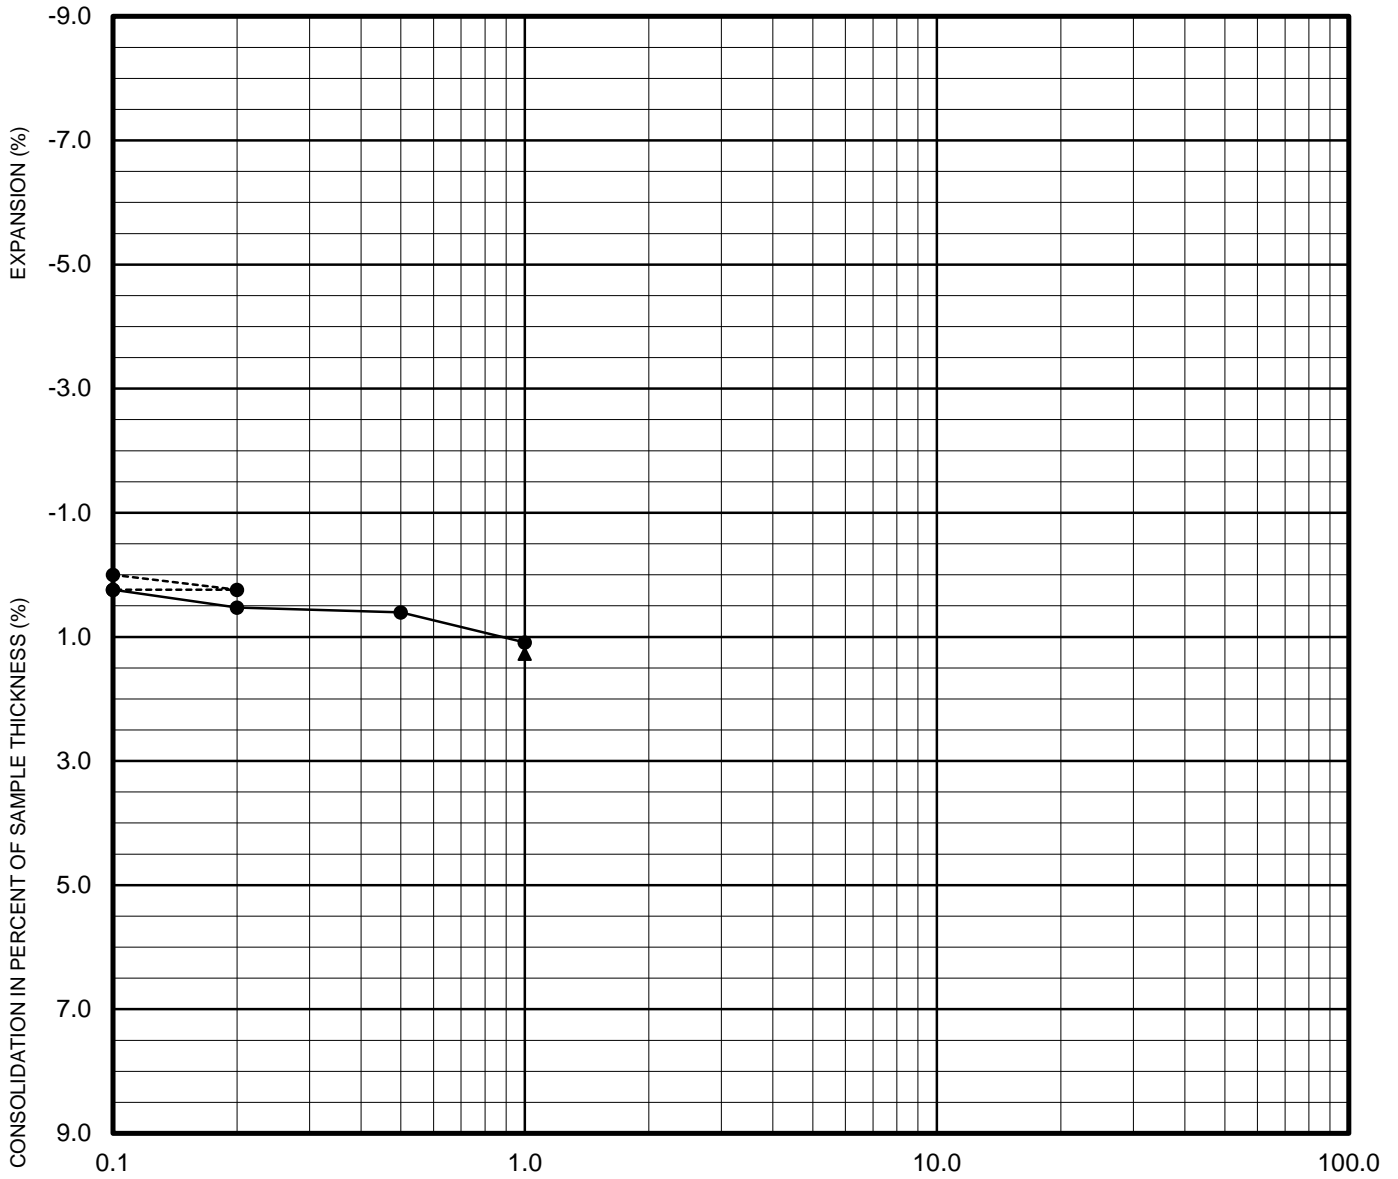
- Seating Cycle
- Loading Prior to Inundation
- ▲— Loading After Inundation
- ▲-- Rebound Cycle

Moisture Increase (%): 1.2  
 Swell Percentage (%): -0.2  
 Swell Pressure (psf): --

**CONSOLIDATION TEST RESULTS**  
 PROPOSED MULTI-FAMILY DEVELOPMENT  
 COMPARK SOUTH, PARKER, COLORADO

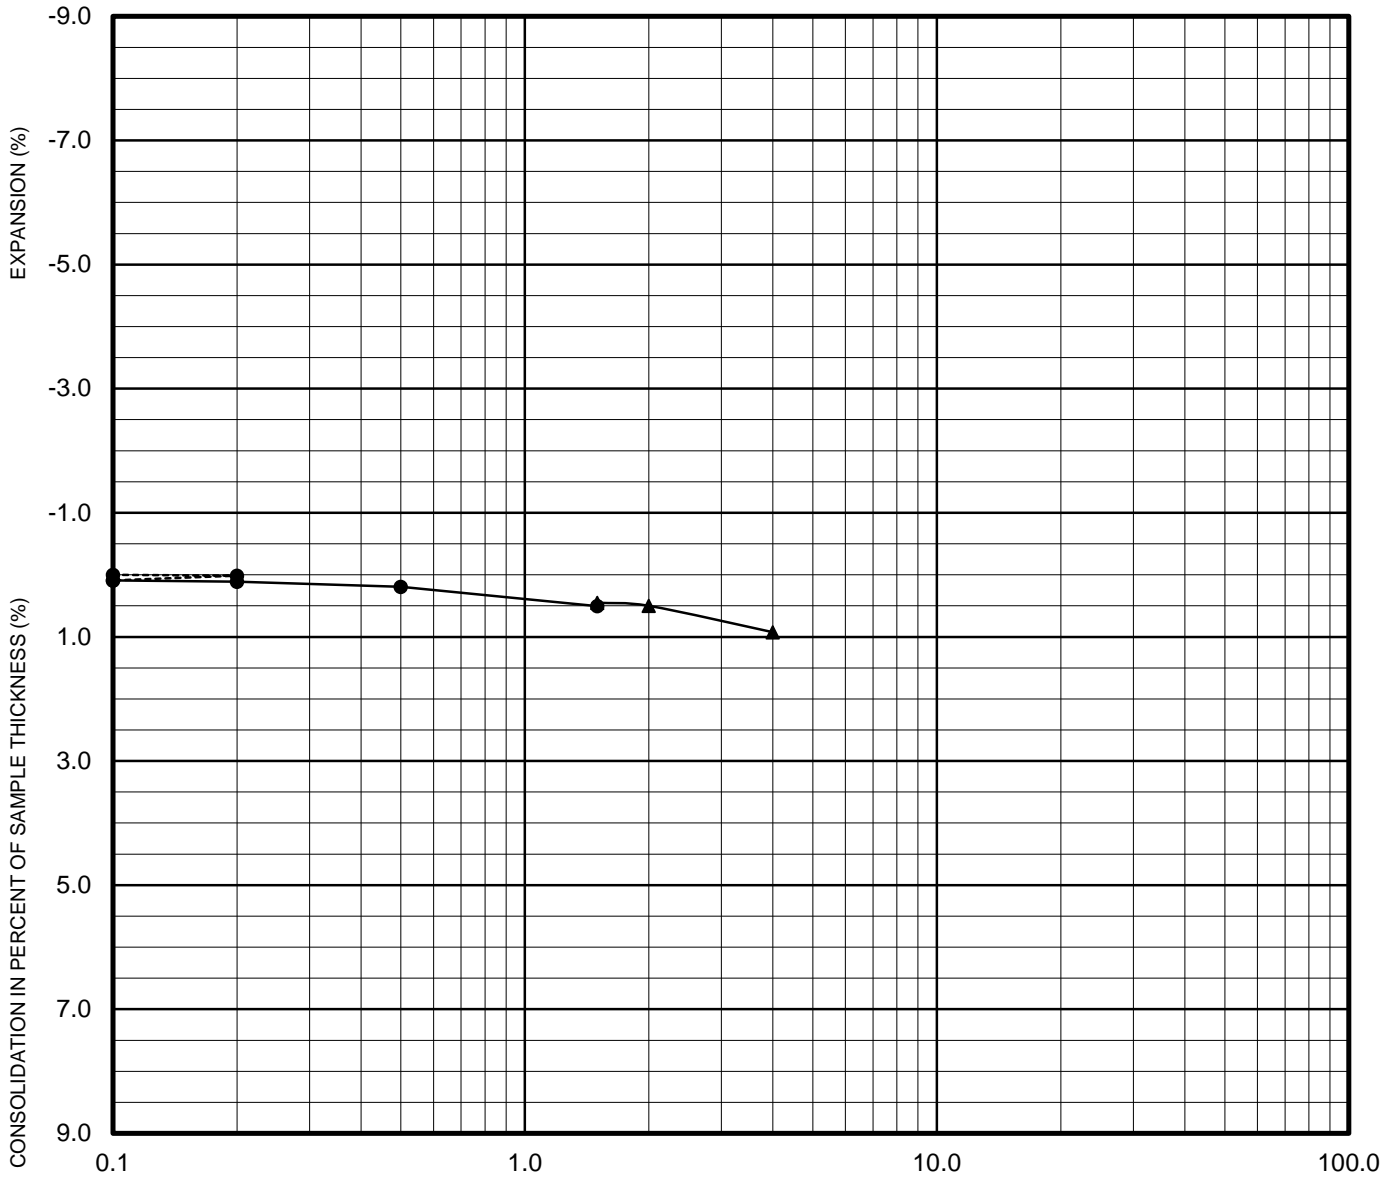
- Seating Cycle
- Loading Prior to Inundation
- ▲— Loading After Inundation
- ▲-- Rebound Cycle

Moisture Increase (%): 0.7  
 Swell Percentage (%): 0.1  
 Swell Pressure (psf): 700

**CONSOLIDATION TEST RESULTS**  
 PROPOSED MULTI-FAMILY DEVELOPMENT  
 COMPARK SOUTH, PARKER, COLORADO
