# Preliminary Geotechnical Evaluation Proposed Multi-Family Development Compark South – Portion of Tract G Compark Village South, Filing No. 1 Parker, Colorado

March 29, 2021 | Project No. 502090001

Subject: Preliminary Geotechnical Evaluation  
Proposed Multi-Family Development  
Compark South – Portion of Tract G  
Compark Village South, Filing No. 1  
Parker, Colorado

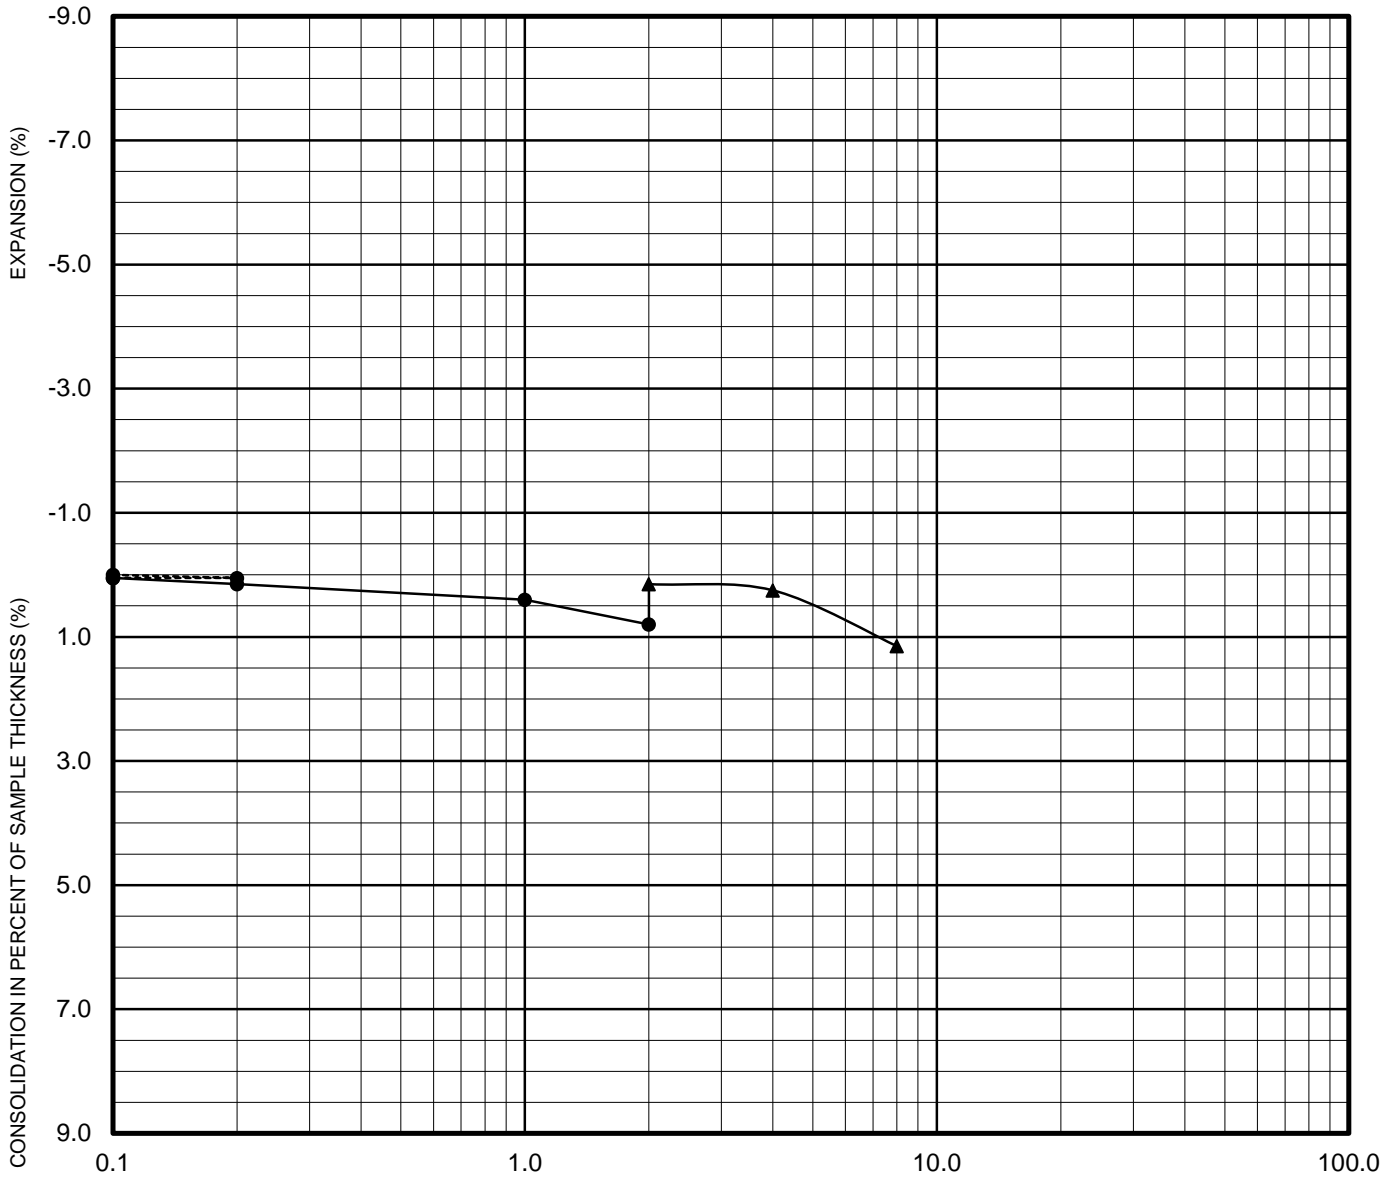
- Seating Cycle
- Loading Prior to Inundation
- ▲— Loading After Inundation
- ▲-- Rebound Cycle

Moisture Increase (%): 1.3  
 Swell Percentage (%): 0.7  
 Swell Pressure (psf): 4,300

**CONSOLIDATION TEST RESULTS**  
 PROPOSED MULTI-FAMILY DEVELOPMENT  
 COMPARK SOUTH, PARKER, COLORADO

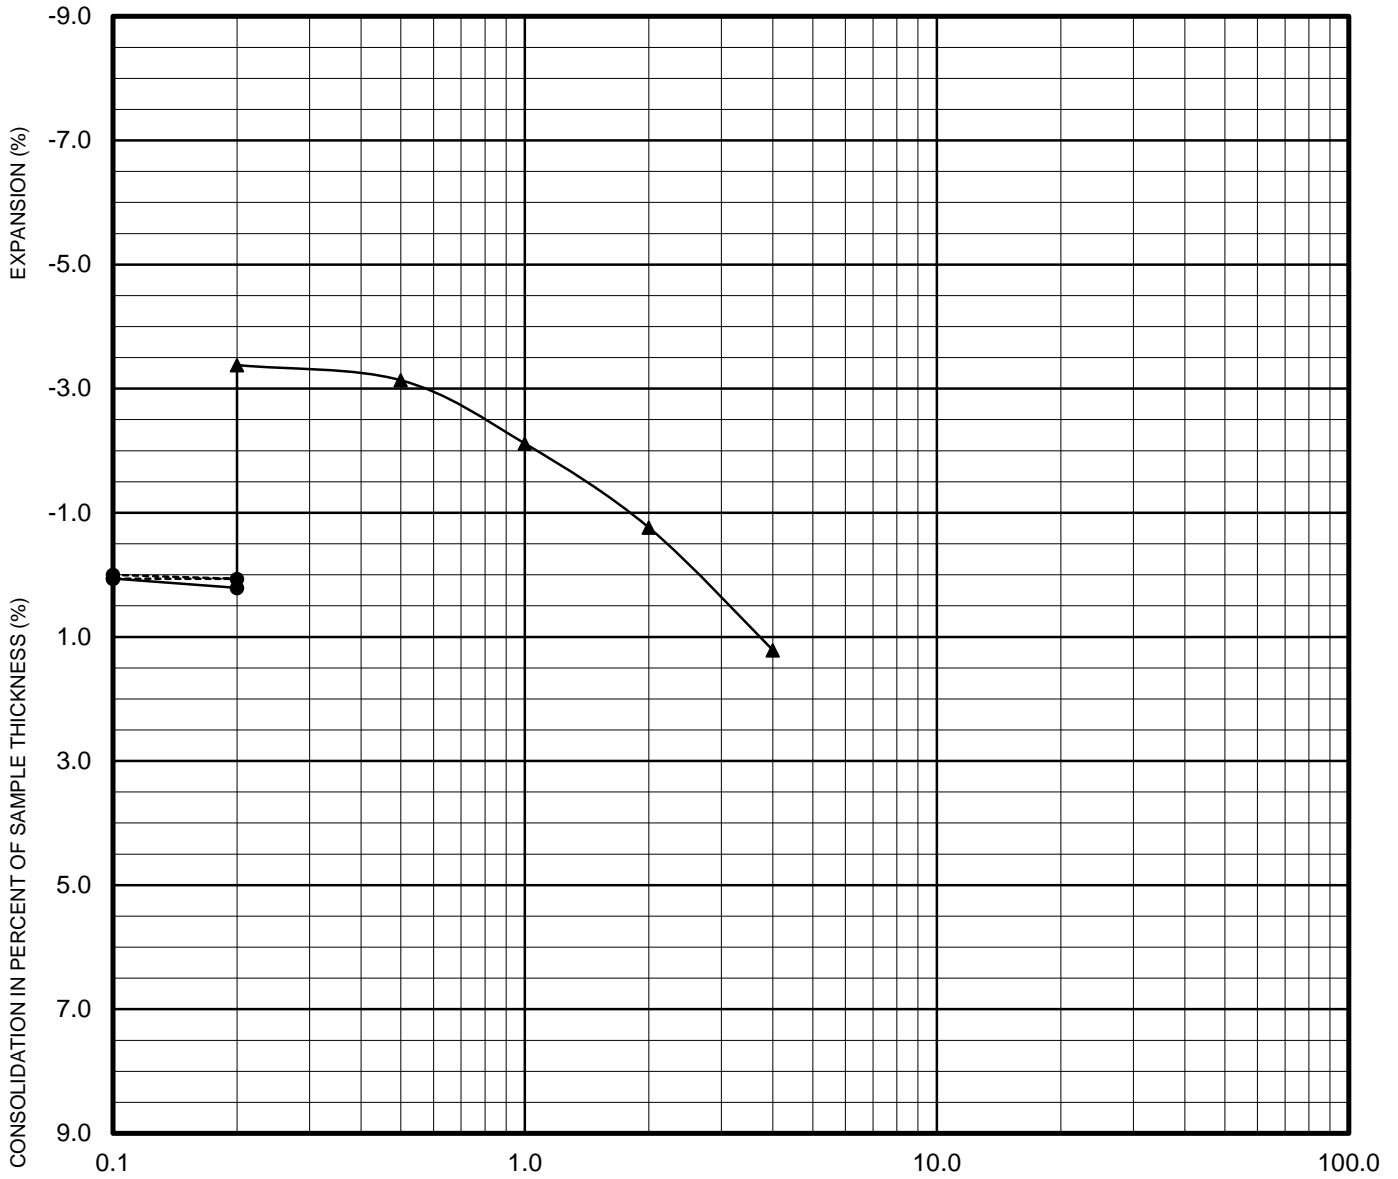
- Seating Cycle
- Loading Prior to Inundation
- ▲— Loading After Inundation
- ▲-- Rebound Cycle

Moisture Increase (%): 6.1  
 Swell Percentage (%): 3.6  
 Swell Pressure (psf): 2,600

**CONSOLIDATION TEST RESULTS**  
 PROPOSED MULTI-FAMILY DEVELOPMENT  
 COMPARK SOUTH, PARKER, COLORADO

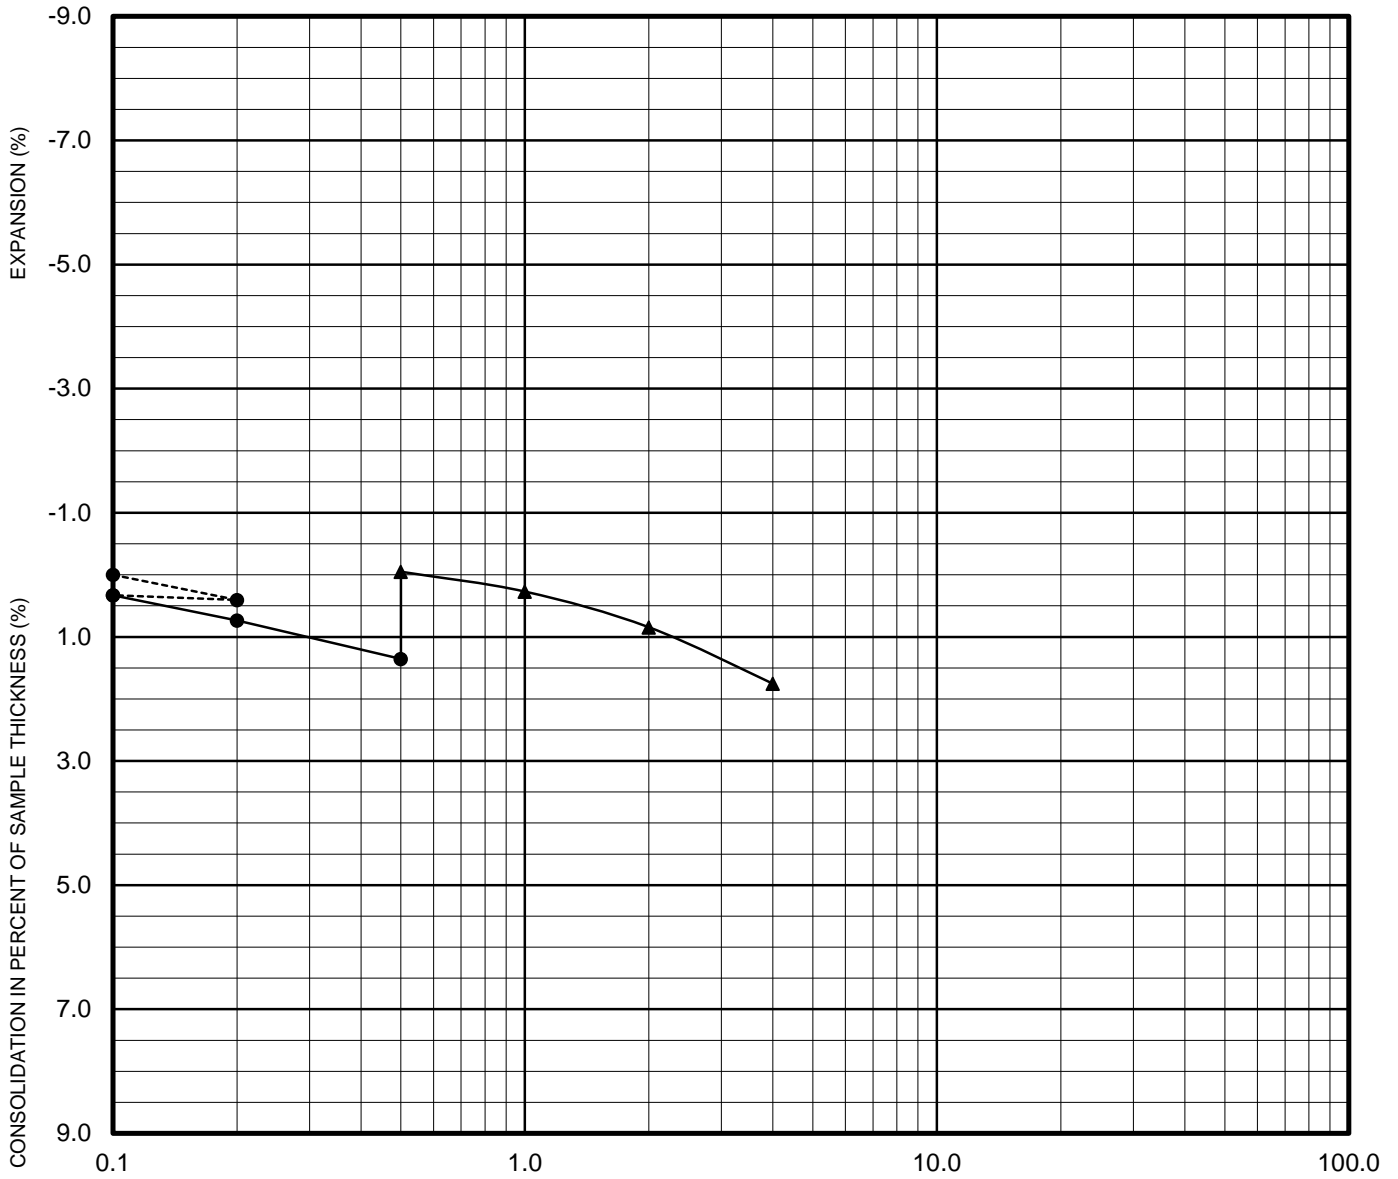
FIGURE B-36

- Seating Cycle
- Loading Prior to Inundation
- ▲— Loading After Inundation
- ▲-- Rebound Cycle

Moisture Increase (%): 1.8  
 Swell Percentage (%): 1.4  
 Swell Pressure (psf): 2,600

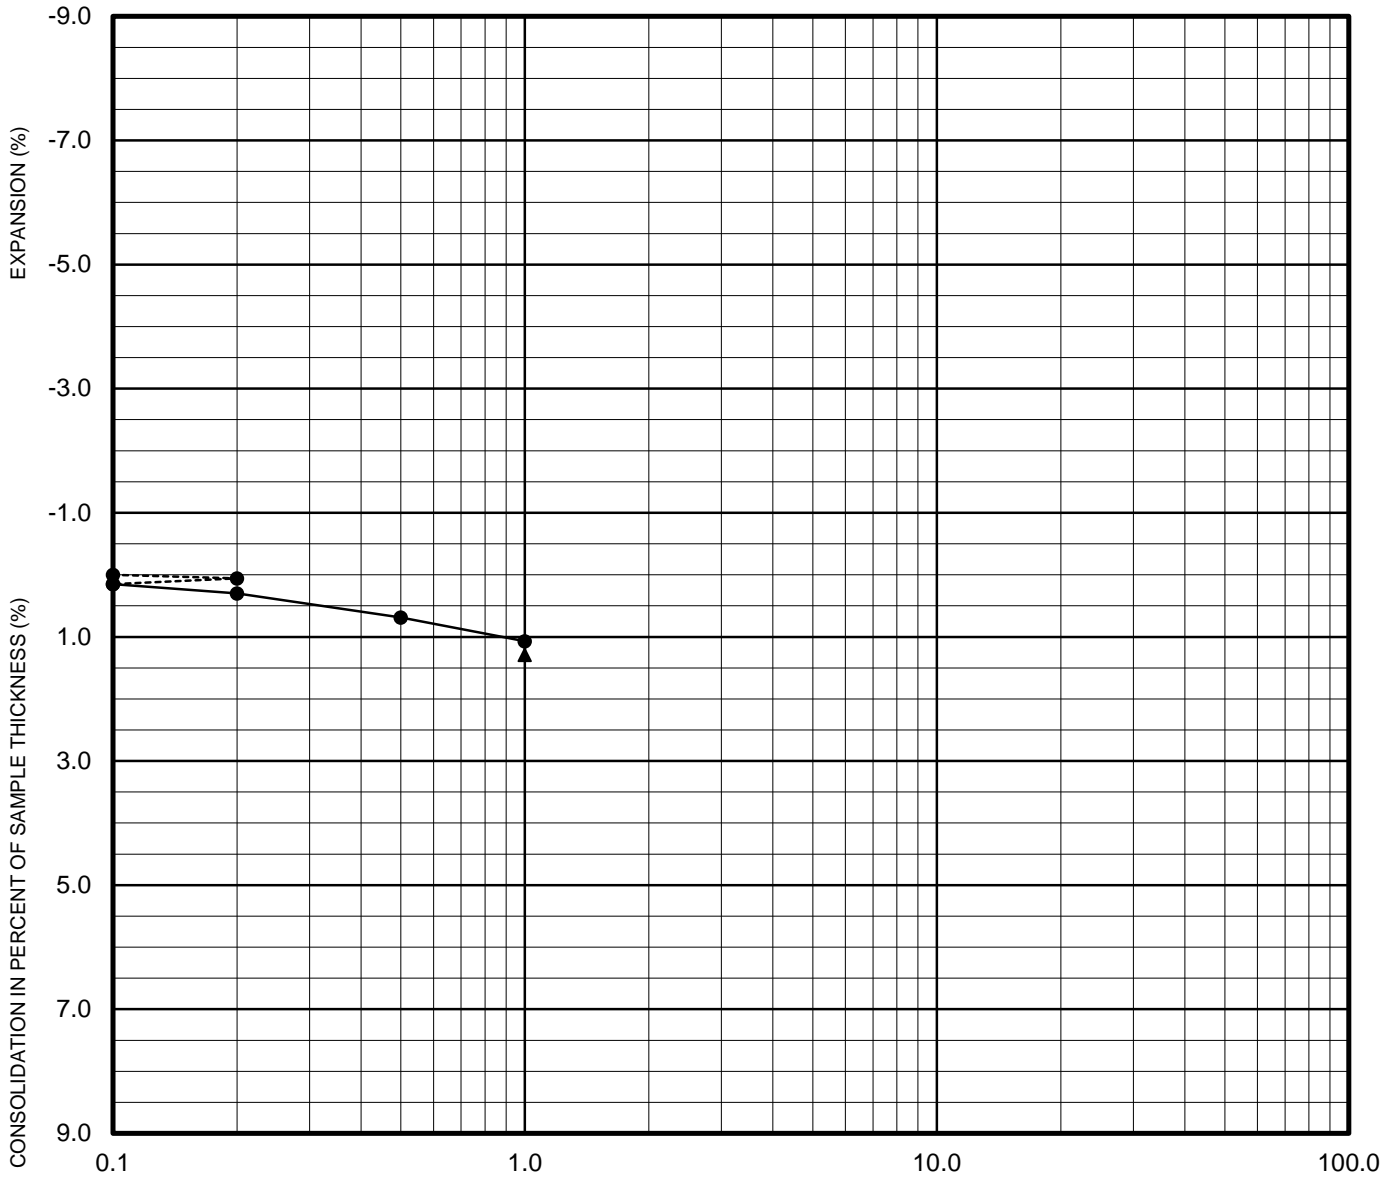
FIGURE B-37

- Seating Cycle
- Loading Prior to Inundation
- ▲— Loading After Inundation
- ▲-- Rebound Cycle

Moisture Increase (%): 0.4  
Swell Percentage (%): -0.2  
Swell Pressure (psf): --

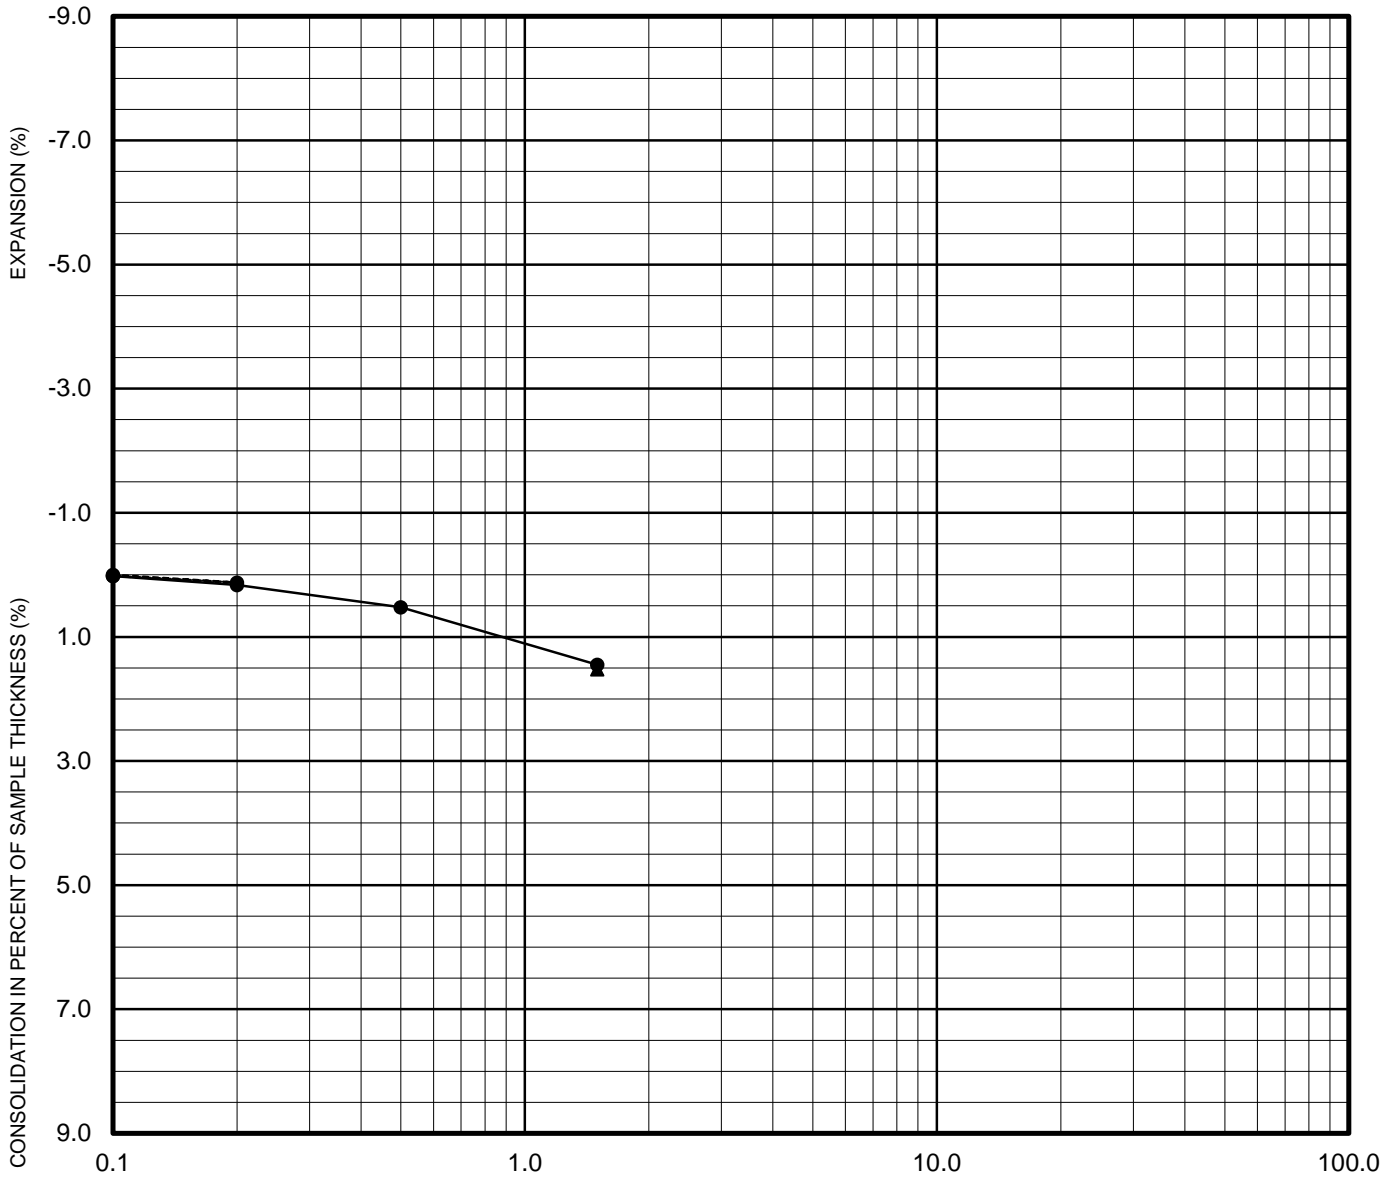
- Seating Cycle
- Loading Prior to Inundation
- ▲— Loading After Inundation
- ▲-- Rebound Cycle

Moisture Increase (%): 2.0  
 Swell Percentage (%): -0.1  
 Swell Pressure (psf): --

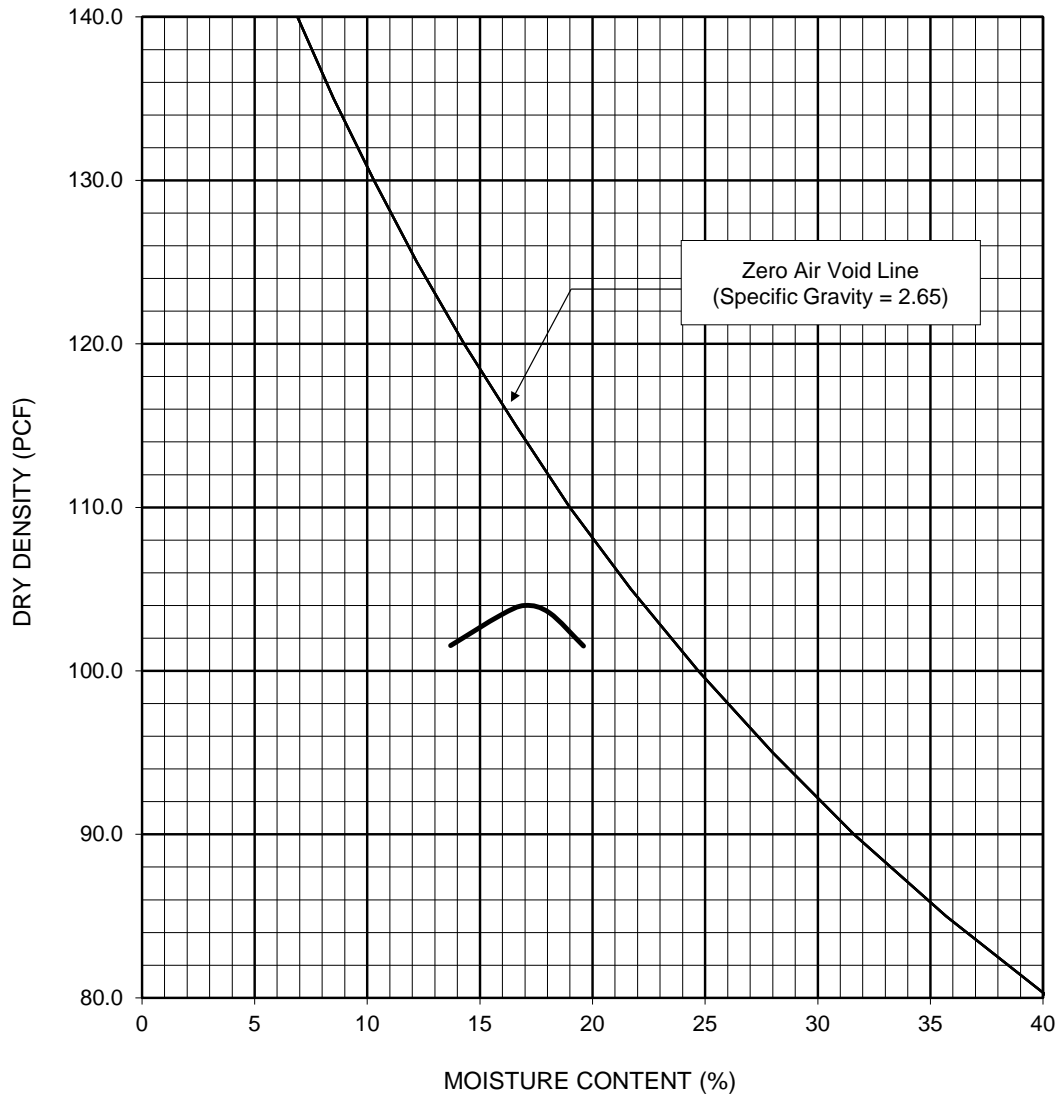
FIGURE B-39

Sample Location	Depth (ft)	Soil Description	Maximum Dry Density (pcf)	Optimum Moisture Content (percent)
B-1,B-8,B-9	0.0-5.0	Brown Well-graded Clayey SAND; Trace Gravel	104.0	17.0
Dry Density and Moisture Content Values Corrected for Oversize (ASTM D 4718)			N/A	N/A

PERFORMED IN GENERAL ACCORDANCE WITH  ASTM D 1557  ASTM D 698 METHOD  A  B  C

The maximum dry density and optimum moisture content of selected representative soil samples were evaluated using the Standard Proctor method in general accordance with ASTM D 698. The results of these tests are summarized on Figures B-39 through B-41.

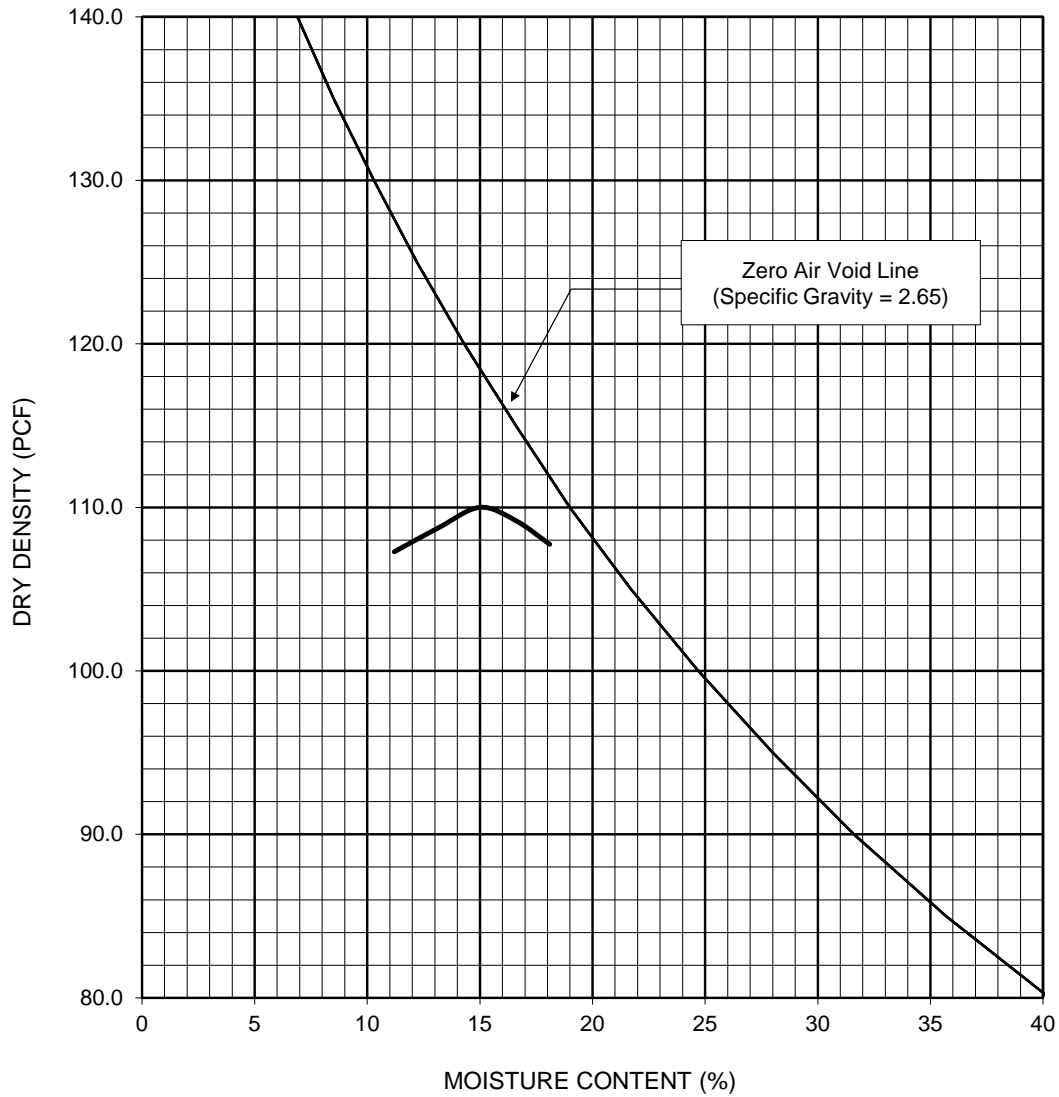
FIGURE B-40

Sample Location	Depth (ft)	Soil Description	Maximum Dry Density (pcf)	Optimum Moisture Content (percent)
B-2,B-5,B-6,B-7	0.0-5.0	Light Brown Clayey SAND	110.0	15.0
Dry Density and Moisture Content Values Corrected for Oversize (ASTM D 4718)			N/A	N/A

PERFORMED IN GENERAL ACCORDANCE WITH  ASTM D 1557  ASTM D 698 METHOD  A  B  C

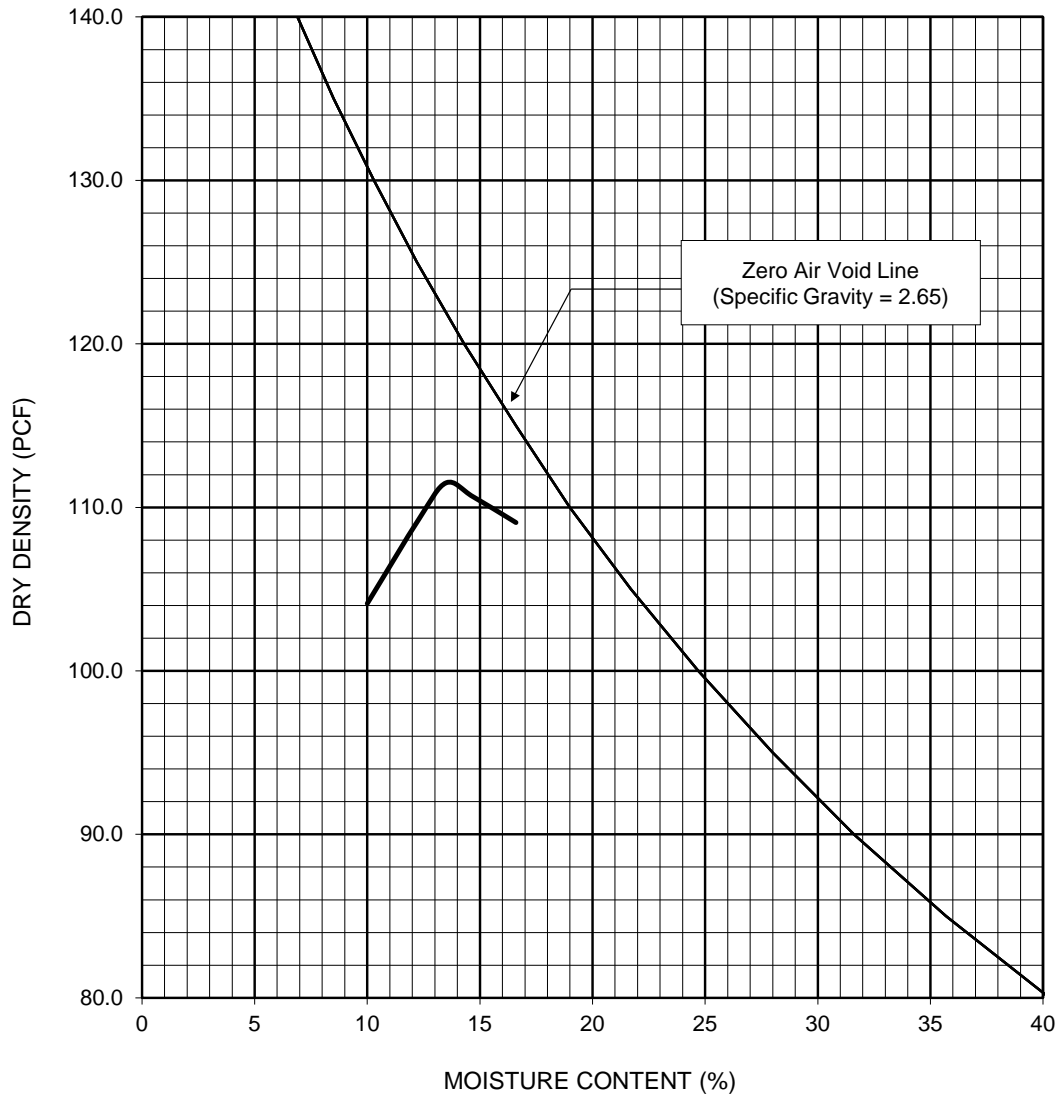
Sample Location	Depth (ft)	Soil Description	Maximum Dry Density (pcf)	Optimum Moisture Content (percent)
B-3, B-4, B-10, B-11	0.0-5.0	Brown Sandy Lean CLAY; Trace Gravel	111.5	13.5
Dry Density and Moisture Content Values Corrected for Oversize (ASTM D 4718)			N/A	N/A

PERFORMED IN GENERAL ACCORDANCE WITH  ASTM D 1557  ASTM D 698 METHOD  A  B  C
